Appendix D

Site Photos

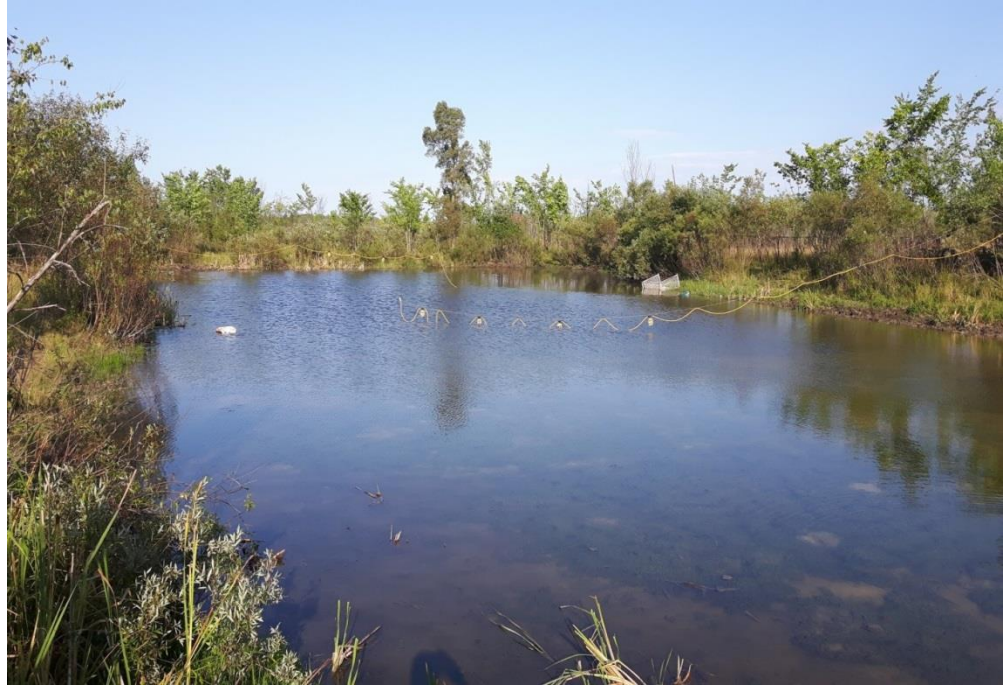
**Photograph 1,
facing east.** Water
body 1, located on a
residential property
southeast of the
intersection of
Hinch Road and
Rattie Road.

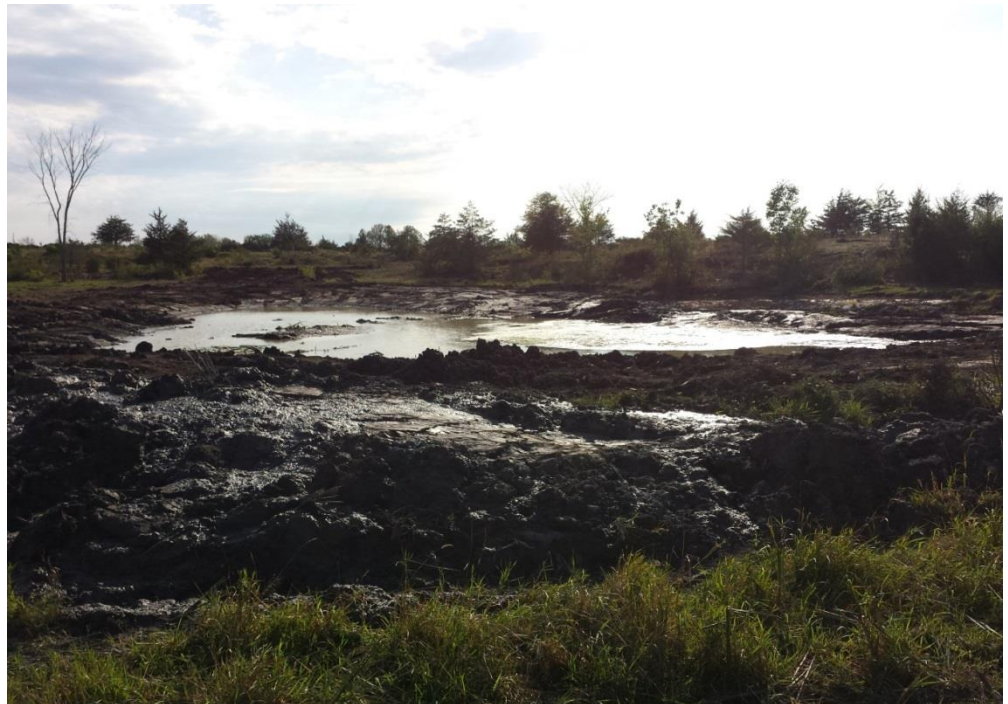
**Photograph 2,
facing west.**
Location of potential
water body 2,
determined to be a
dugout pond.

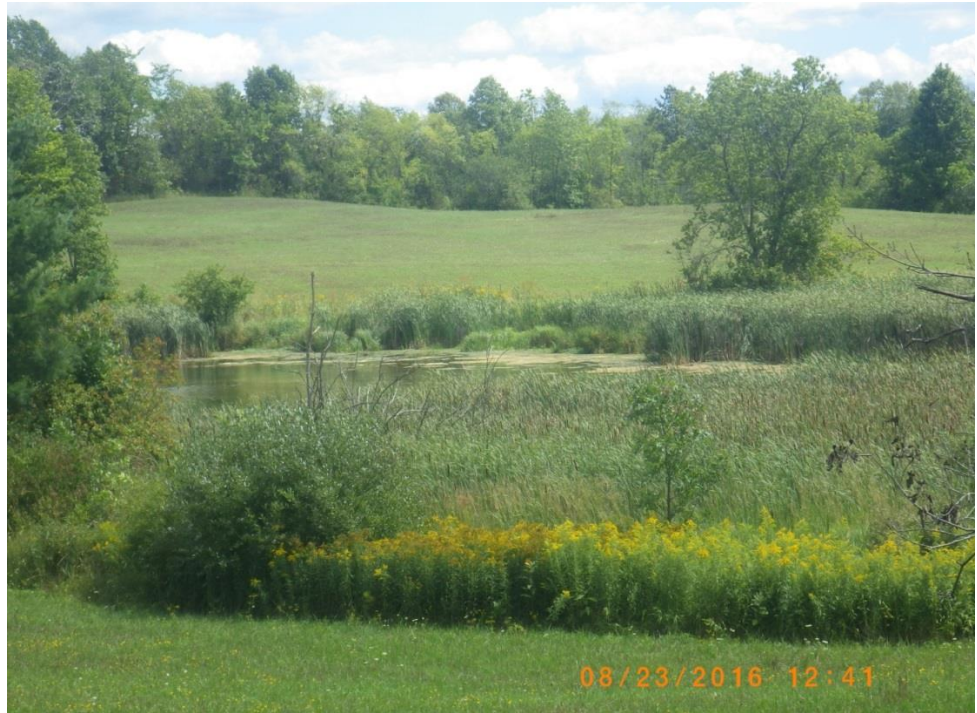
**Photograph 3,
facing southeast.**

Potential water body
3, determined to be
an area of shallow
open water within a
wetland. Photograph
taken from Edges
Road.

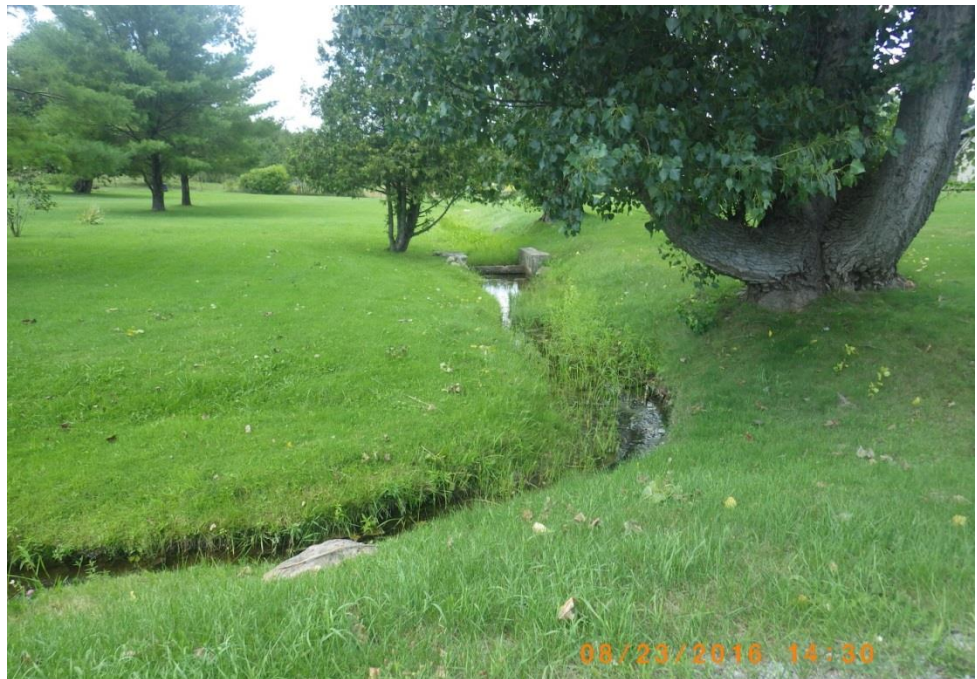
**Photograph 4,
facing north.**

Upstream end of Mud
Creek prior to crossing
Centreville Road.
Photo shows concrete
barrier that may
negatively impact fish
migration through the
watercourse.

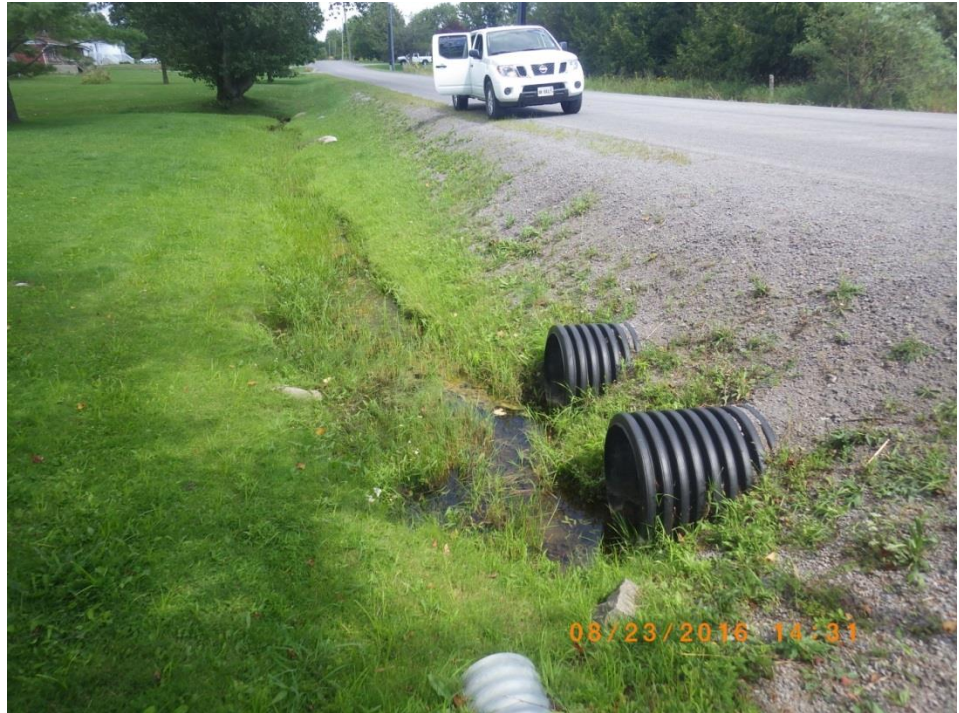
**Photograph 5,
facing east.**

Location of Mud Creek,
flowing southward
under Centreville road
via two culverts.

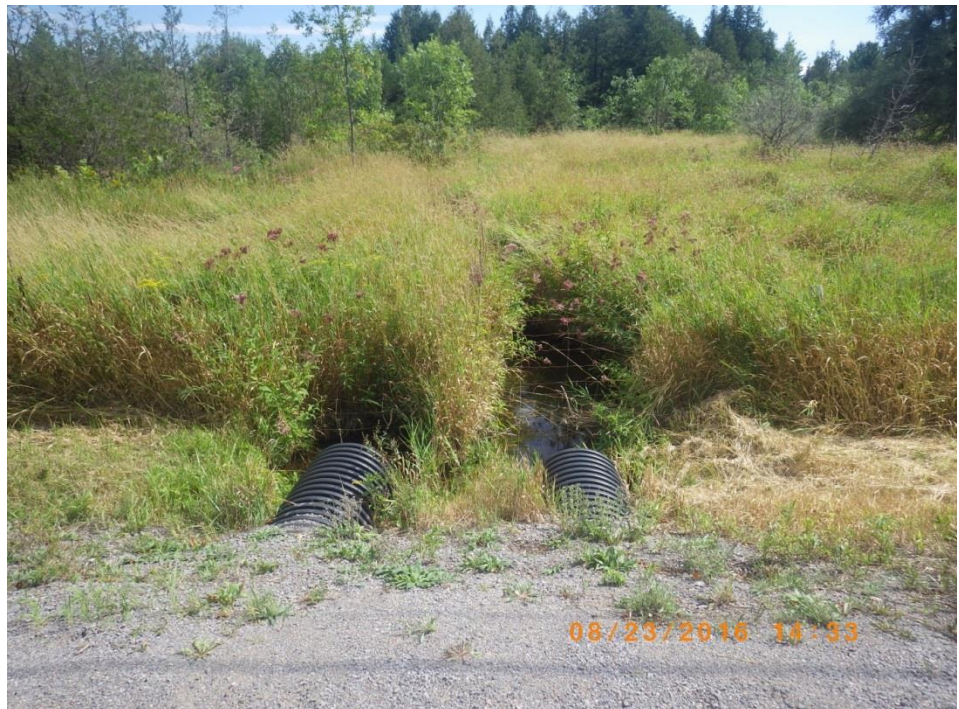
**Photograph 6,
facing south.**

Downstream end of
Mud Creek where it
crosses Centreville
Road, flowing
southward into an
adjacent Reed Canary
Grass Mineral Meadow
Marsh.

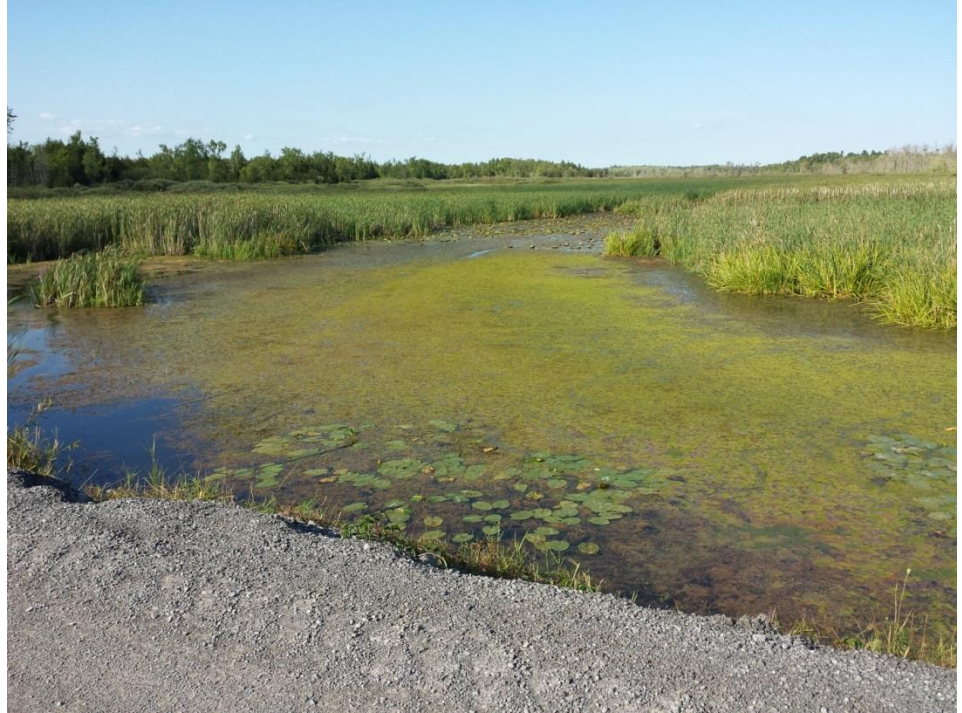
**Photograph 7,
facing southwest.**

Mud Creek, flowing
under Rattie Road
within the Project
Location via a series of
CSP culverts.

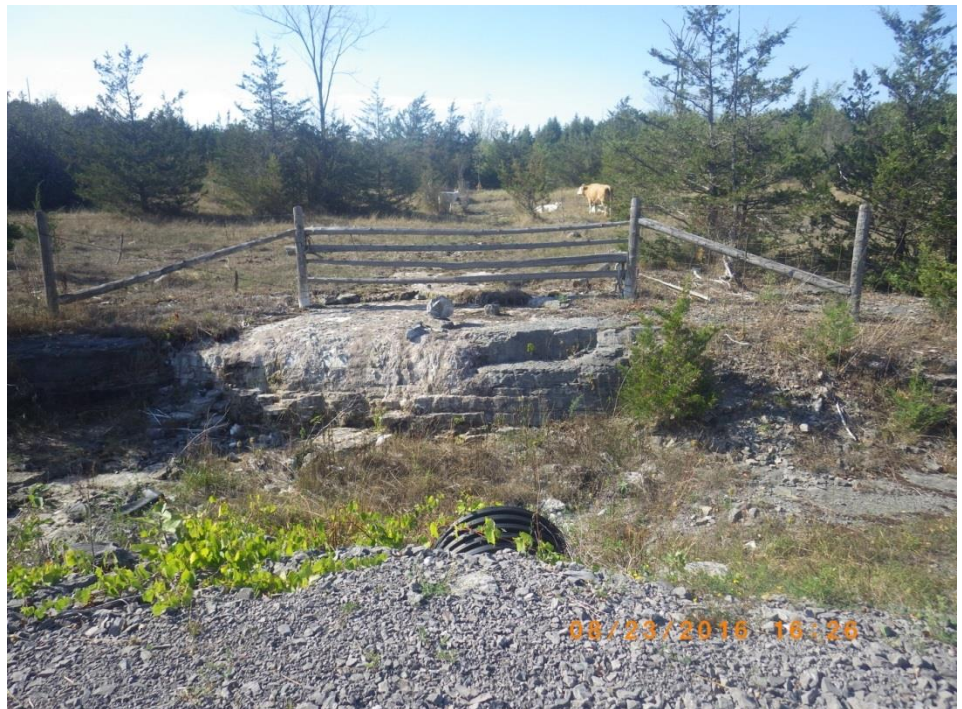
**Photograph 8,
facing north.**

Location of Tributary 1
to Mud Creek,
determined to be a
shallow grassed
spillway used for
drainage of the
surrounding pasture
area.

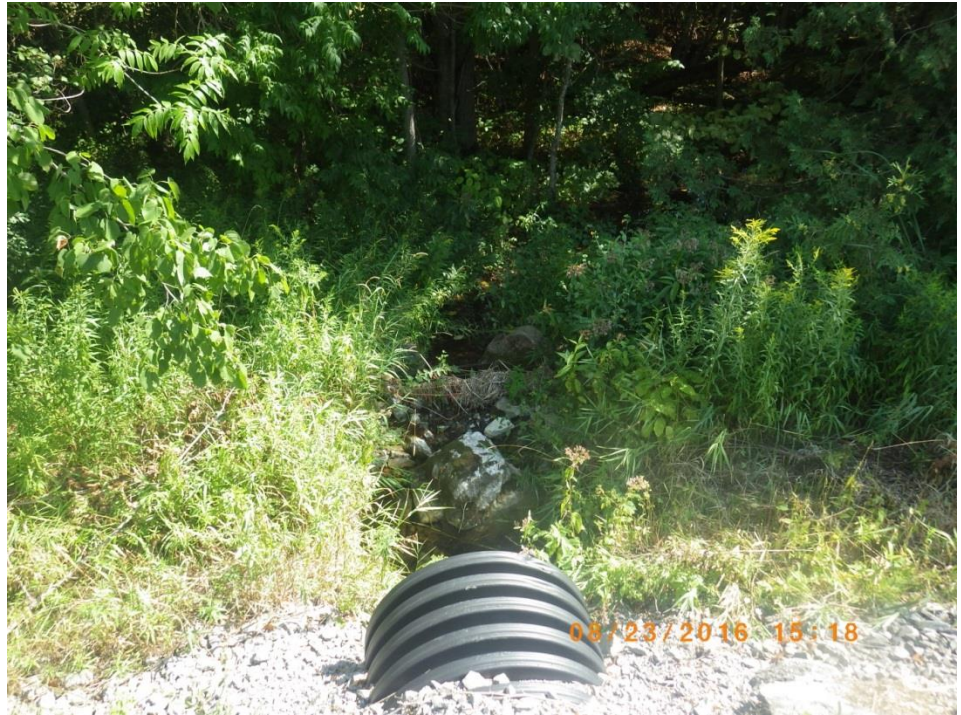
**Photograph 9,
facing south.**

Location of Tributary 2
to Mud Creek, flowing
southward under
Centreville road via an
culvert.

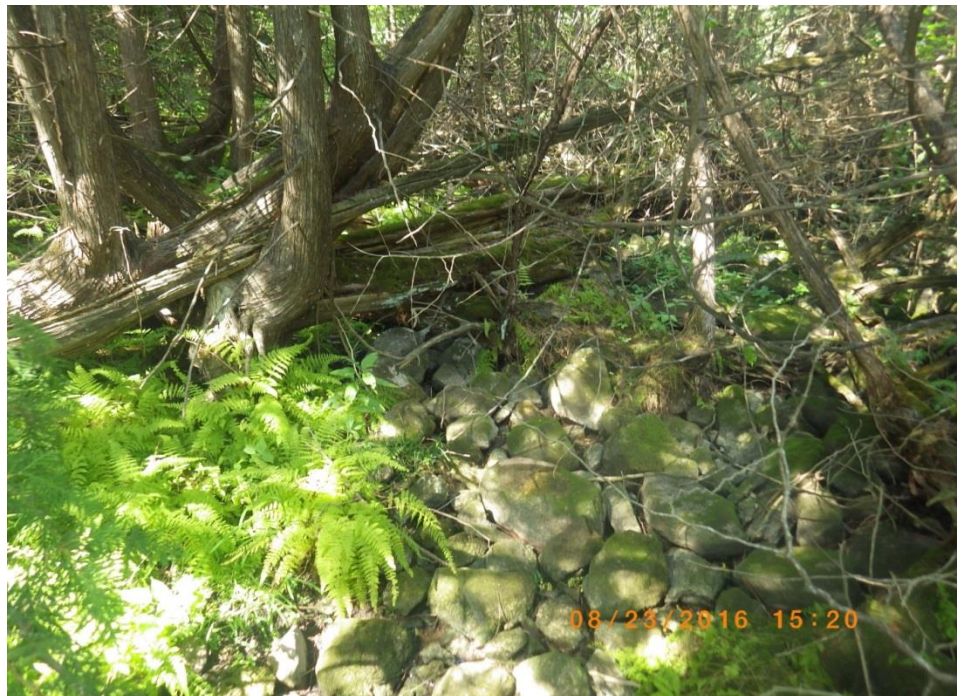
**Photograph 10,
facing northeast.**

Substrates found within
Tributary 2 to Mud
Creek were pre-
dominantly cobble,
gravel and boulders.

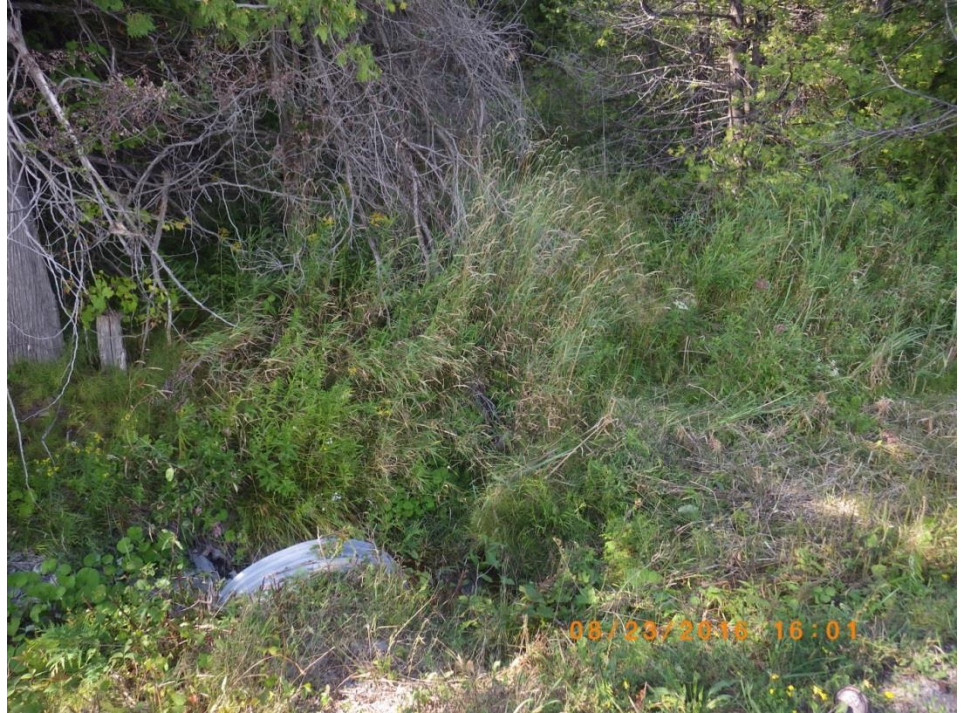
**Photograph 11,
facing northeast.**
Upstream end of
Tributary 2.1 to Mud
Creek at the
intersection with the
Project Location on
Centreville Road, facing
upstream.

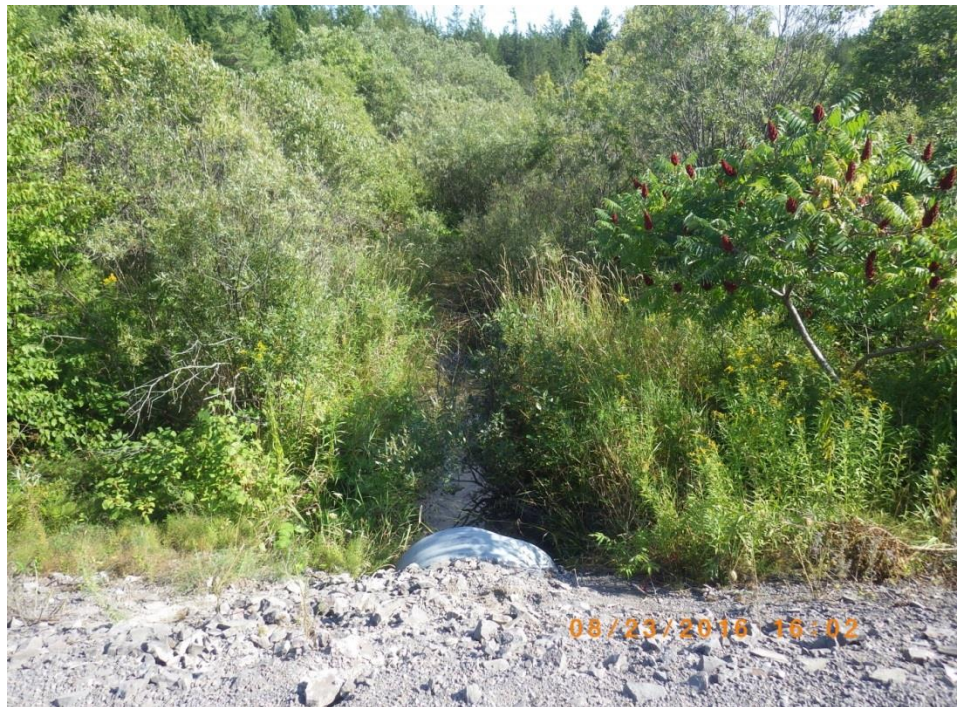
**Photograph 12,
facing south.**
Downstream end of
Tributary 2.1 to Mud
Creek at the
intersection with the
Project Location on
Centreville Road, facing
downstream.

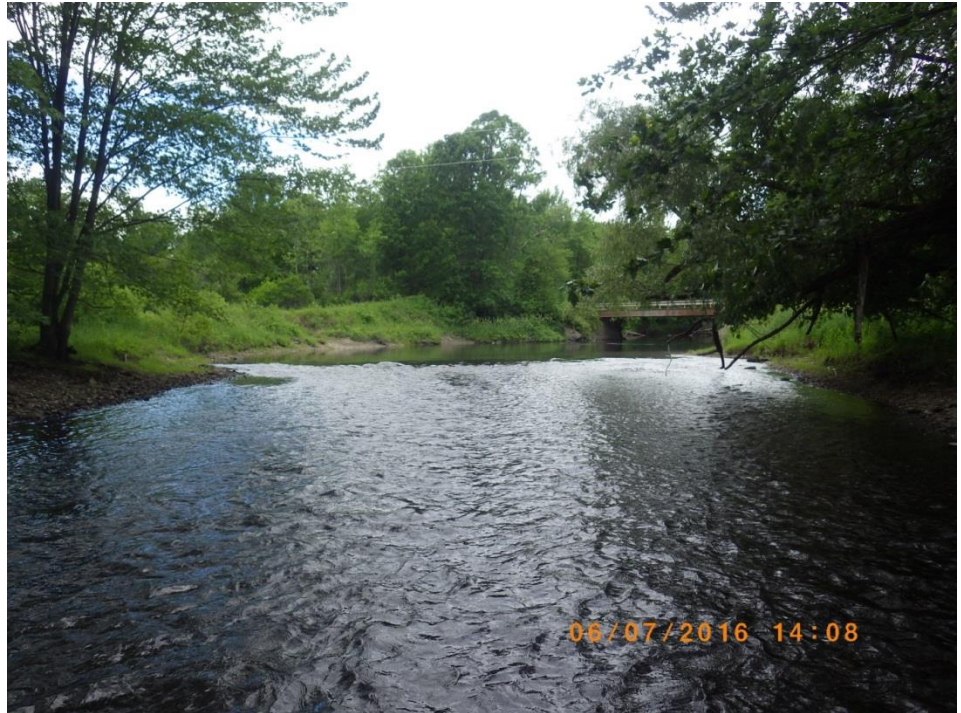
**Photograph 13,
facing northeast.**

Location of Salmon River, facing upstream towards the intersection with Sheffield Bridge Road.

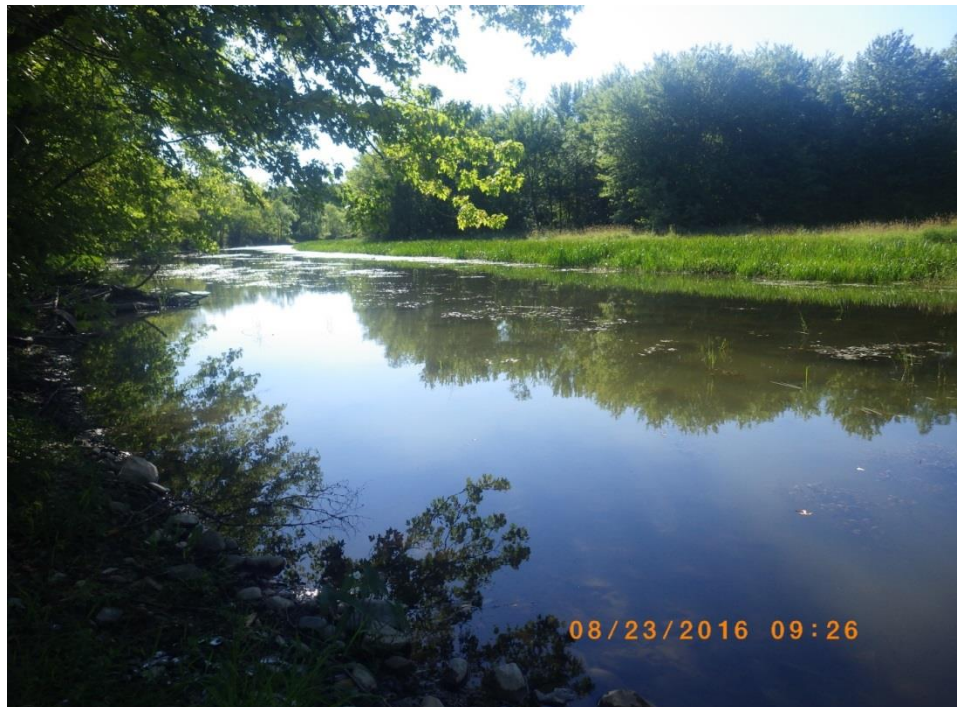
**Photograph 14,
facing southeast.**

Habitat within the Salmon River was observed as primarily flat morphology. Photo taken near Sheffield Bridge Road when Salmon River flows within 120 m setback of the Project Location.

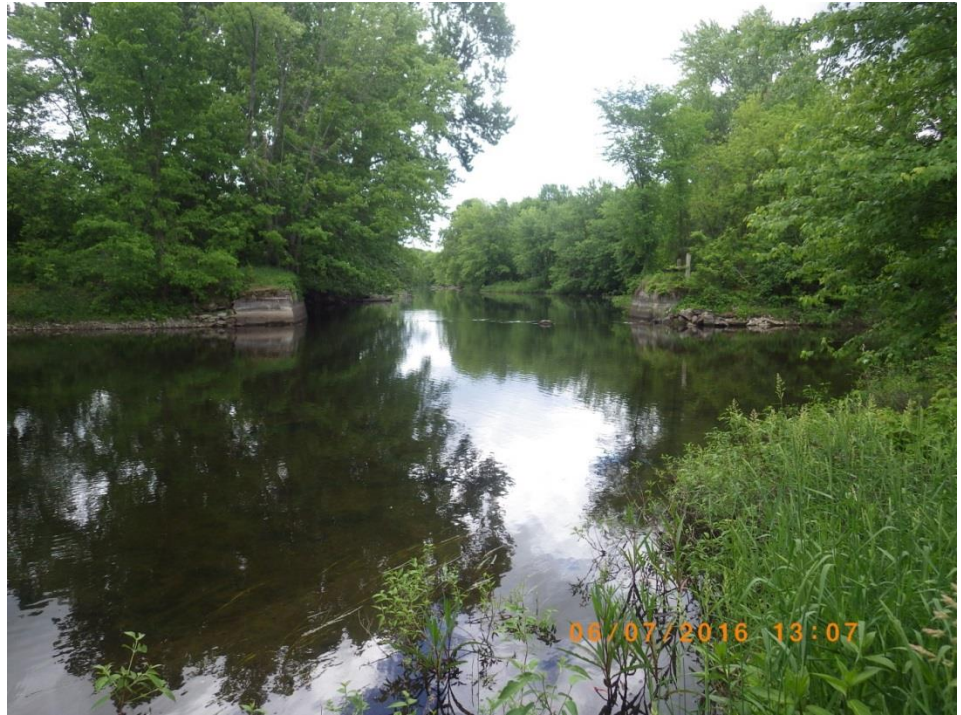
**Photograph 15,
facing south.**

Salmon River, facing
downstream toward
the intersection of the
River with the Project
near Haggerty Road.

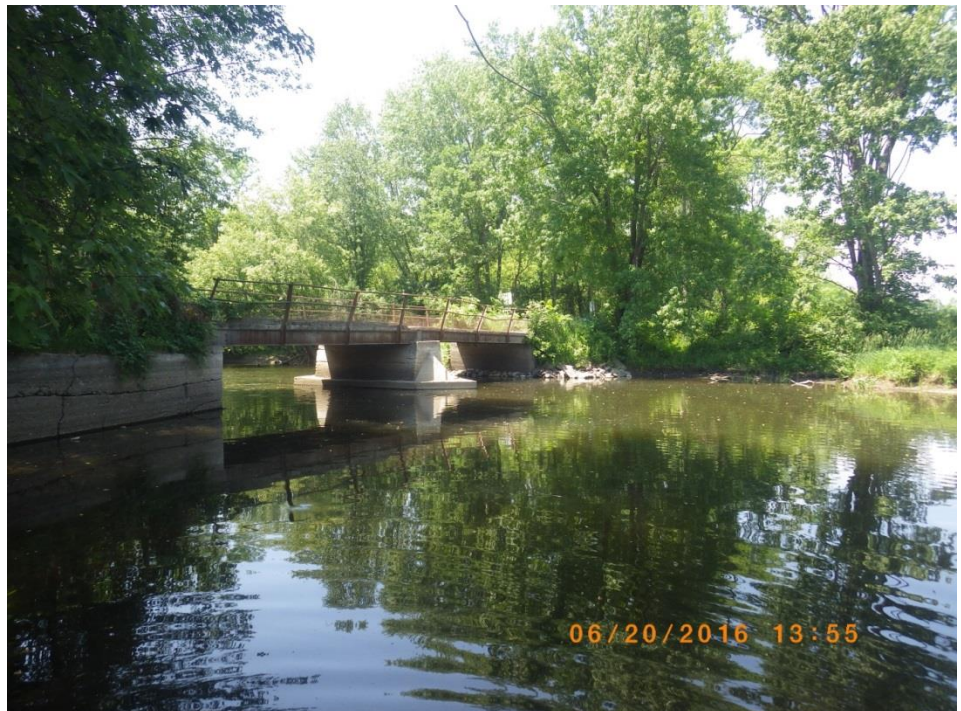
Photograph 16
Salmon River at
intersection with
Teskey Road.

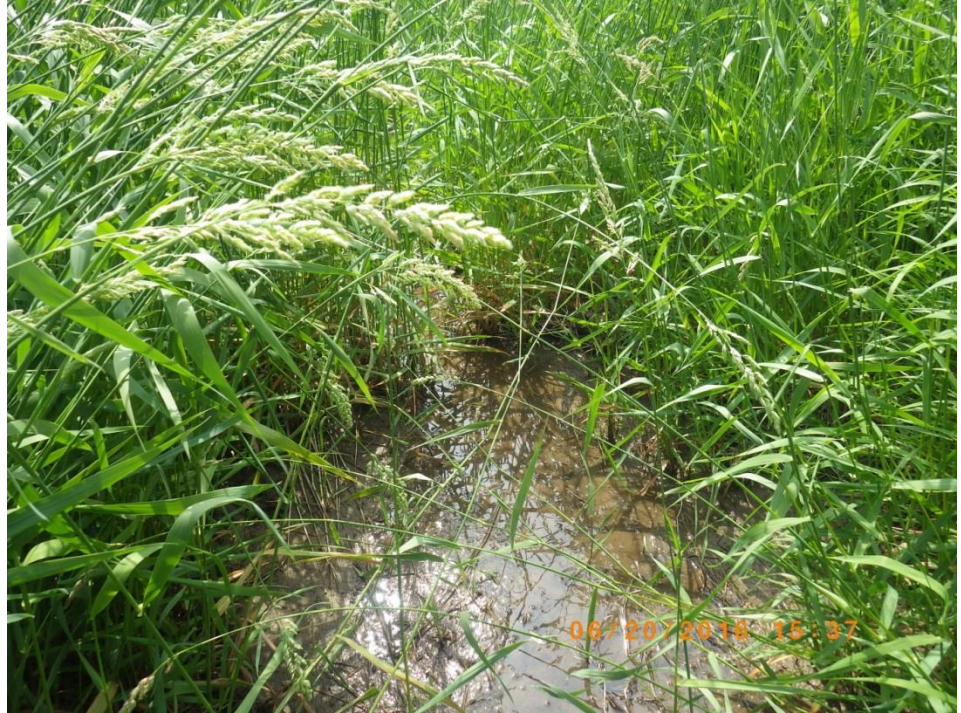
**Photograph 17,
facing west.**

Tributary 1 to the Salmon River was surrounded by meadow habitat, with overhanging vegetation providing in-stream cover. Muck was observed as the dominant substrate. Photo taken upstream of the intersection with Teskey Road.

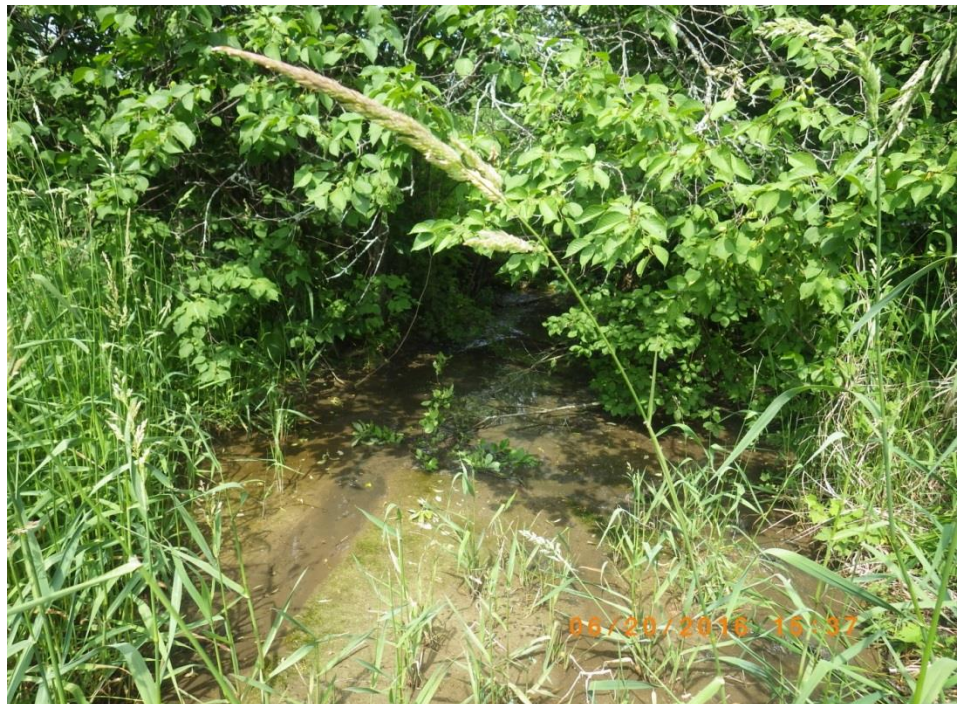
**Photograph 18,
facing east.**

Tributary 1 to the Salmon River. Photo taken downstream of intersection with Teskey Road.

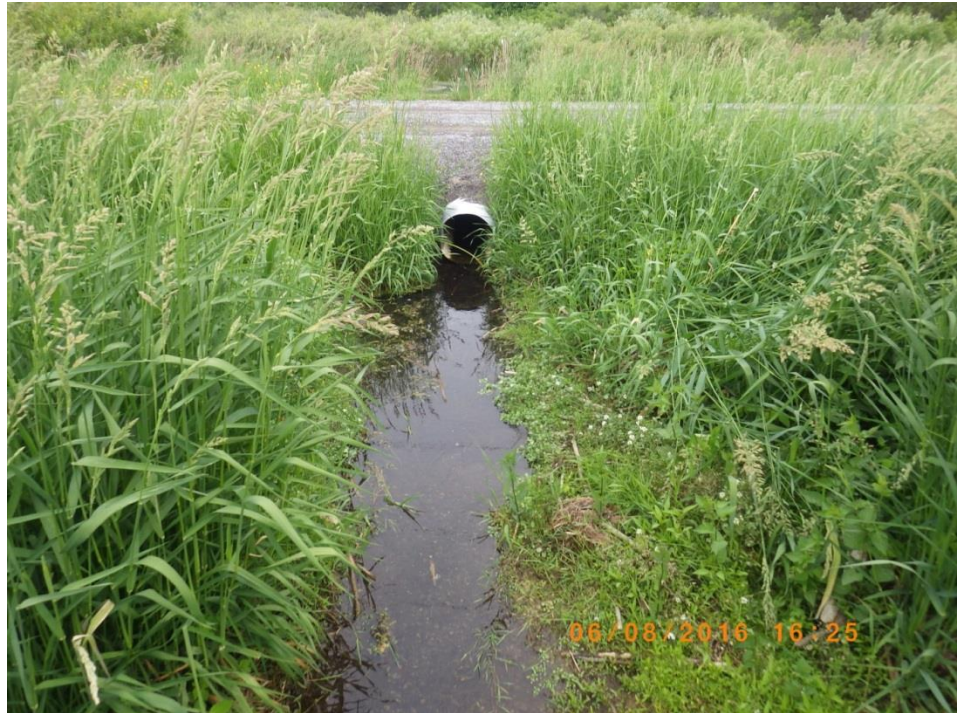
**Photograph 19,
facing west.**

Tributary 2 to the
Salmon River, flowing
westward within the
Project Location under
Edges Road via a CSP
culvert.

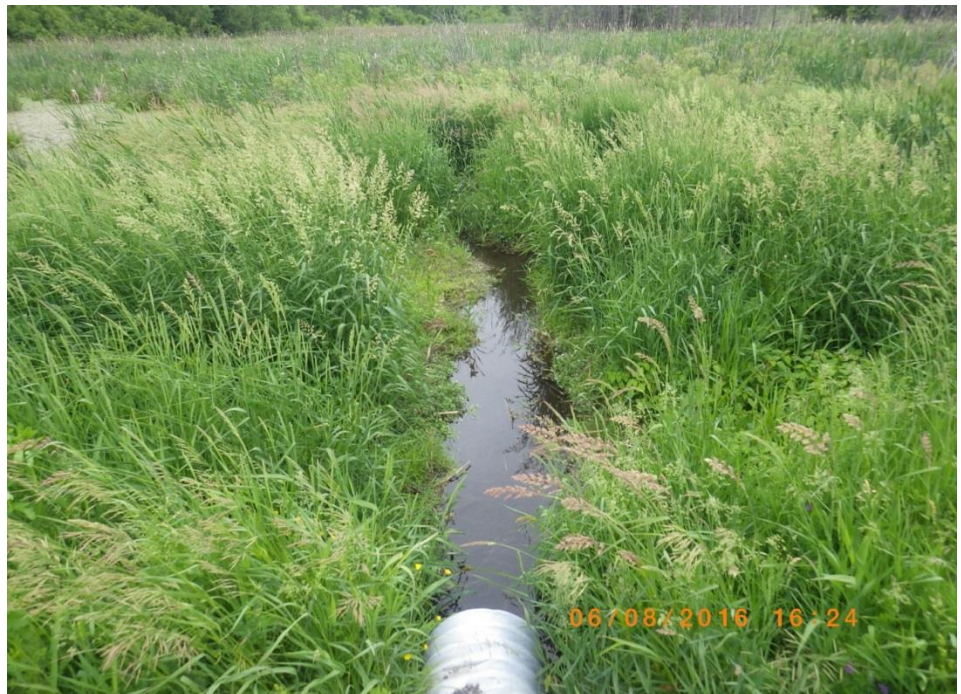
**Photograph 20,
facing west.**

Downstream end of
Tributary 2 to the
Salmon River.

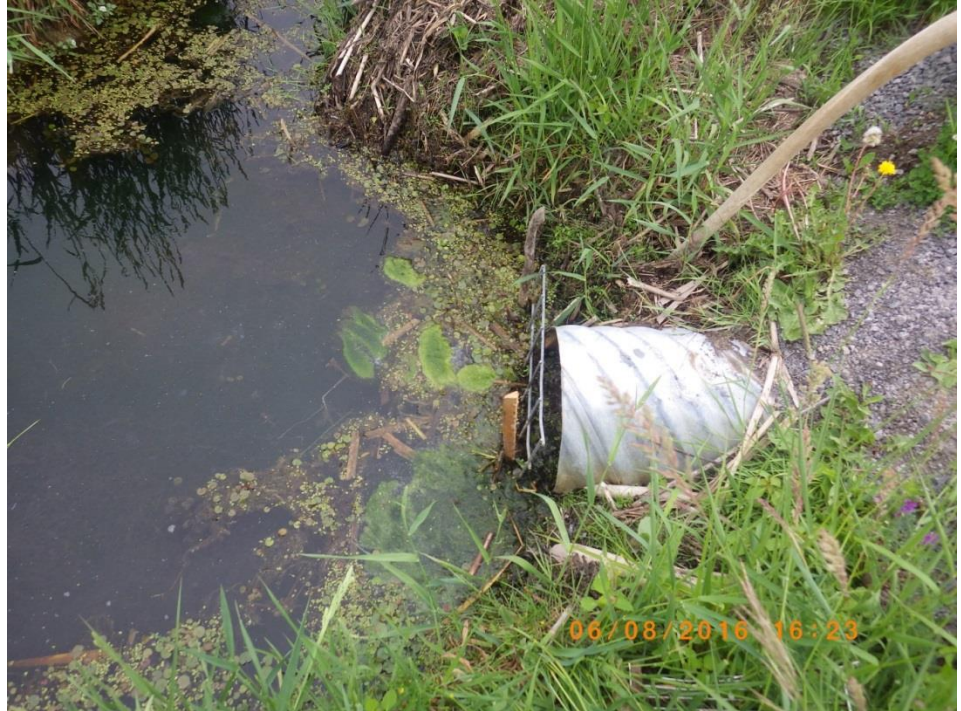
**Photograph 21,
facing northeast.**

A small grate attached to the upstream end of the culvert at the intersection of Tributary 2 to the Salmon River and Edges Road could provide migratory obstruction for various fish species.

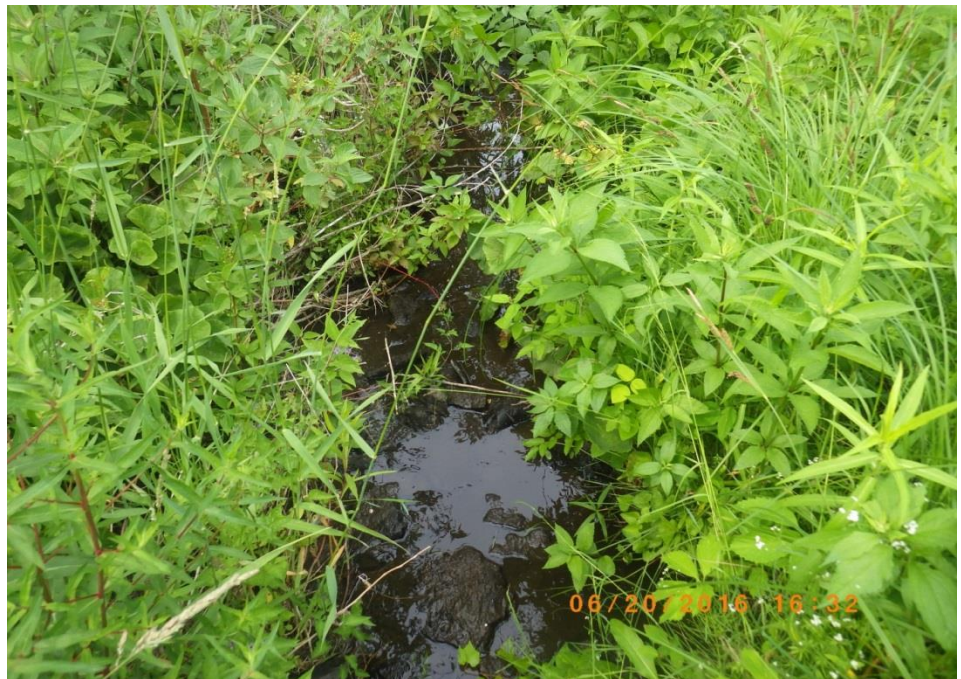
**Photograph 22,
facing south.**

Tributary 2.1 to the Salmon River. Photo taken facing upstream near the intersection with County Road 27, east of Teskey Road.

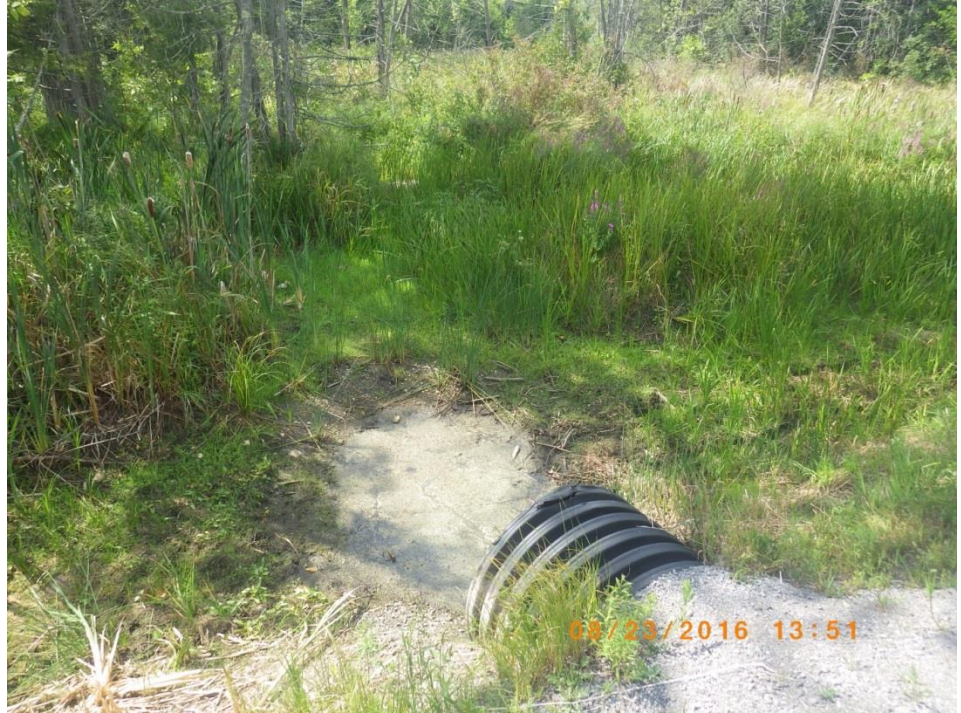
**Photograph 23,
facing west.**

Tributary 2.1 to the
Salmon River at
intersection with
County Road 27, south
of Marlin Road. Photo
taken facing
downstream.

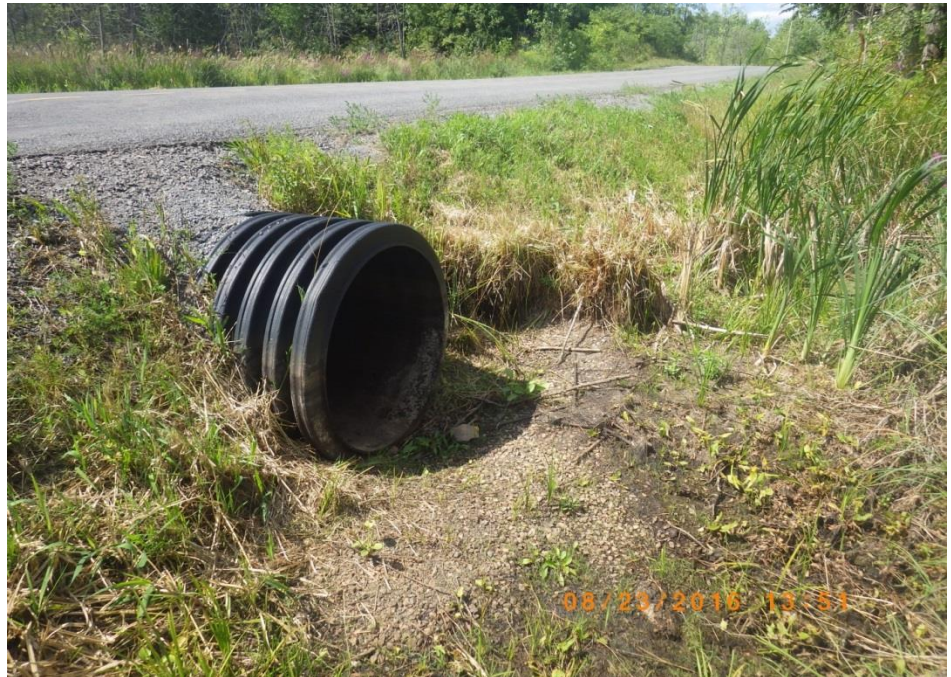
**Photograph 24,
facing southeast.**

Tributary 2.1 to the
Salmon River at
intersection with
County Road 27, south
of Marlin Road. Photo
taken facing upstream
end of culvert.

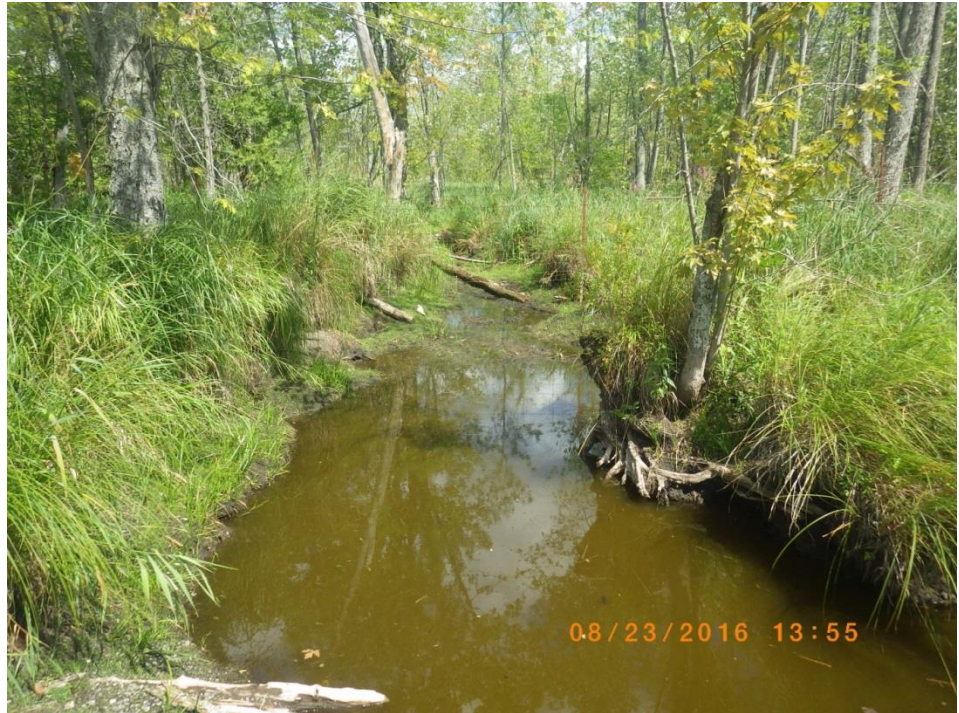
**Photograph 25,
facing northeast.**

Tributary 2.1 to the
Salmon River at pool
area approximately 50
m south of the
intersection with
County Road 27, south
of Marlin Road.

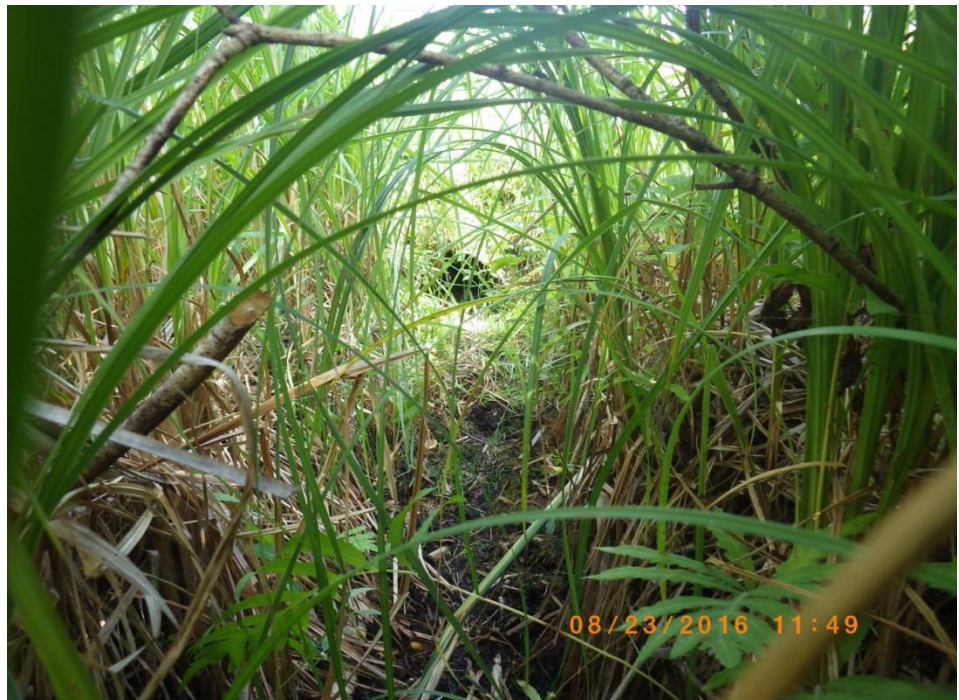
**Photograph 26,
facing west.**

Tributary 2.2 to the
Salmon River. Photo
taken facing
downstream towards
the CSP culvert at the
intersection with
Edges Road.

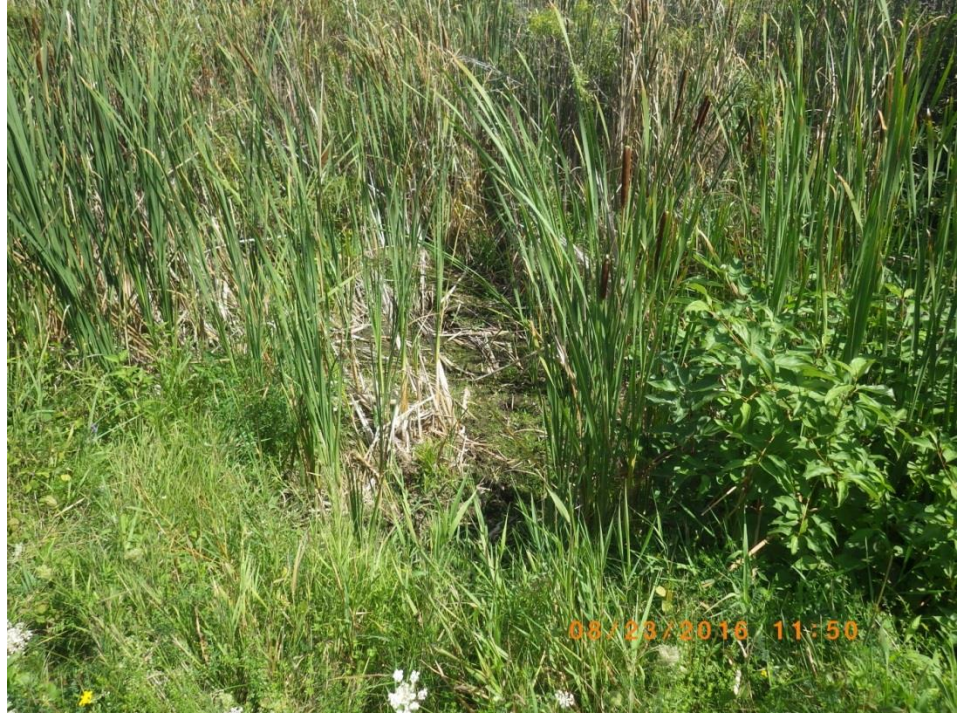
**Photograph 27,
facing west.**

Intersection of
Tributary 2.2 to the
Salmon River with
Edges Road. Photo
taken from the road.

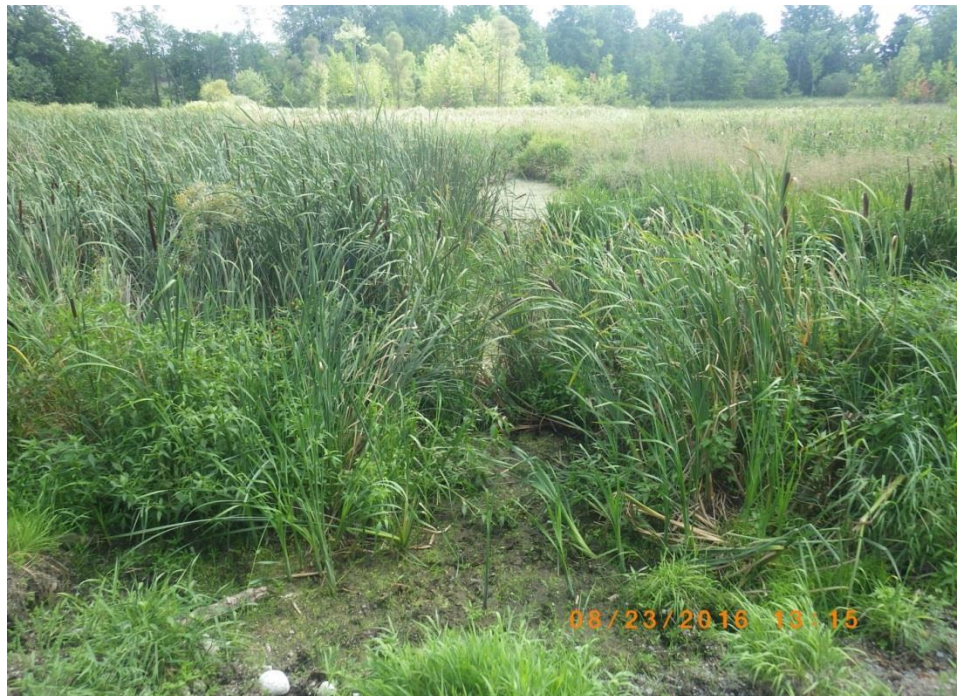
**Photograph 28,
facing southeast.**

Potential Tributary 2.3
to the Salmon River
was found to be an
area of open water
associated with a
wetland, southeast of
Marlin Road. Not an
applicable water body.

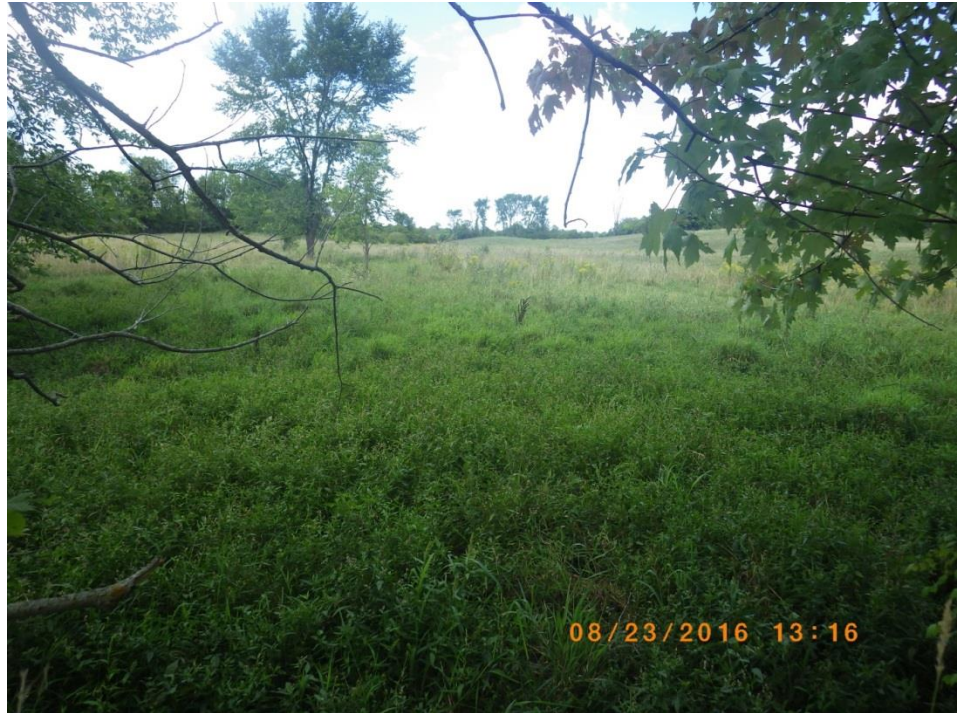
**Photograph 29,
facing northwest.**

Area where Tributary 2.3 to the Salmon River was mapped during records review. No evidence of a watercourse was observed downstream of the culvert location adjacent to the wetland on Marlin Road.

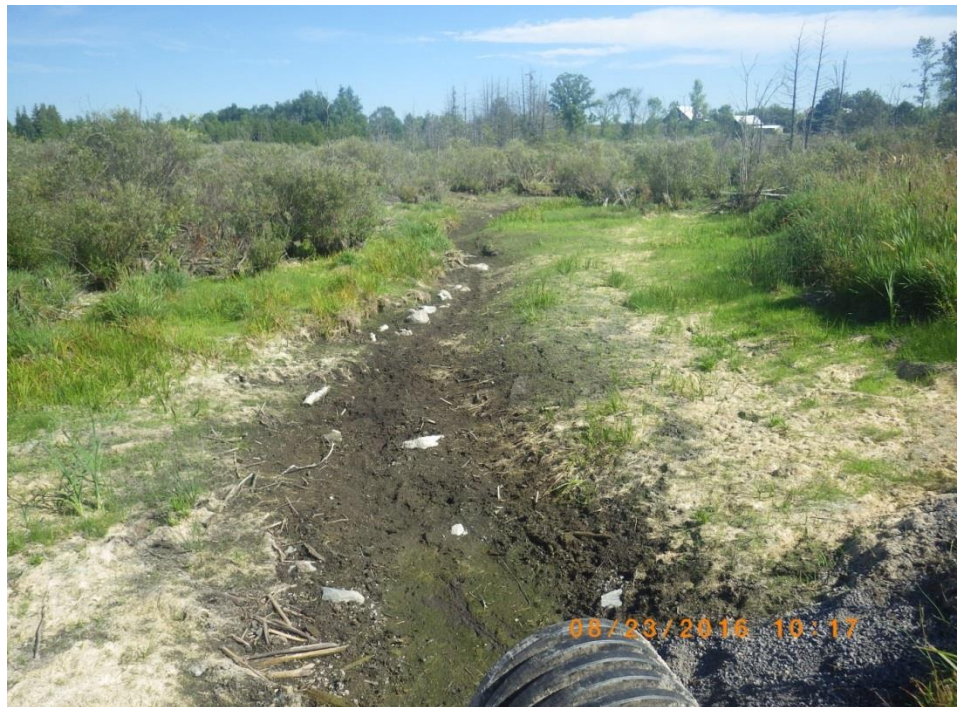
**Photograph 30,
facing northeast.**

Tributary 3 to the Salmon River at intersection with Haggerty Road.

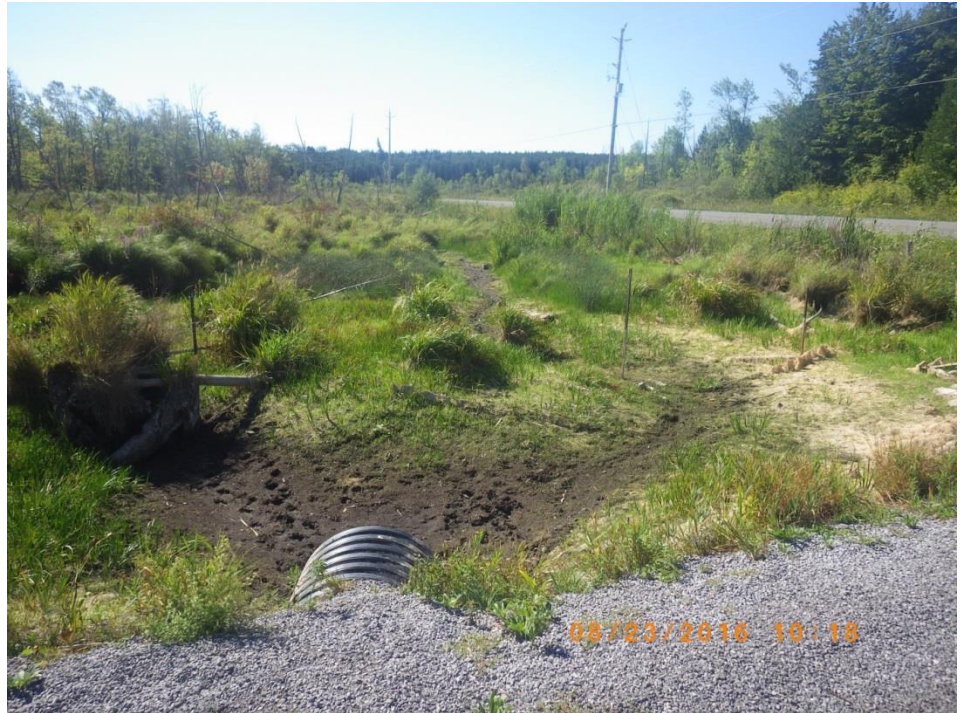
**Photograph 31,
facing southwest.**
Tributary 3 to the
Salmon River at
intersection with
Haggerty Road.

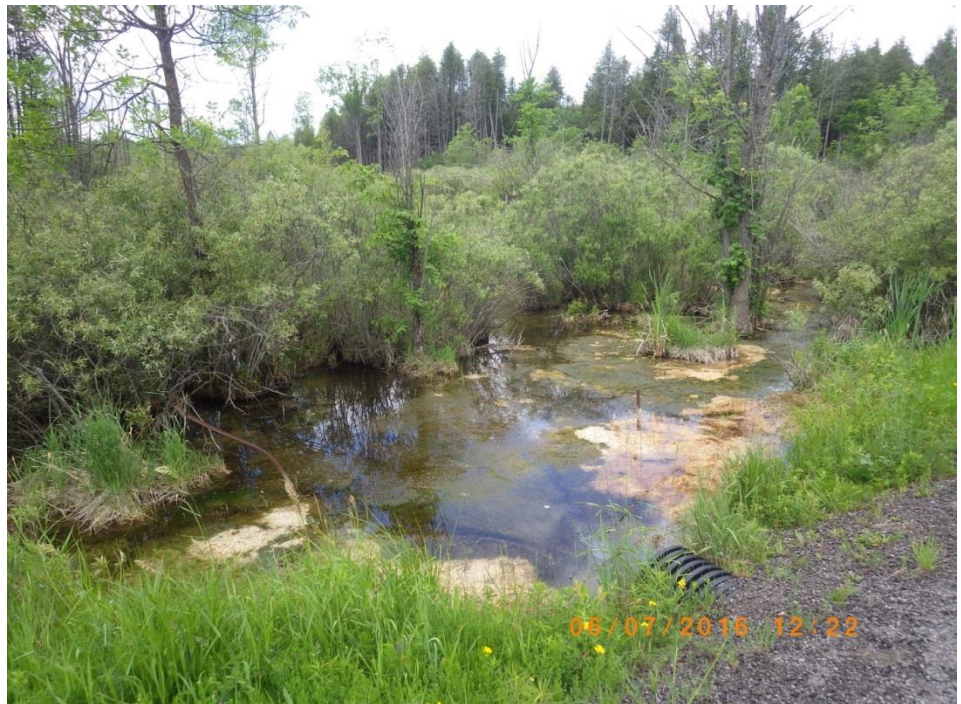
**Photograph 32,
facing northwest.**
Upstream end of
Tributary 3.1 of the
Salmon River at the
intersection with the
Project Location on
Miller Road, facing
upstream.
