Appendix D

Site Photos

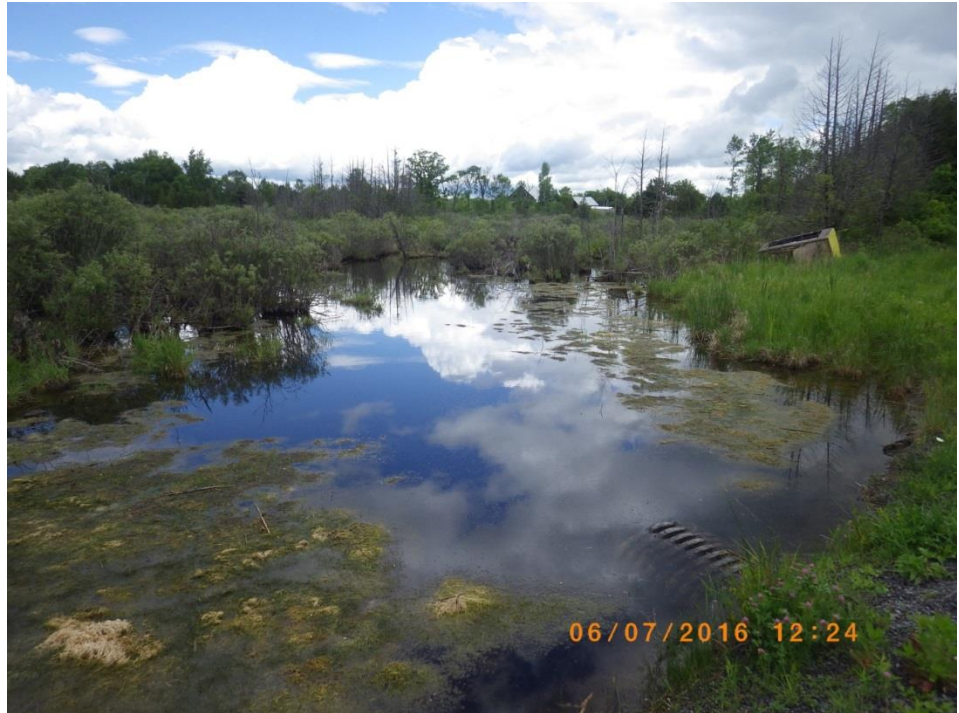
**Photograph 33,
facing southeast.**
Downstream end of
Tributary 3.1 of the
Salmon River at the
intersection with the
Project Location on
Miller Road, facing
downstream.

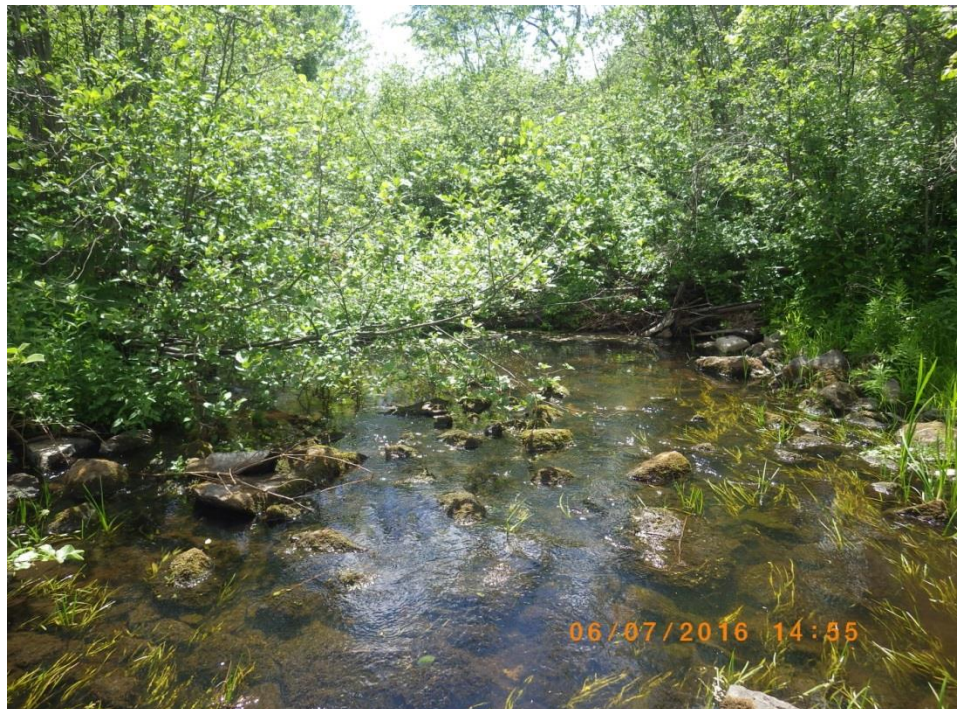
**Photograph 34,
facing west.**
Downstream end of
intersection between
Black Creek and the
Project Location on
Murphy Road.

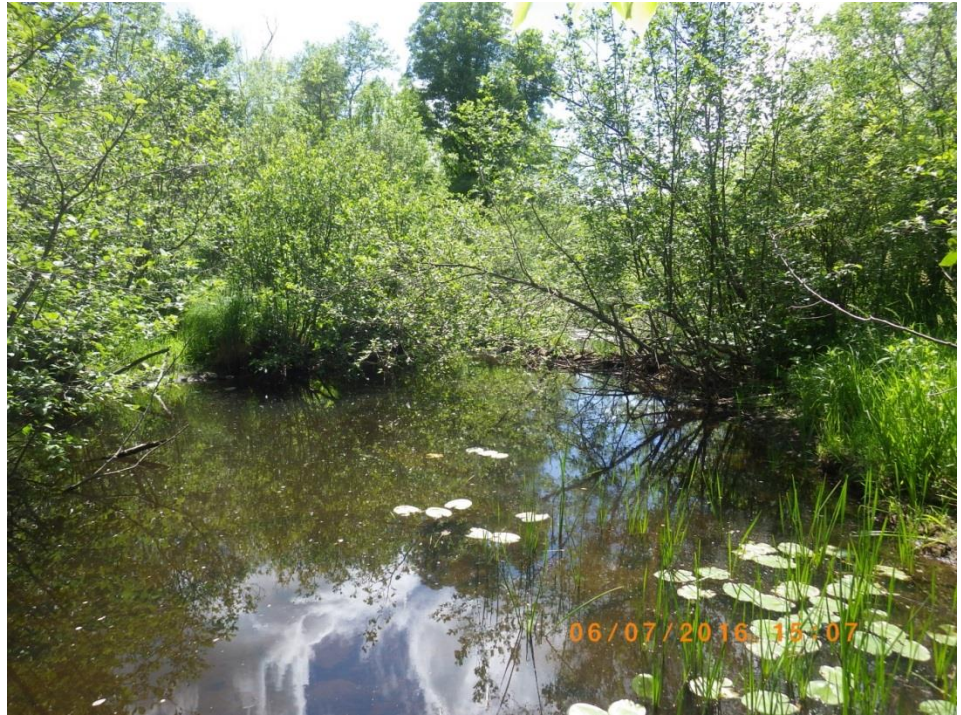
**Photograph 35,
facing east.**

Upstream end of
intersection between
Black Creek and the
Project Location on
Murphy Road, facing
upstream.

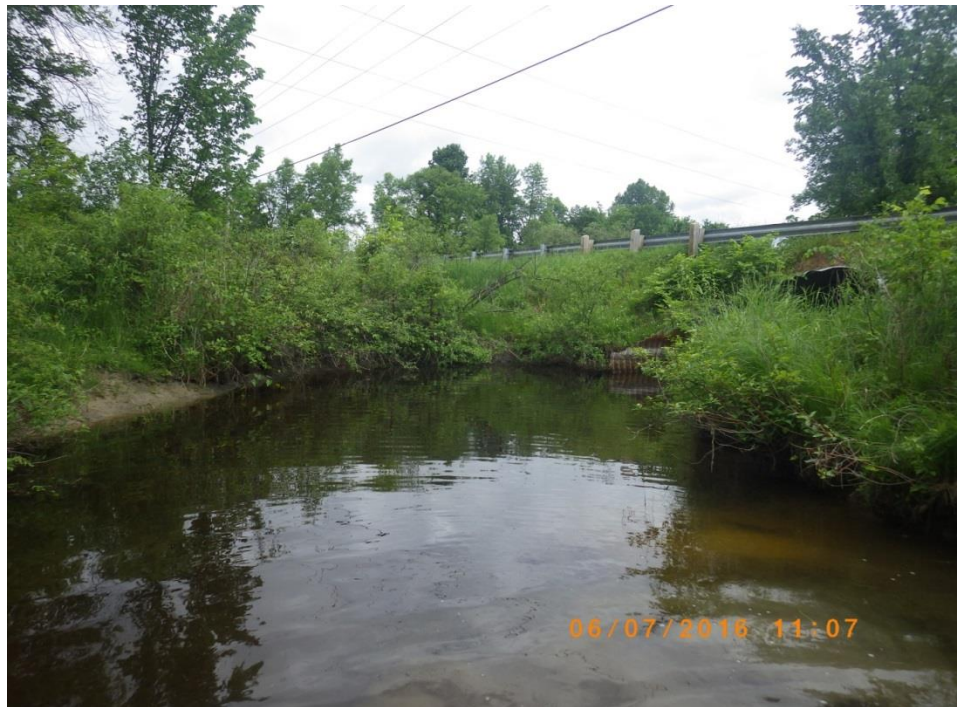
**Photograph 36,
facing east.**

Upstream end of
Pennell's Creek near
intersection with the
Project Location on
Miller Road, facing
downstream.

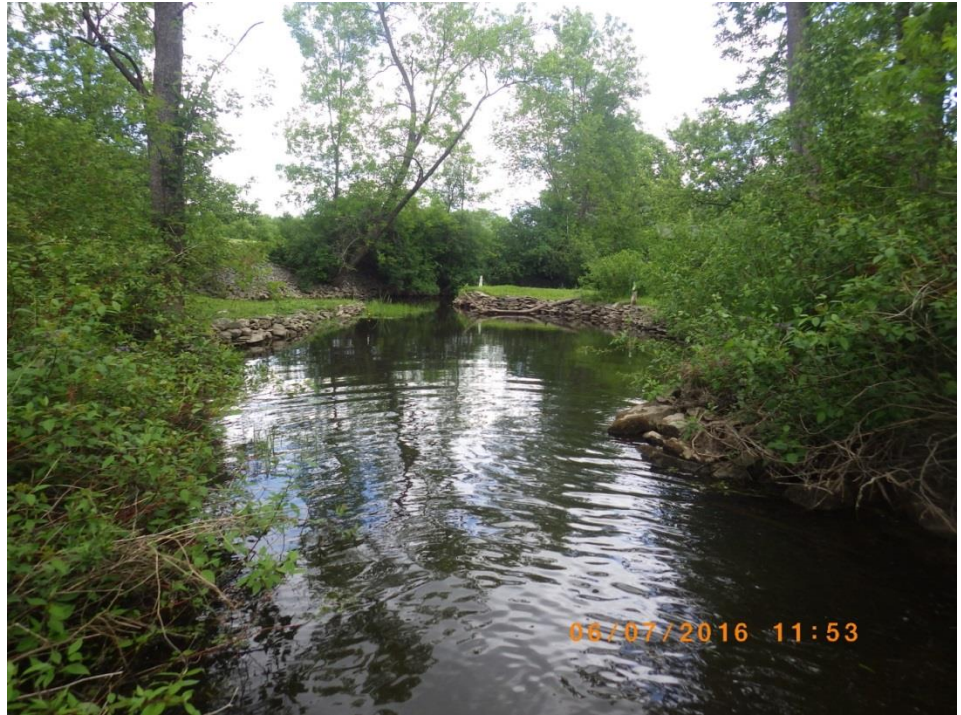
**Photograph 37,
facing east.**

Downstream end of
Pennell's Creek near
intersection with the
Project Location on
Miller Road, facing
downstream.

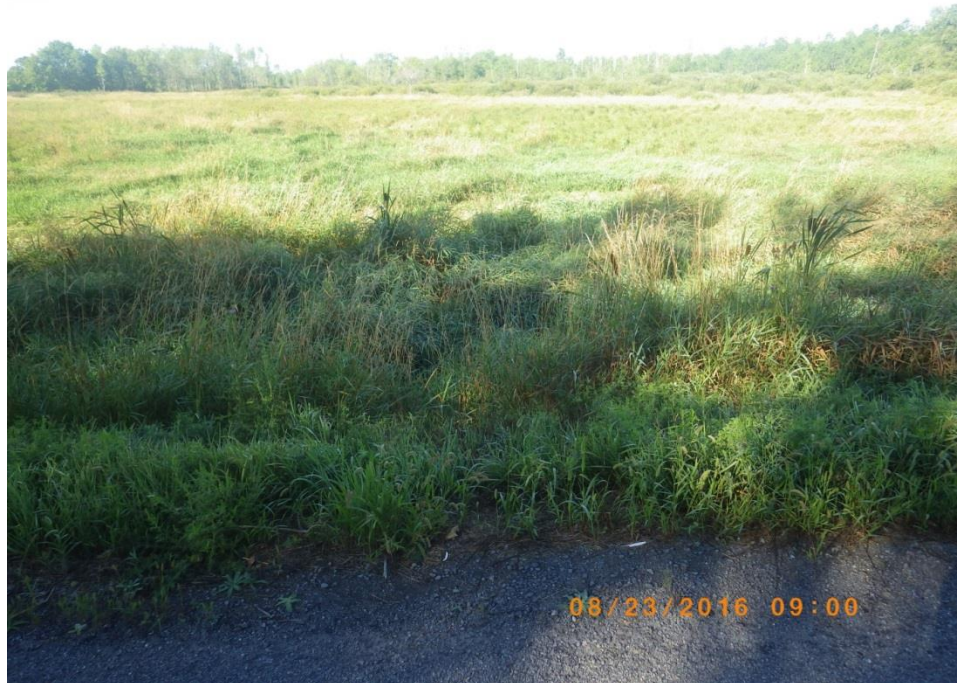
**Photograph 38,
facing west.**

Evidence of the
mapped Tributary to
Pennell's Creek was
not observed in
assessment location.
Mapped watercourse
is estimated to be a
combination of
drainage swales
through the
agricultural field to the
east and surface water
in the grassed
roadside ditches.
