**Loyalist Solar Project
L-006345-SPV-001-054
Cultural Heritage Assessment
Township of Stone Mills
Multiple Lots and Concessions
Geographic Township of Camden East
County of Lennox and Addington, Ontario**

HR-082-2016

04/02/2017
Revised

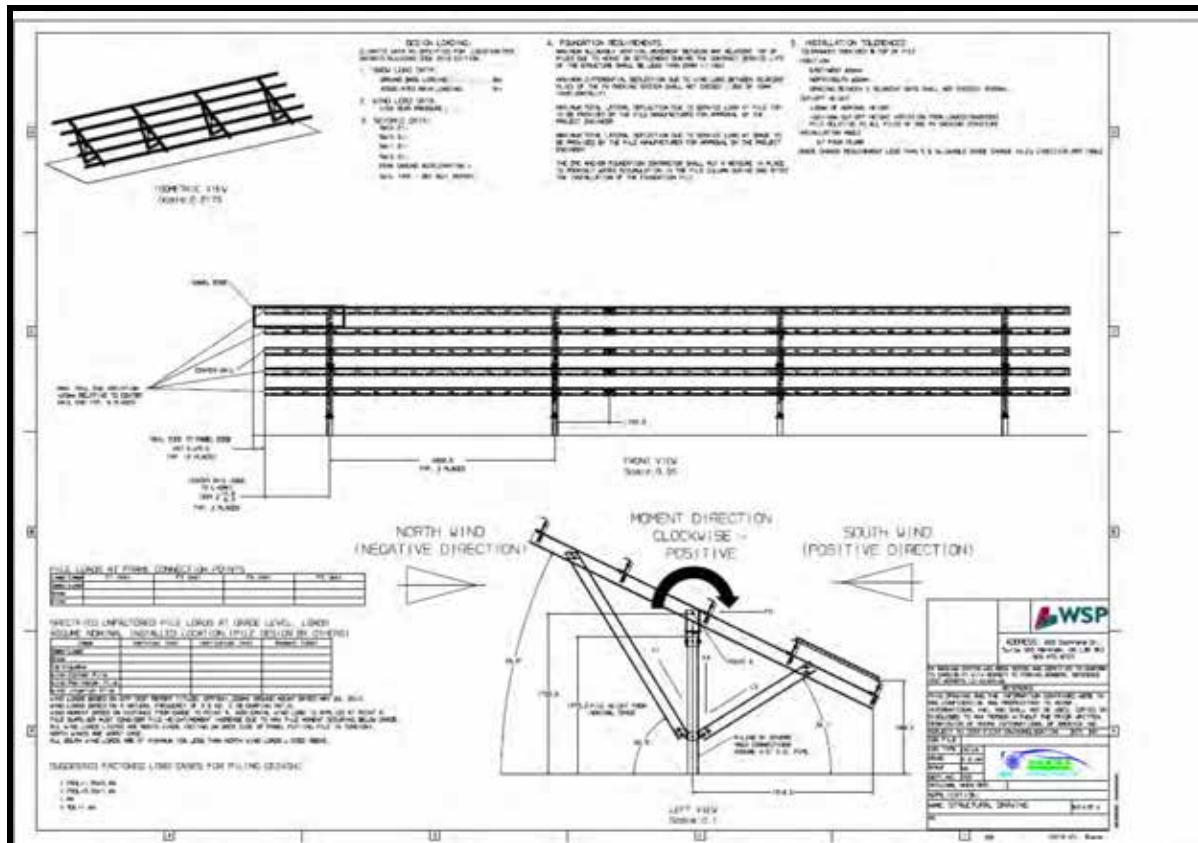
Image 9: Schematic of racking system and panel
(Provided by BluEarth)

As outlined in the *Draft Project Description Report*: “The PV panels will be aligned in rows to be spaced 5 to 12 m apart and will be mounted on racking structures” (Dillon Consulting 2016a: 10). Image 10 shows this typical Solar Farm layout, which shows the extent and density of the infrastructure on the landscape. Image 11 is an illustrative example of the solar panel and racking systems sale in relation to existing buildings and structures on the landscape.

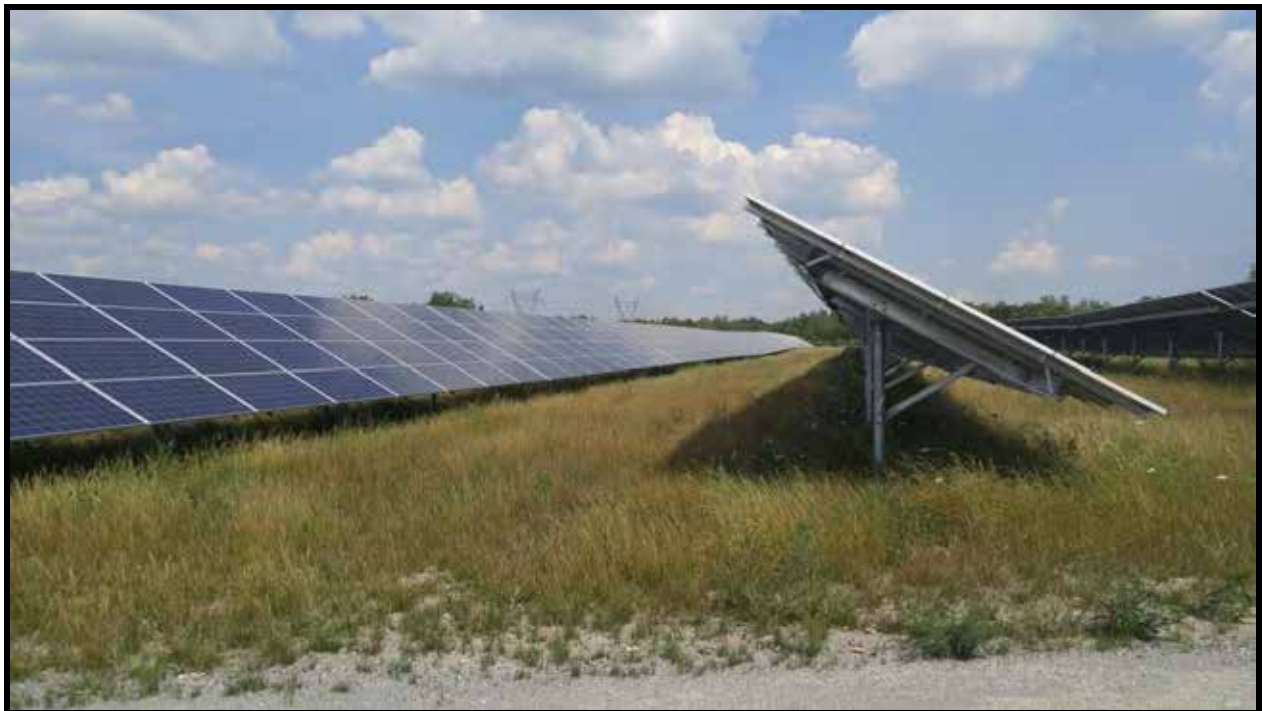
Image 10: View of Typical Solar Farm Layout

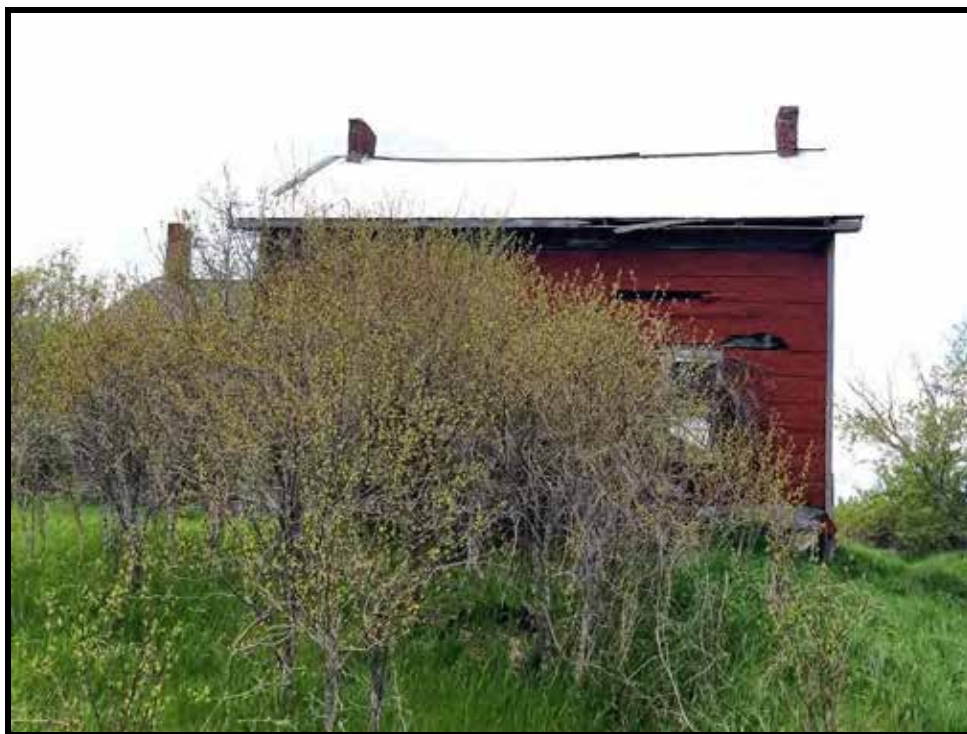
Image 12: Façade of 697 Hinch Road (NAP021)
(Photo taken on May 19, 2016; Facing North)

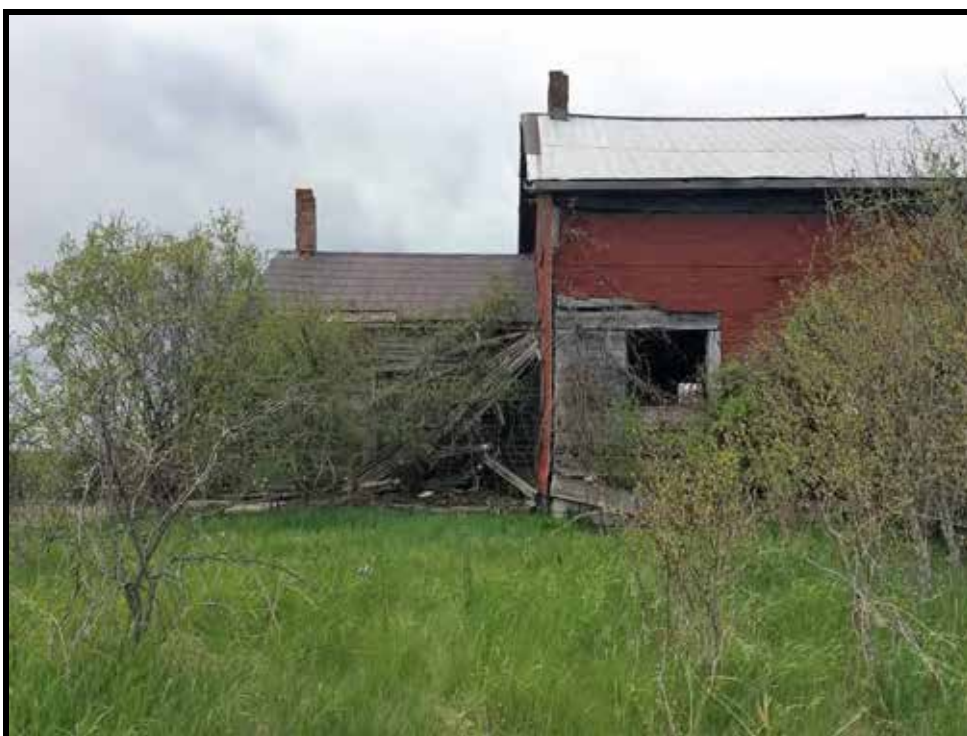
Image 13: Detail of Façade of 697 Hinch Road (NAP021)
(Photo taken on May 19, 2016; Facing North)

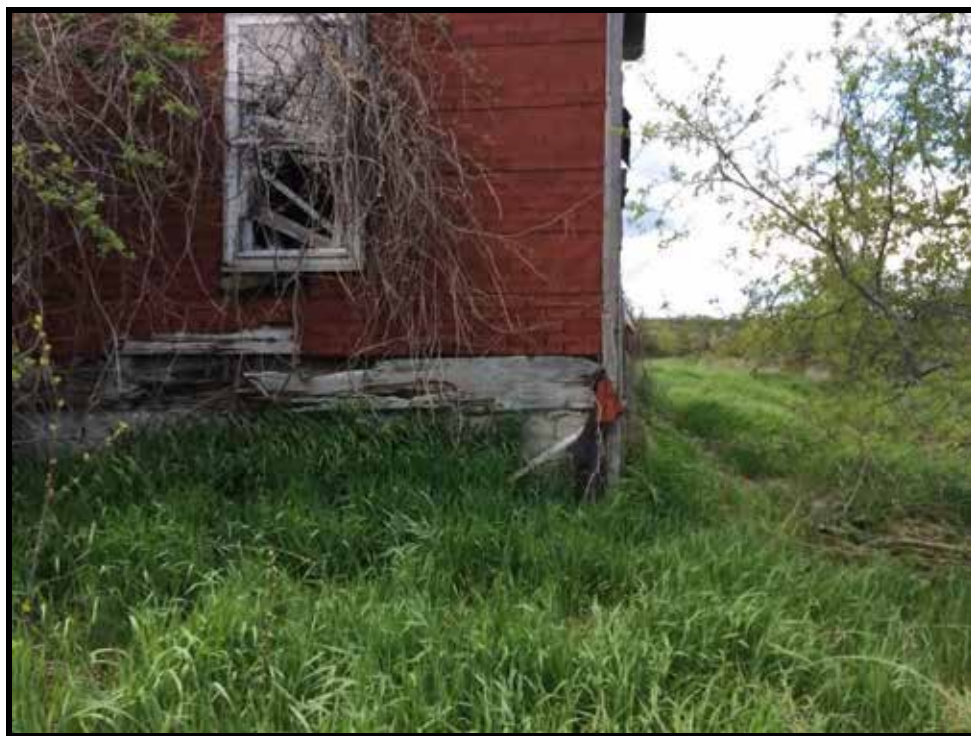
Image 14: Detail of Clapboard under Insulbrick of 697 Hinch Road (NAP021)
(Photo taken on May 19, 2016; Facing North)

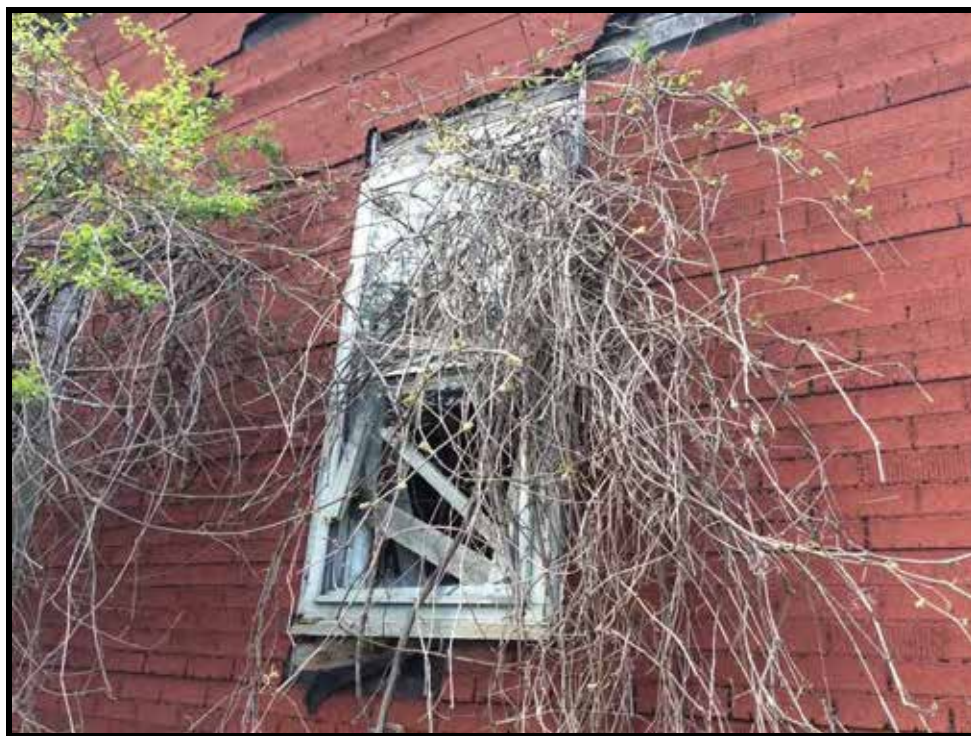
Image 15: Detail of Window on Façade of 697 Hinch Road (NAP021)
(Photo taken on May 19, 2016; Facing Northwest)

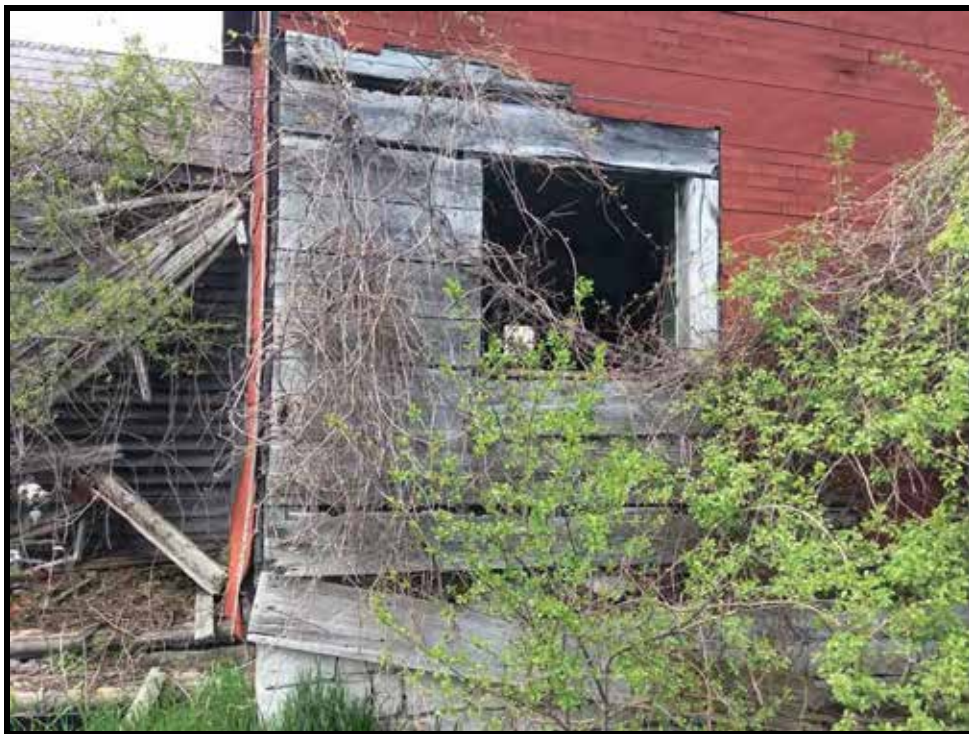
Image 16: Detail of Window on Façade of 697 Hinch Road (NAP021)
(Photo taken on May 19, 2016; Facing North)

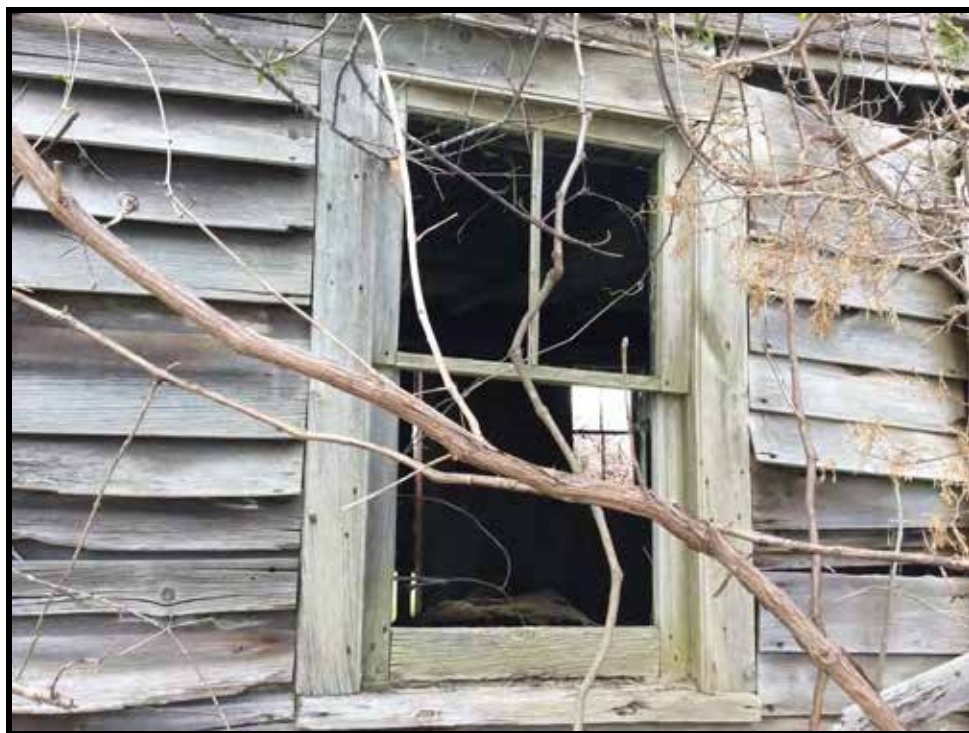
Image 17: Detail of Window and Clapboard in Addition of 697 Hinch Road (NAP021)
(Photo taken on May 19, 2016; Facing North)

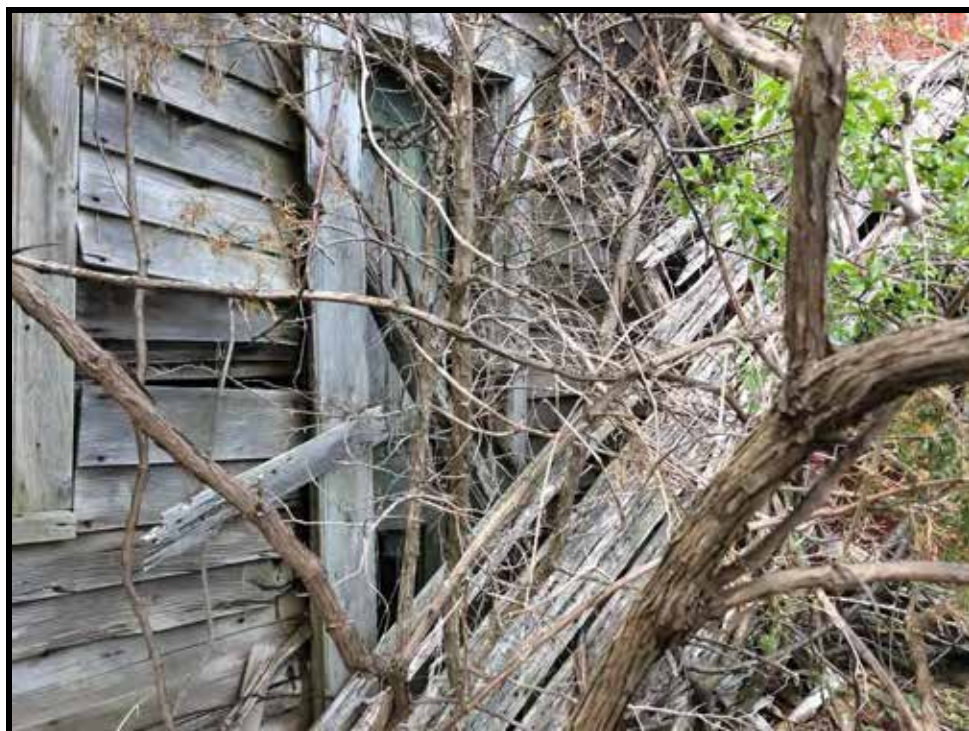
Image 19: Detail of Window and Clapboard on the Addition of 697 Hinch Road (NAP021)
(Photo taken on May 19, 2016; Facing Northeast)

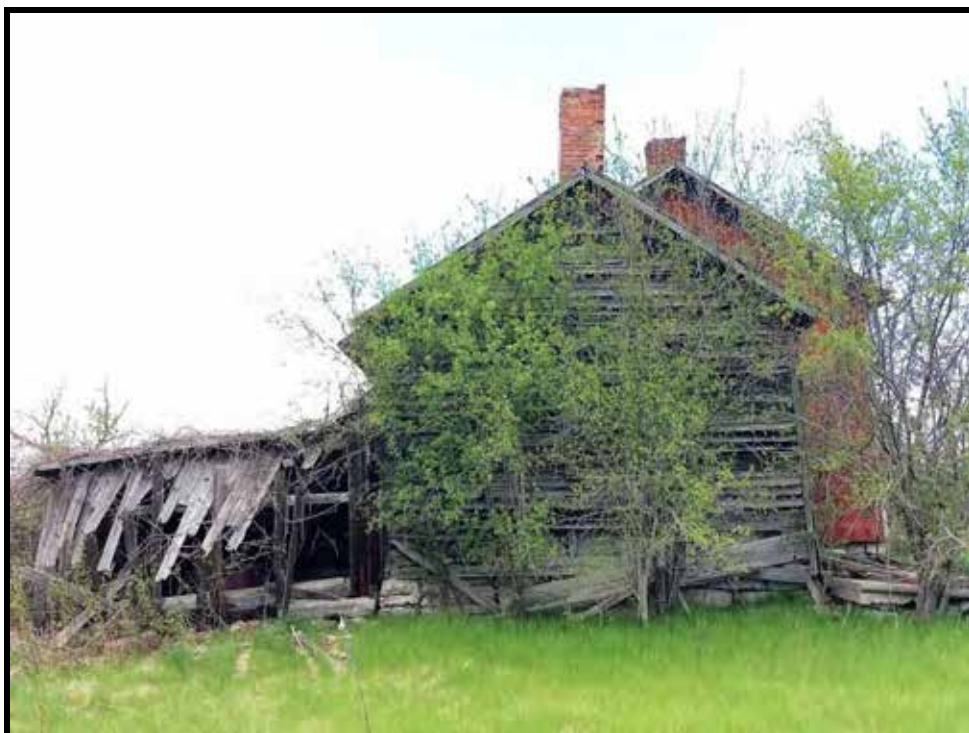
Image 23: West Elevation of Addition of 697 Hinch Road (NAP021)
(Photo taken on May 19, 2016; Facing East)

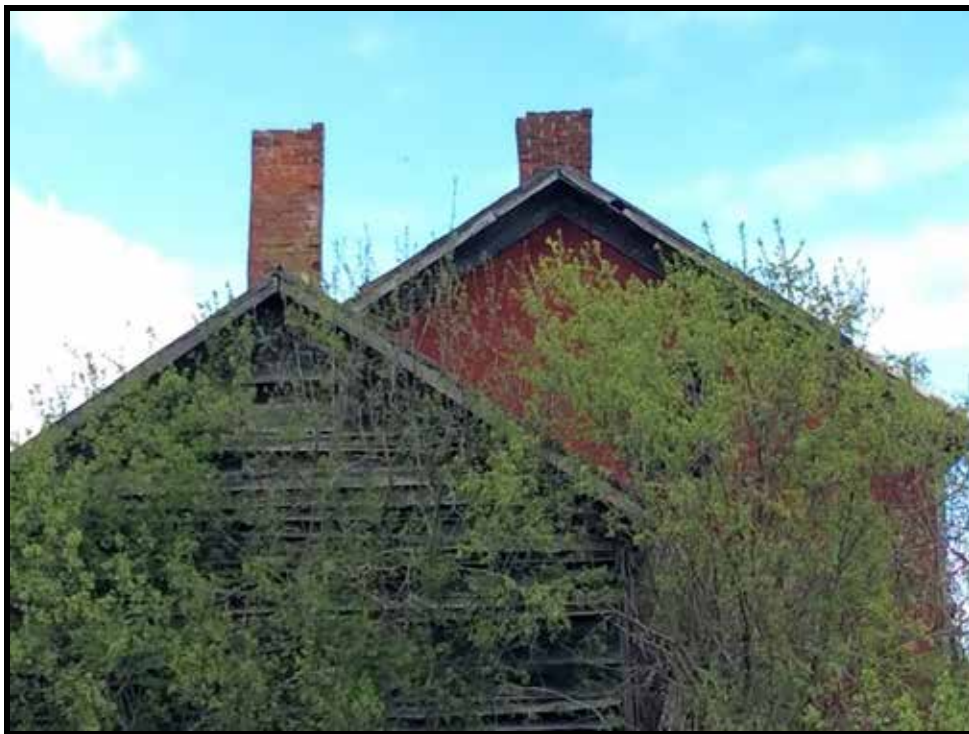
Image 24: Detail of Brick Chimneys of 697 Hinch Road (NAP021)
(Photo taken on May 19, 2016; Facing East)

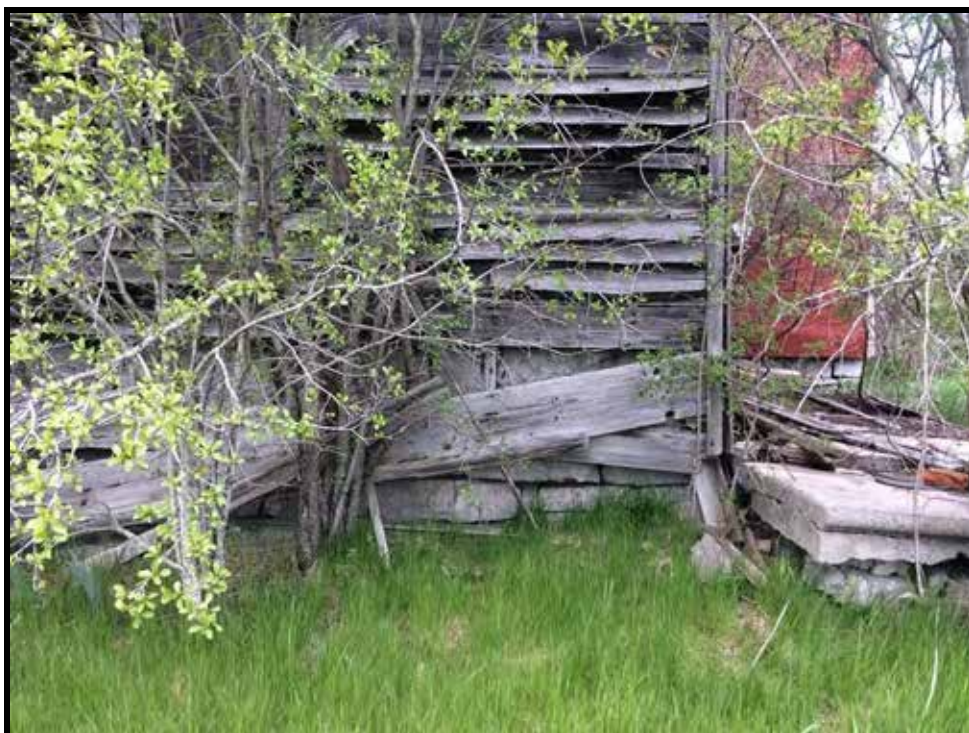
Image 25: Detail of Cut Stone Foundation of Addition of 697 Hinch Road (NAP021)
(Photo taken on May 19, 2016; Facing East)

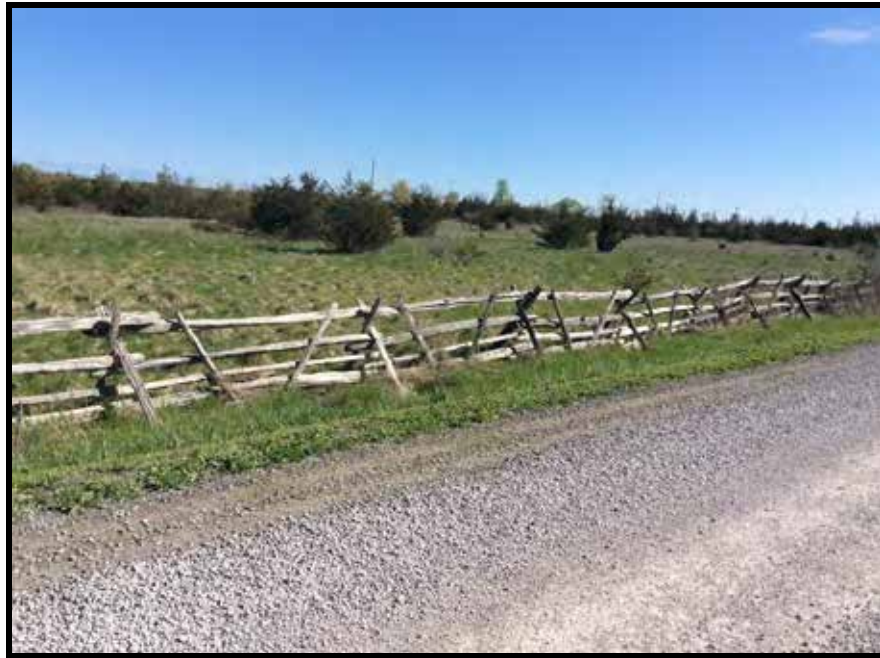
Figure 1: Example of Split Rail Fencing

Within the landscape of the Loyalist Solar Project there are three types of wood fencing: split rail (Figure 1), snake (Figure 2) and bolder (Figure 3). The fencing is found along property lines and in some instances within the Municipal Right-of-Ways (Figure 4).

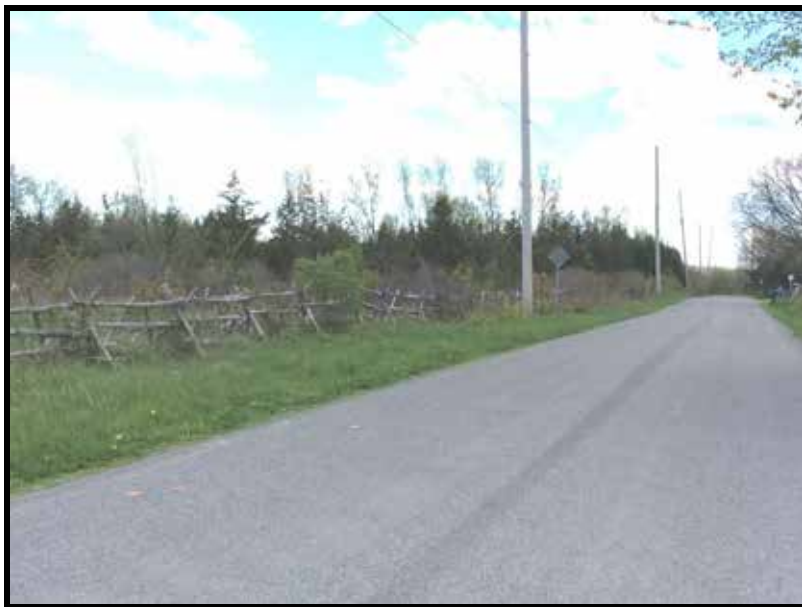
Figure 4: Example of Split Rail Fencing in Right-of-Way
