**ST. COLUMBAN WIND PROJECT
WATER ASSESSMENT AND
WATER BODY REPORT**

File No. 160960649
June 2012

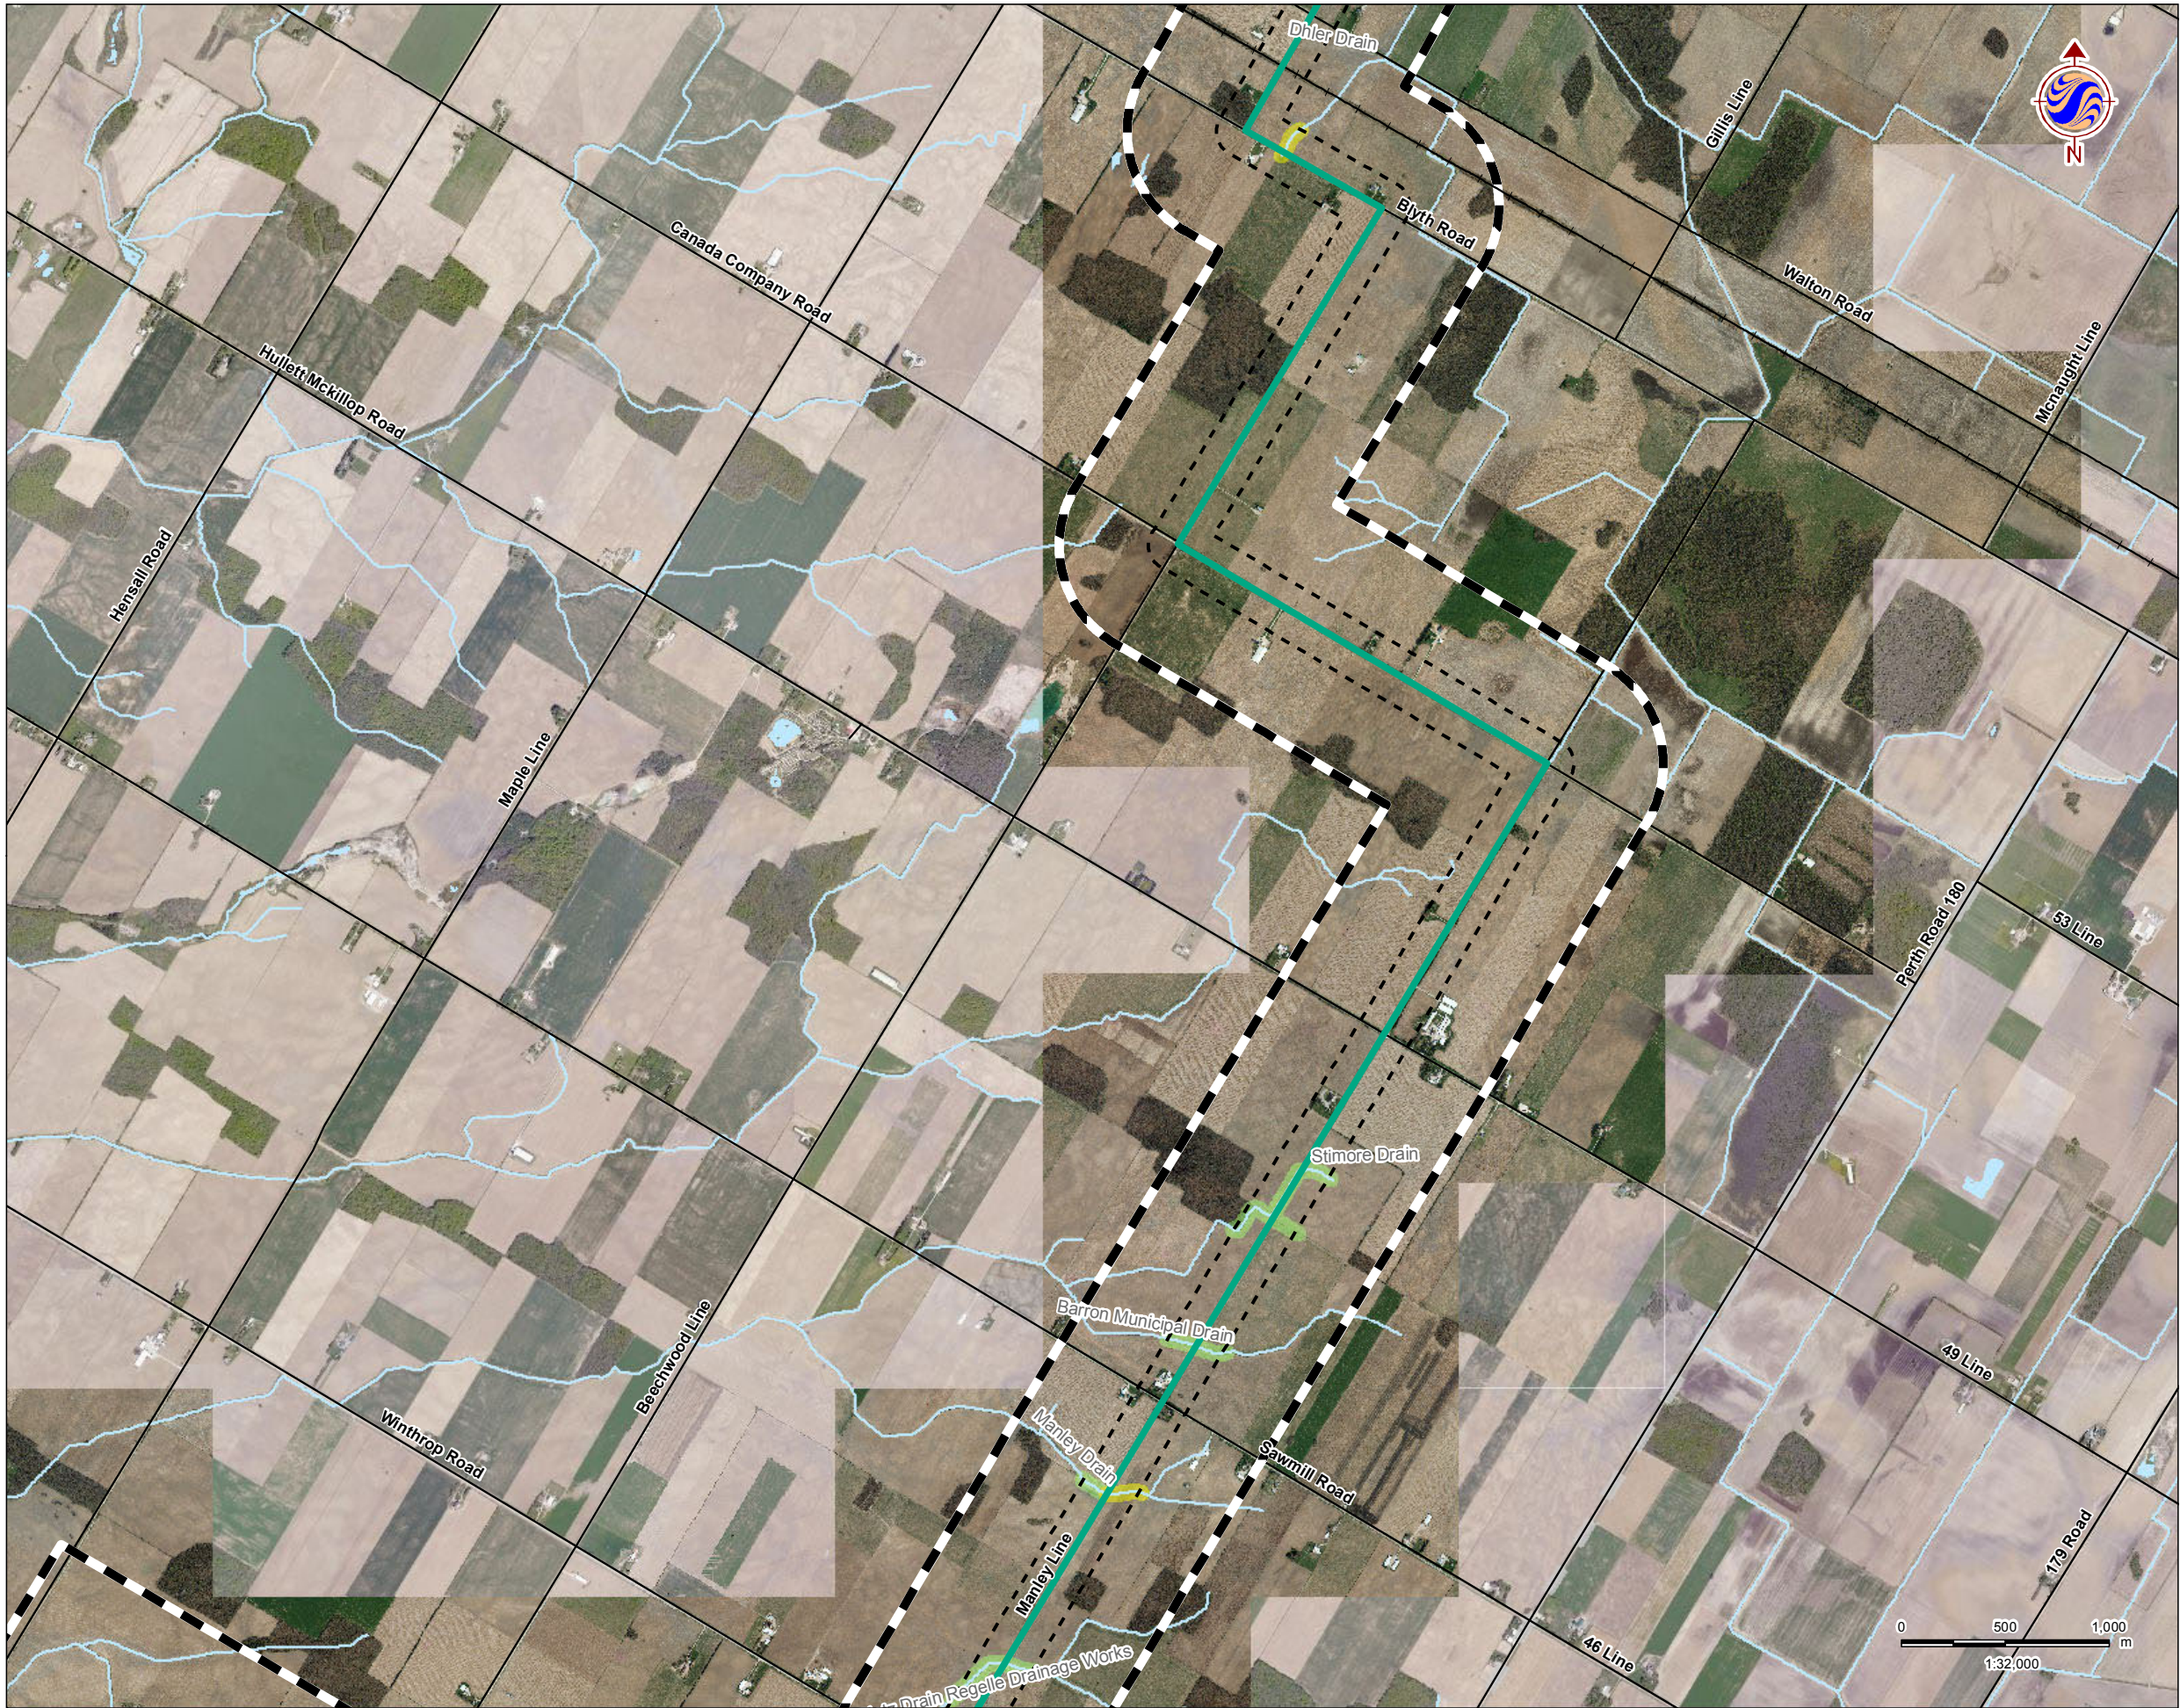
Title
WATER BODY LOCATIONS
Tile 1 of 5

Locations where water bodies are present within 120 m of a proposed project component are presented in **Figure 2**, and are summarized in **Table 3.1**. The designation of various features as water bodies was agreed upon by field staff using field conditions at the time of the survey and the definition of water body provided in O. Reg. 359/09.

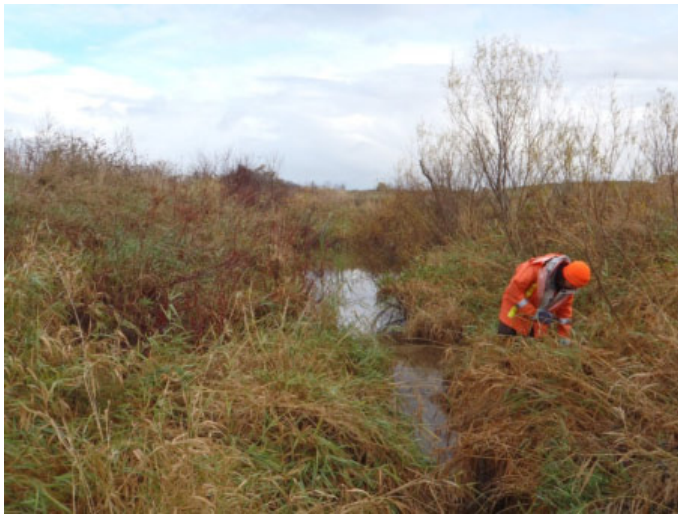
Photo 1: Ryan Drain A - Facing upstream (northeast). Site is located about 250 metres northeast of the Bridge Road and Maple Line intersection.

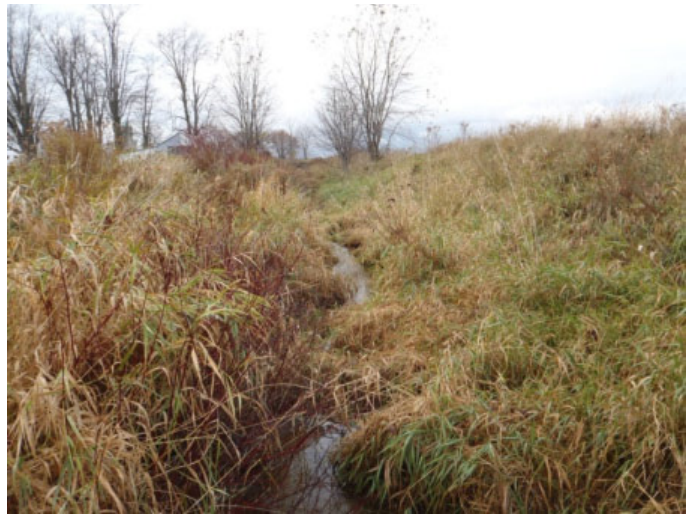
Photo 2: Ryan Drain A - Facing downstream (southwest). Site is located about 250 metres northeast of the Bridge Road and Maple Line intersection.

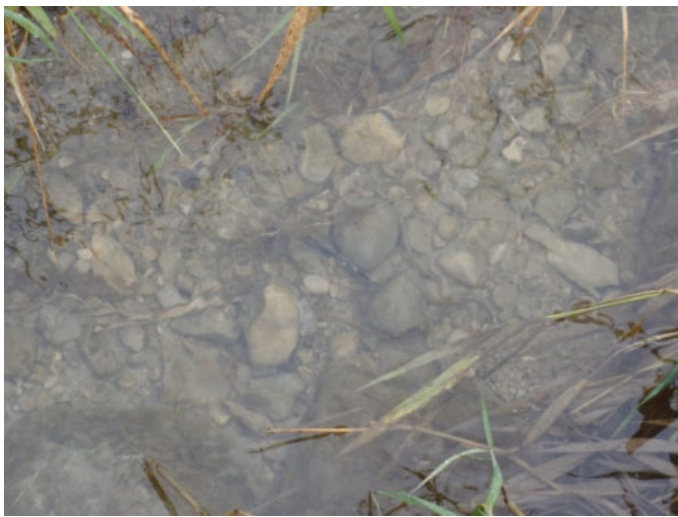
Photo 3: Ryan Drain A - Existing substrate conditions. Site is located about 250 metres northeast of the Bridge Road and Maple Line intersection.

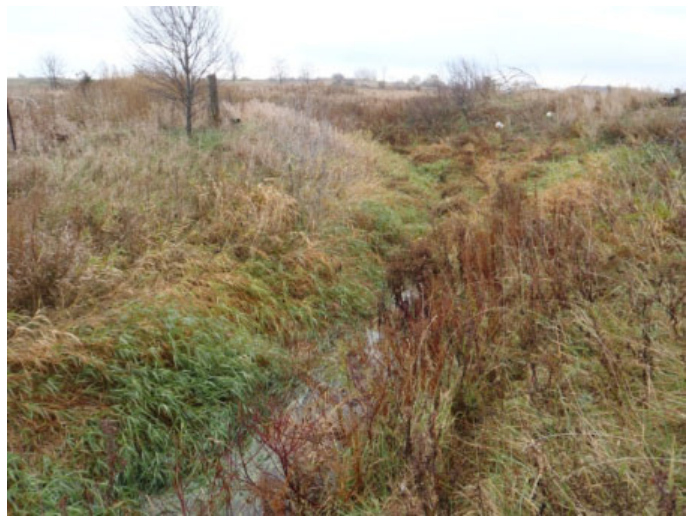
Photo 4: Ryan Drain B - Facing upstream (southeast). Photo location is approximately 200 m east of Beechwood Line, northeast of Bridge Road.

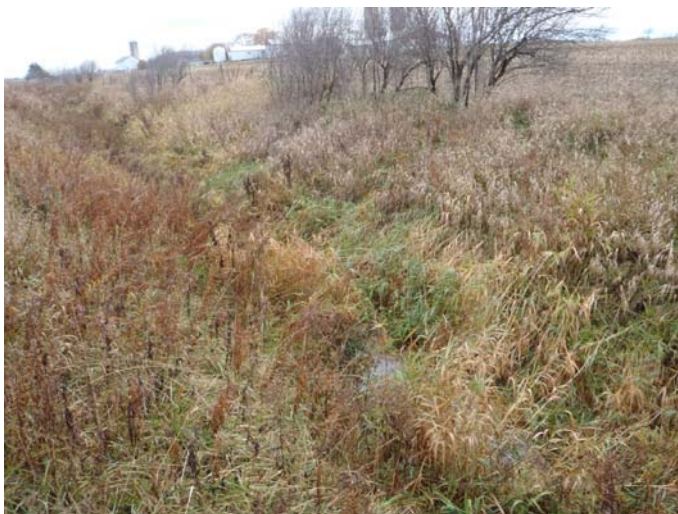
Photo 5: Ryan Drain B - Facing upstream (southeast). Photo location is approximately 200 m east of Beechwood Line, northeast of Bridge Road.

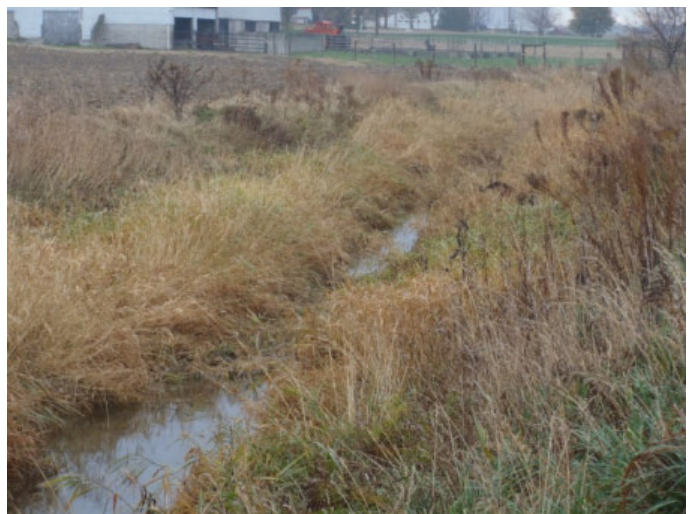
Photo 6: Ryan Drain B - Facing upstream (southeast). Photo location is approximately 200 m west of Beechwood Line, northwest of Bridge Road

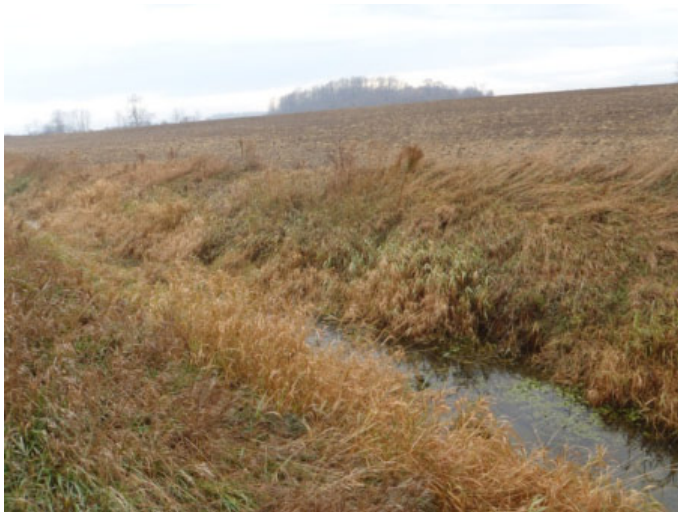
Photo 7: Ryan Drain B - Facing downstream (northwest). Photo location is approximately 200 m west of Beechwood Line, northwest of Bridge Road.

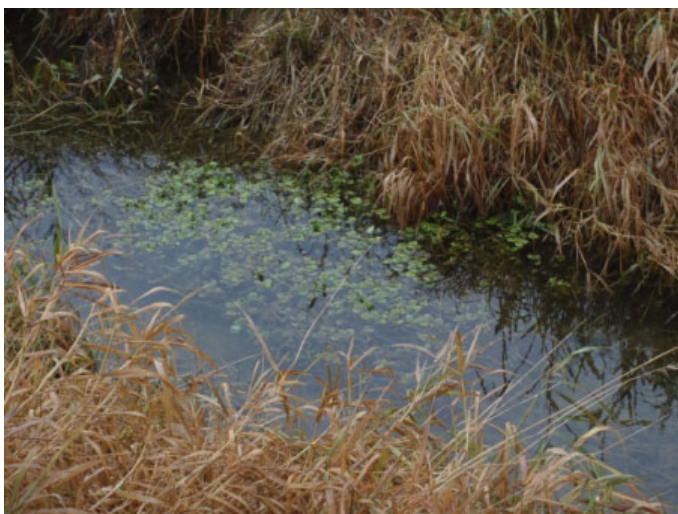
Photo 9: Ryan Drain B – Note dense patches of watercress. Photo location is approximately 200 m west of Beechwood Line, northwest of Bridge Road.

Ryan Drain C	Class C Drain Permanent flow; predominantly run morphology; large, dense patches of watercress observed in October 2011.	To be crossed by underground interconnection line adjacent to Manley Road.	Temporary increase in surface water turbidity due to possible runoff during construction. See Section 4.1.	Ensure appropriate sediment and erosion controls implemented. See Sections 5.1 to 5.3.	No net effects are expected to this water body.

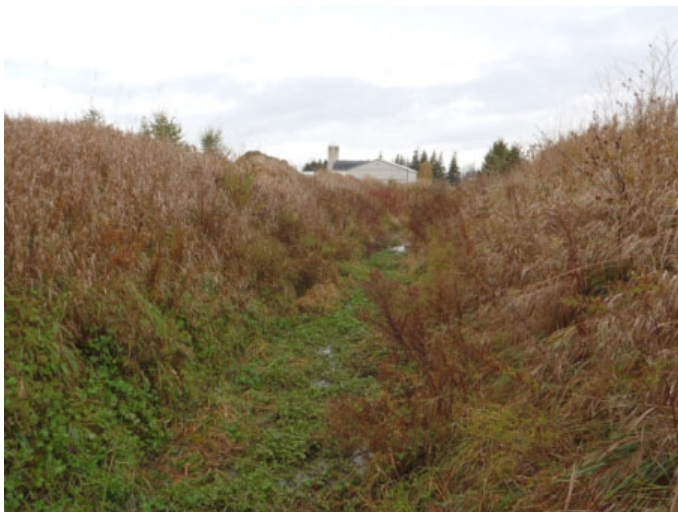
Photo 11: Krouskopf Drain A - Facing downstream (northwest). Site is located half way between Beechwood Line and Manley Line, 75 metres south of Bridge Road.

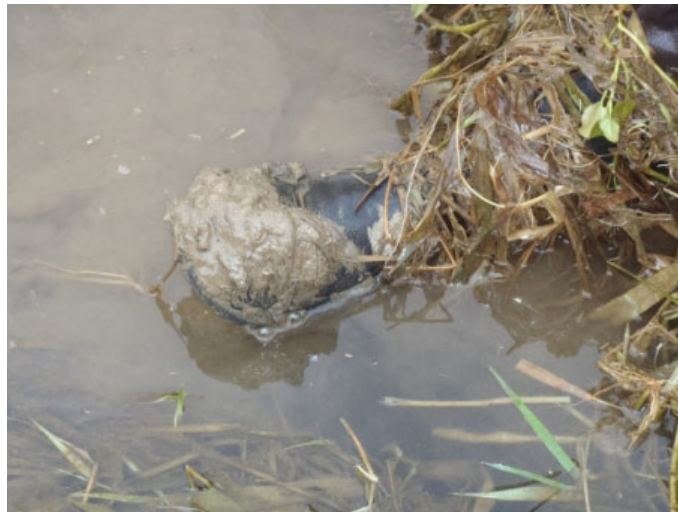
Photo 8: Ryan Drain B - Existing substrate conditions. Photo location is approximately 200 m west of Beechwood Line, northwest of Bridge Road.

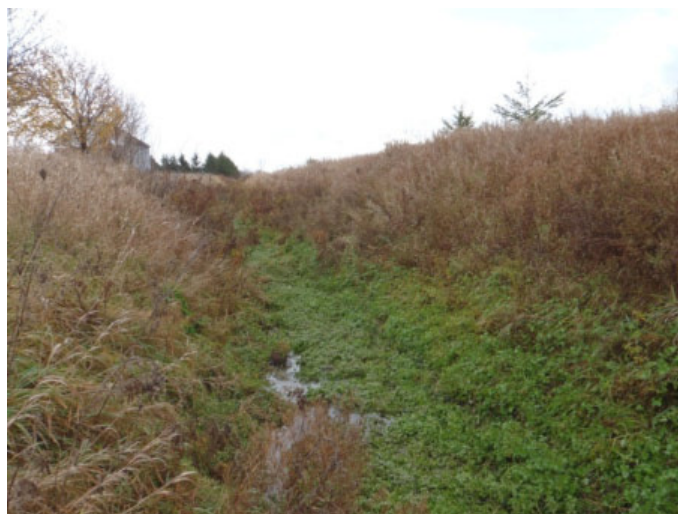
Photo 10: Krouskopf Drain A - Facing upstream (southeast). Site is located half way between Beechwood Line and Manley Line, 75 metres south of Bridge Road.

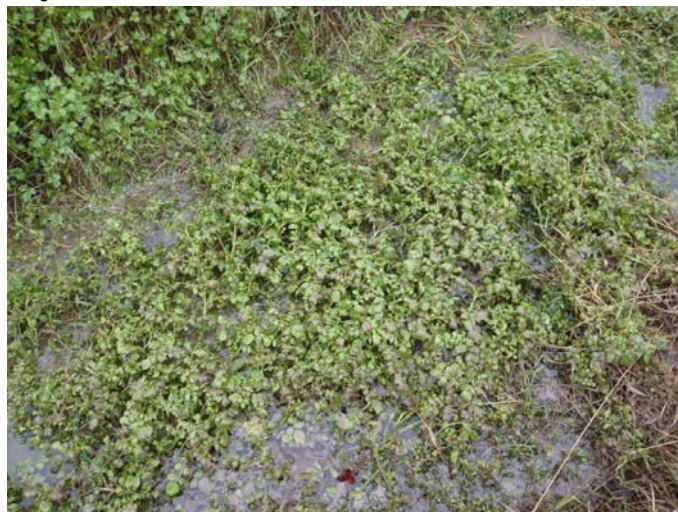
Photo 12: Krouskopf Drain A – Note dense watercress covering water surface. Site is located half way between Beechwood Line and Manley Line, 75 metres south of Bridge Road.

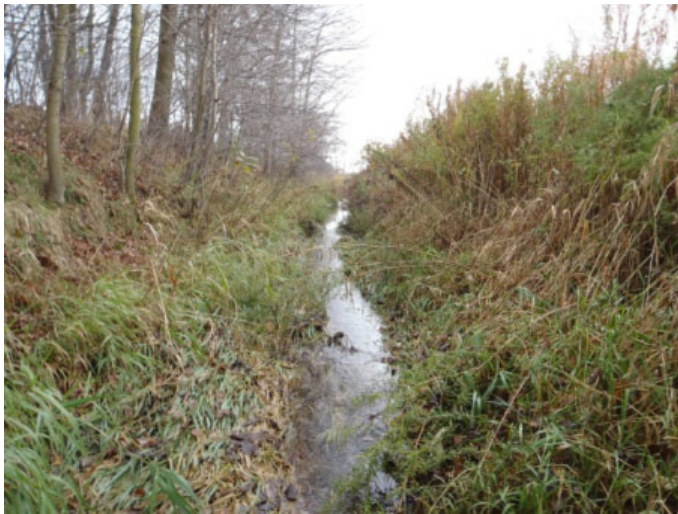
Photo 13: Woods Drain - Facing upstream (southeast). Site is located approximately 600 m north of Hydro Line Road and 1.3 km east of Beechwood Line.

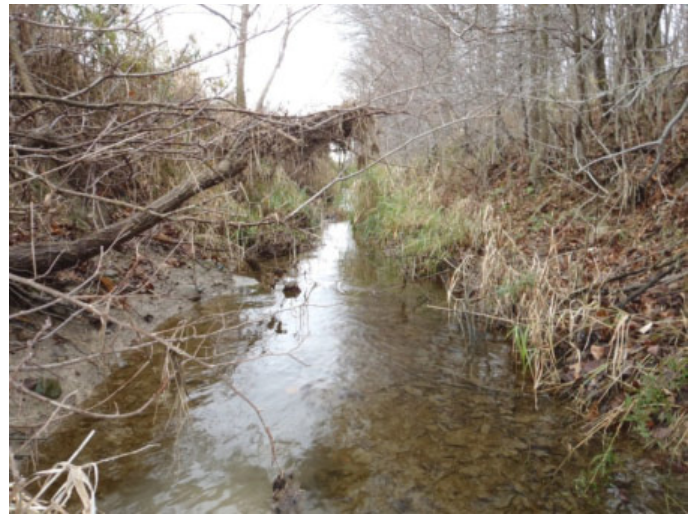
Photo 14: Woods Drain - Facing downstream (northwest). Site is located approximately 600 m north of Hydro Line Road and 1.3 km east of Beechwood Line.

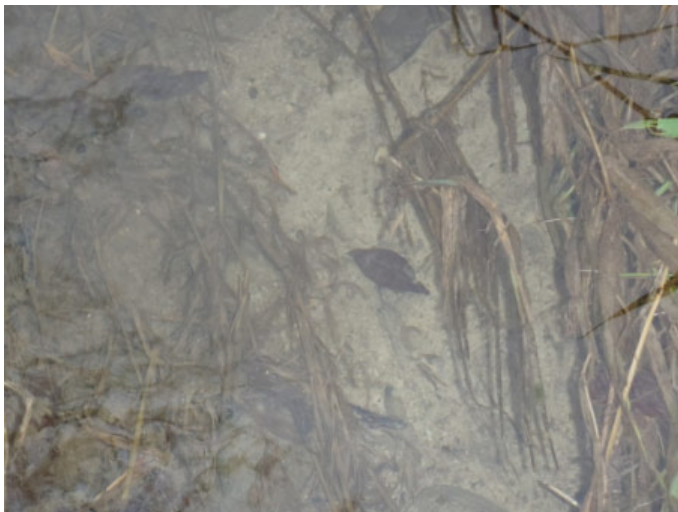
Photo 15: Woods Drain - Existing substrate conditions. Site is located approximately 600 m north of Hydro Line Road and 1.3 km east of Beechwood Line.

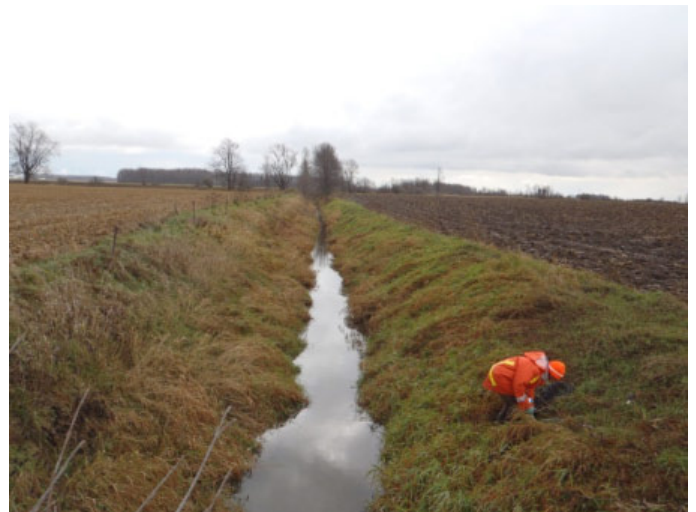
Photo 16: Canada Company Drain - Facing upstream (southeast). Site is located approximately 1 km east of Beechwood Road and 500 m south of Hydro Line Road.

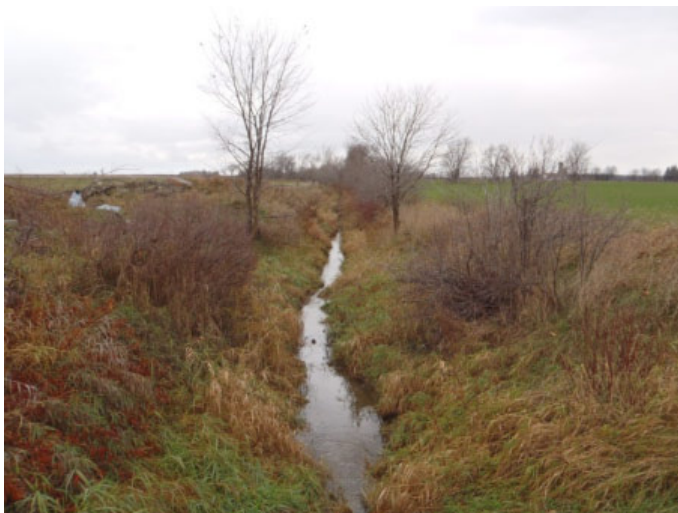
Photo 17: Canada Company Drain - Facing upstream (southeast). Site is located approximately 1 km east of Beechwood Road and 500 m south of Hydro Line Road.

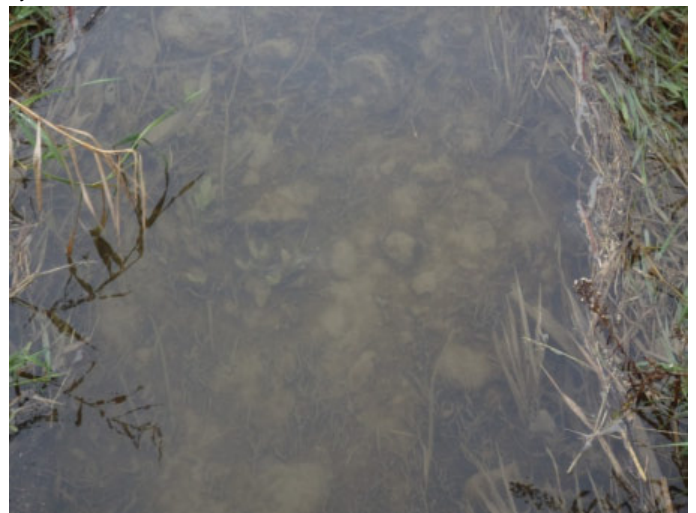
Photo 18: Canada Company Drain - Existing substrate conditions. Site is located approximately 1 km east of Beechwood Road and 500 m south of Hydro Line Road.

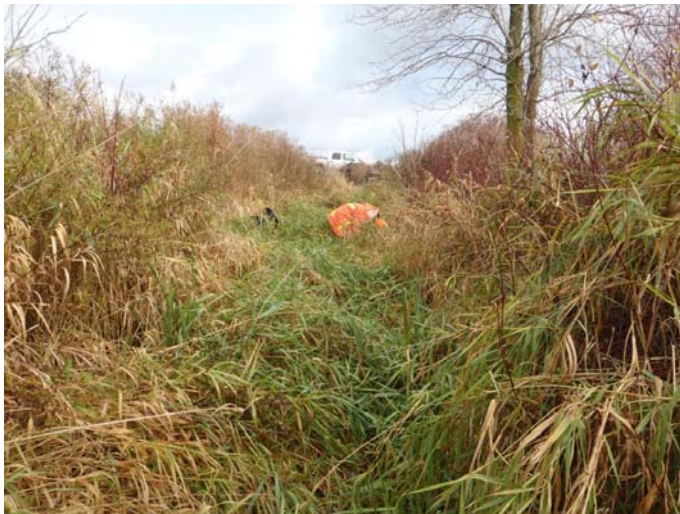
Photo 19: Carpenter Drain – Facing upstream approximately 50 m downstream (west) of Road 180. Note dense grasses.

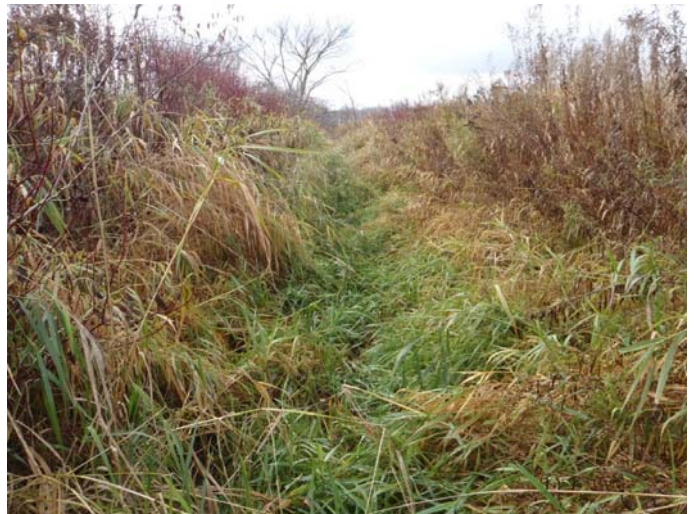
Photo 20: Carpenter Drain – Facing downstream approximately 50 m downstream (west) of Road 180

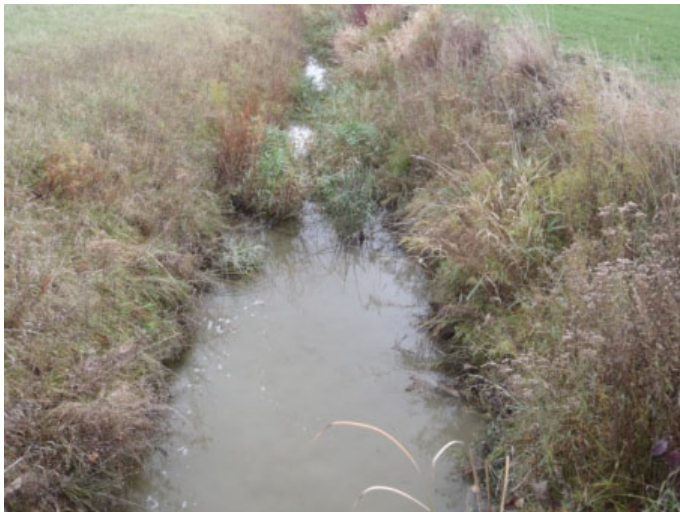
Photo 21: Woods Drain C - Facing upstream (southeast). Site is located on Bridge Road, northwest of Perth Road 180.

Woods Drain C	Class C Drain Permanent flow; dominated by pool and run morphology; no in-water vegetation observed in April 2011. Dense patches of watercress observed throughout channel in November 2011. Bankfull width = 3 - 4 m Water depth = 30 cm Substrate = sand, gravel, silt, cobble, clay, boulder, and detritus. Direct fish habitat.	To be crossed by underground collector system adjacent to Manley Line.	Temporary increase in surface water turbidity due to possible runoff during construction. See Section 4.1 to 4.3.	Use DFO Operational Statement for Punch and Bore Crossing, Directional Drilling, or Open Cut. See Appendix E	No net effects are expected to this water body at this location.

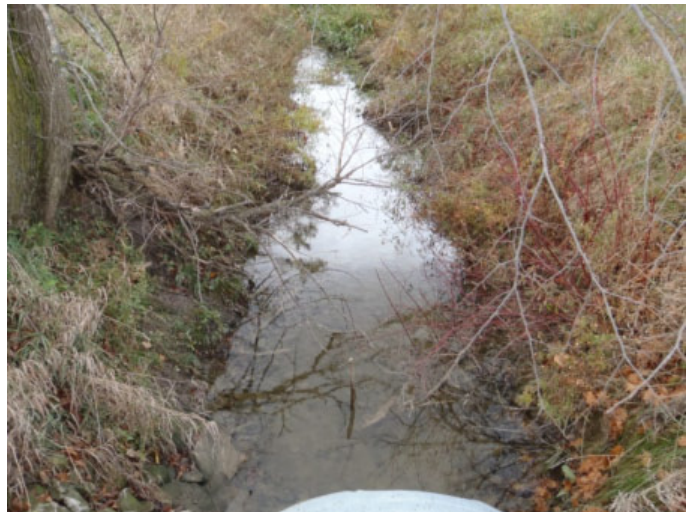
Photo 22: Woods Drain C - Facing downstream (northwest). Site is located on Bridge Road, northwest of Perth Road 180.

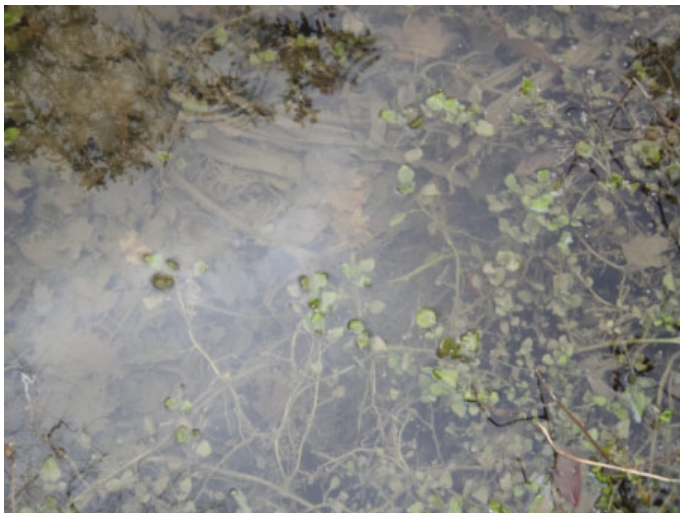
Photo 23: Woods Drain C - Existing substrate conditions. Site is located on Bridge Road, northwest of Perth Road 180.

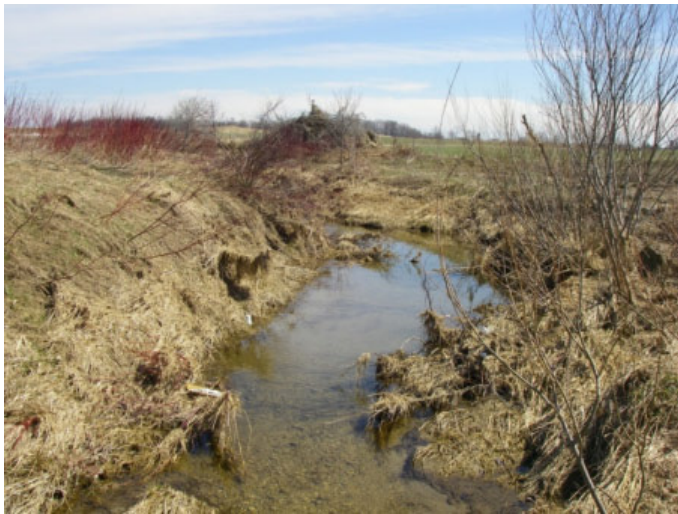
Photo 1: Ryan Drain A - Facing upstream (northeast). Site is located about 250 metres northeast of the Bridge Road and Maple Line intersection.

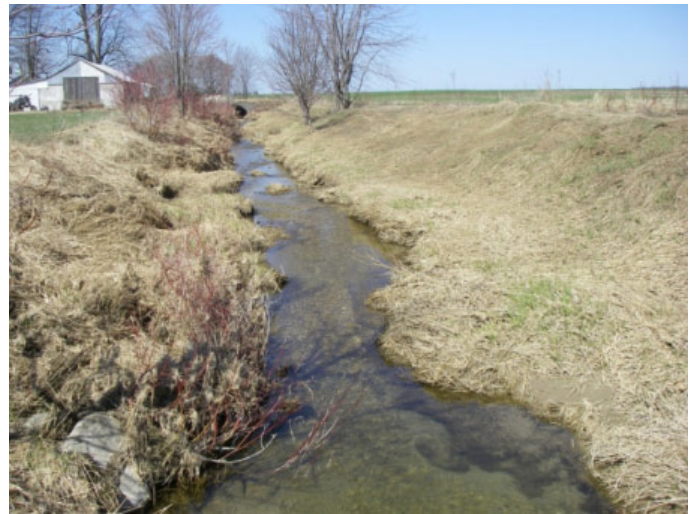
Photo 2: Ryan Drain A - Facing downstream (southwest). Site is located about 250 metres northeast of the Bridge Road and Maple Line intersection.

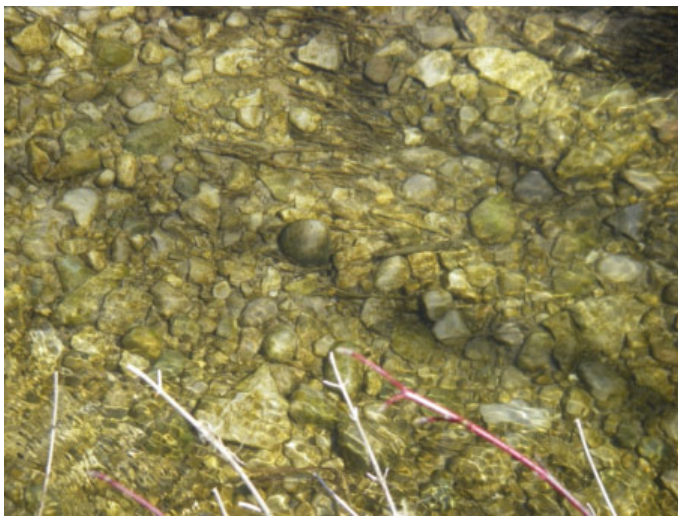
Photo 3: Ryan Drain A - Existing substrate conditions. Site is located about 250 metres northeast of the Bridge Road and Maple Line intersection.

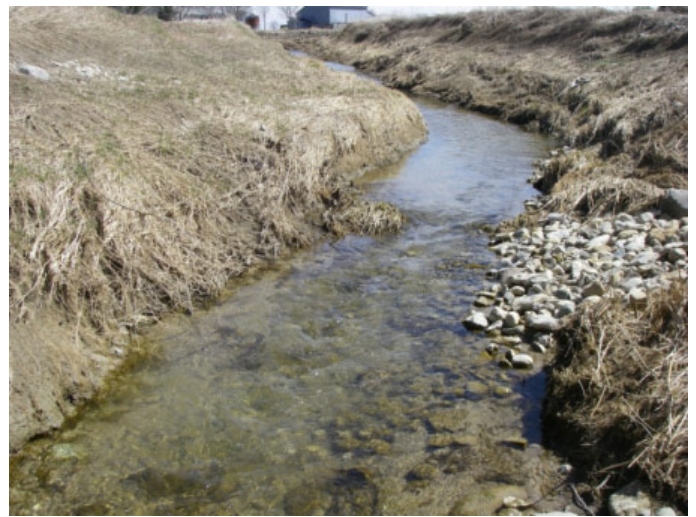
Photo 4: Dillon Drain - Facing upstream (northeast). Site is located on Beechwood Line, about 700 metres southwest of Summerhill Road.

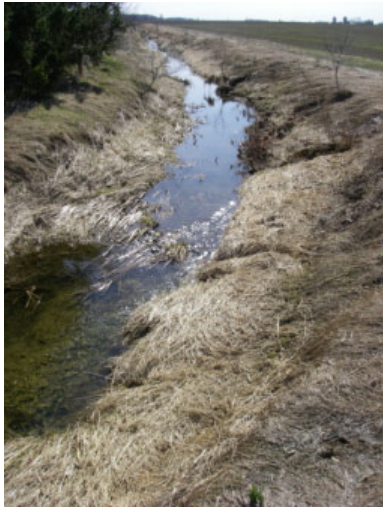
Photo 7: Ryan Drain B - Facing upstream (southeast). Site is located on Beechwood Line, northeast of Bridge Road.

Photo 8: Ryan Drain B - Facing downstream (northwest). Site is located on Beechwood Line, northeast of Bridge Road.

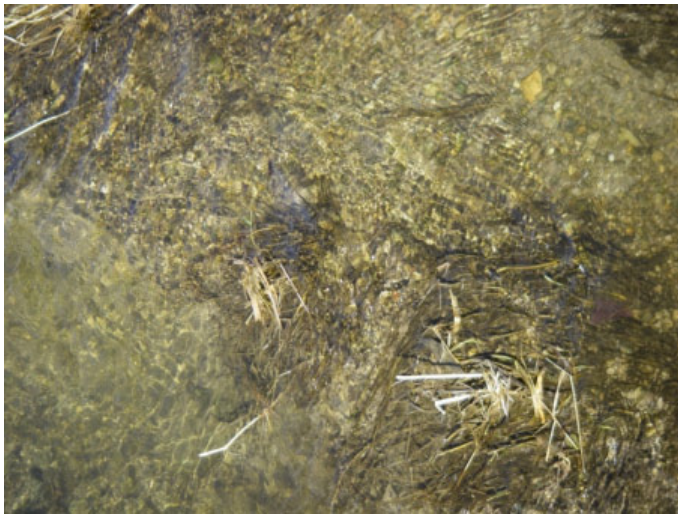
Photo 9: Ryan Drain B - Existing substrate conditions. Site is located on Beechwood Line, northeast of Bridge Road.

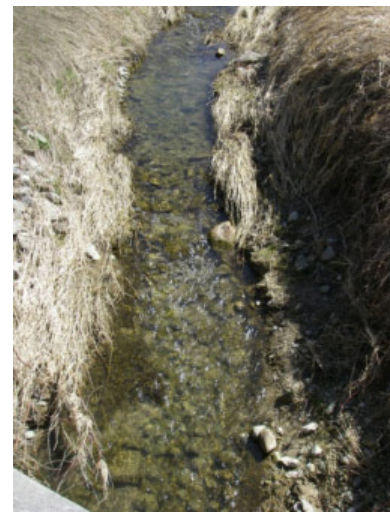
Photo 10: Woods Drain B - Facing upstream (southeast). Site is located at the corner of Beechwood Line and Hydro Line Road.

Photo 11: Woods Drain B - Facing downstream (northwest). Site is located at the corner of Beechwood Line and Hydro Line Road.

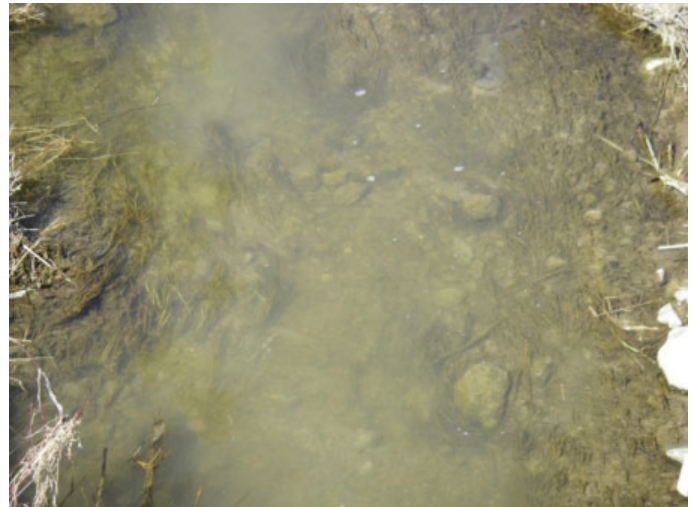
Photo 12: Woods Drain B - Existing substrate conditions. Site is located at the corner of Beechwood Line and Hydro Line Road.

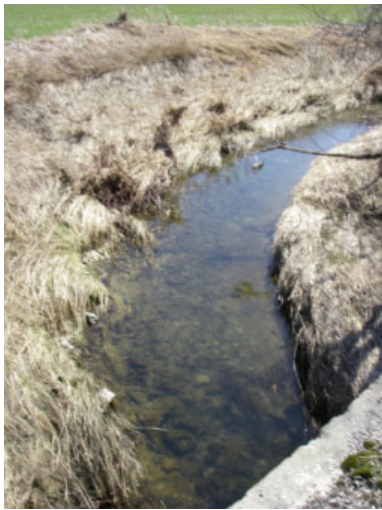
Photo 13: Canada Company Drain - Facing upstream (southwest). Site is located 200 metres southwest of the Hydro Line Road and Beechwood Line intersection.

Photo 14: Canada Company Drain - Facing downstream (northwest). Site is located 200 metres southwest of the Hydro Line Road and Beechwood Line intersection.

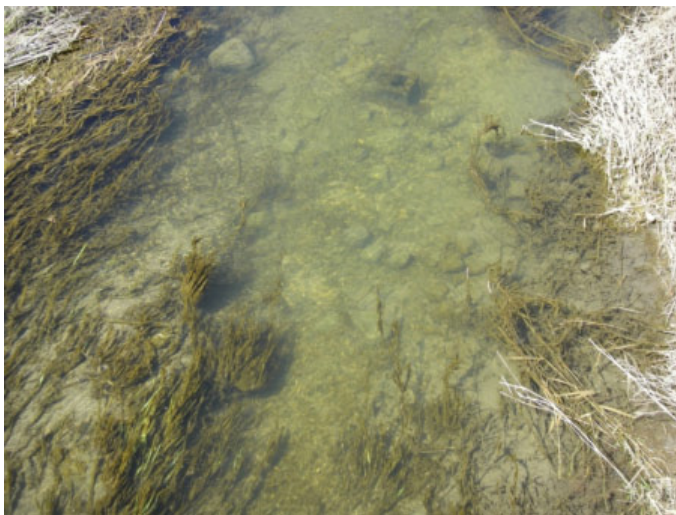
Photo 15: Canada Company Drain - Existing substrate conditions. Site is located 200 metres southwest of the Hydro Line Road and Beechwood Line intersection.

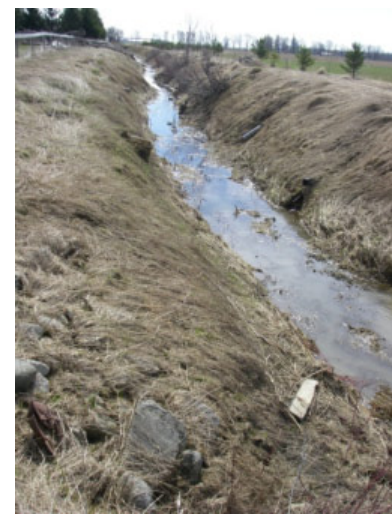
Photo 16: Krouskopf Drain A - Facing upstream (southeast). Site is located half way between Beechwood Line and Manley Line, 75 metres south of Bridge Road.

Photo 17: Krouskopf Drain A - Facing downstream (northwest). Site is located half way between Beechwood Line and Manley Line, 75 metres south of Bridge Road.

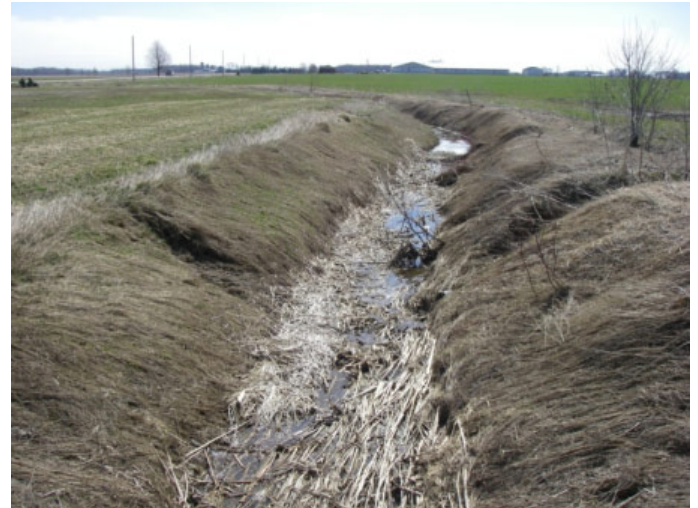
Photo 18: Krouskopf Drain A - Existing substrate conditions. Site is located half way between Beechwood Line and Manley Line, 75 metres south of Bridge Road.

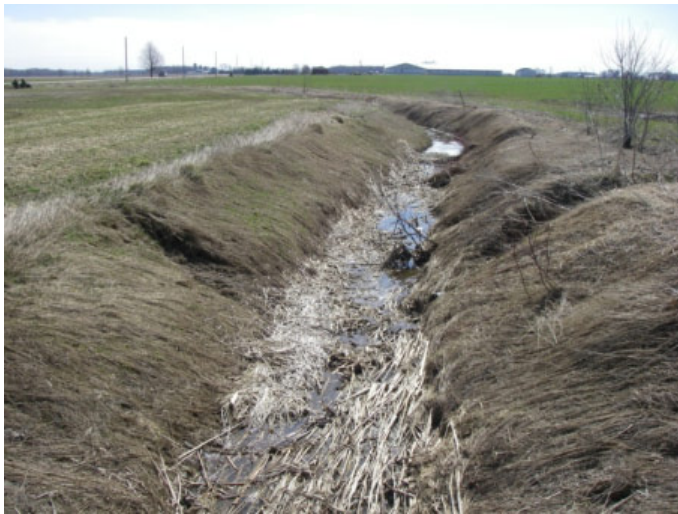
Photo 19: Krouskopf Drain B - Facing upstream (southeast). Site is located at the corner of the Bridge Road and Manley Line intersection.

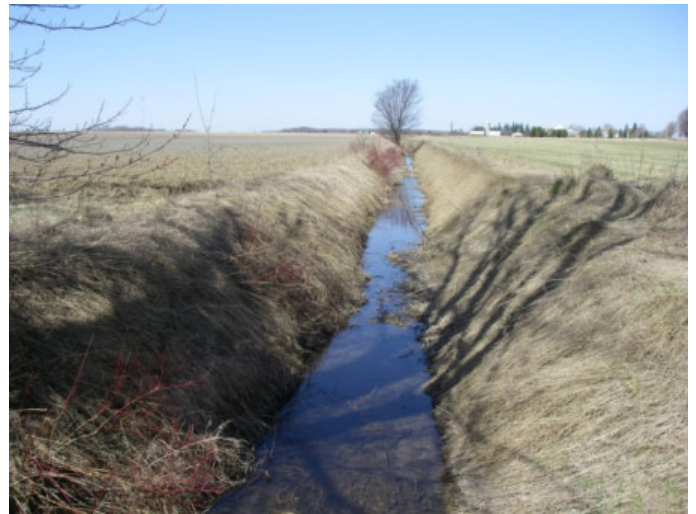
Photo 20: Krouskopf Drain B - Facing downstream (northwest). Site is located at the corner of the Bridge Road and Manley Line intersection.

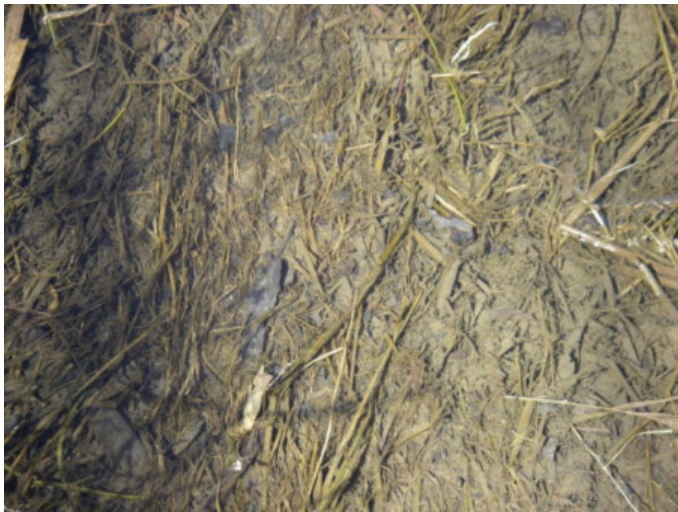
Photo 21: Krouskopf Drain B - Existing substrate conditions. Site is located at the corner of the Bridge Road and Manley Line intersection.

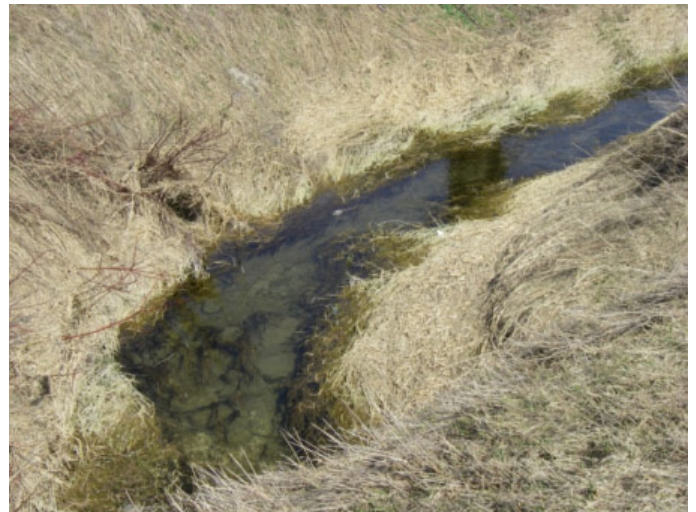
Photo 22: O'Rourke Drain - Facing upstream (southeast). Site is located at the intersection of 181 Road and Hydro Line Road.

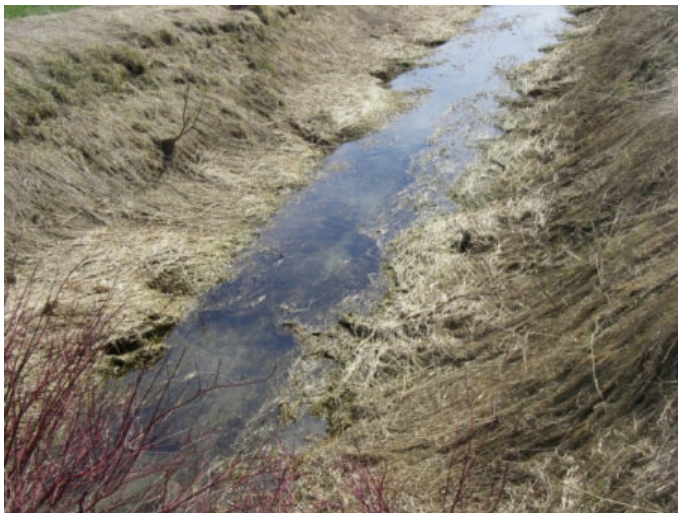
Photo 23: O'Rourke Drain - Facing downstream (northwest). Site is located at the intersection of 181 Road and Hydro Line Road.

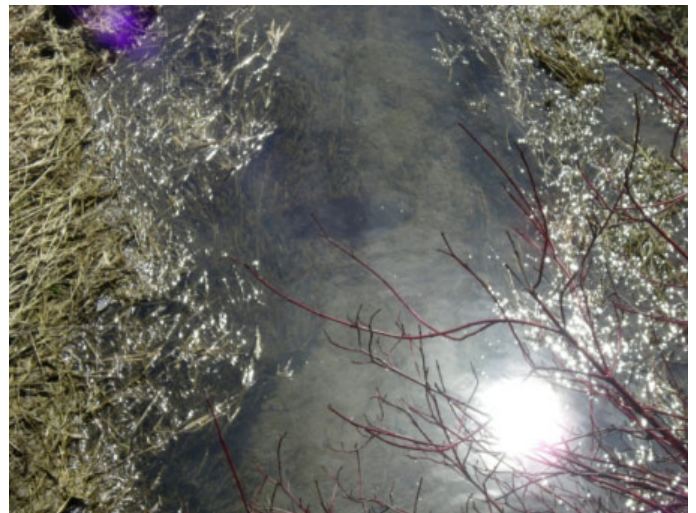
Photo 24: O'Rourke Drain - Existing substrate conditions. Site is located at the intersection of 181 Road and Hydro Line Road.

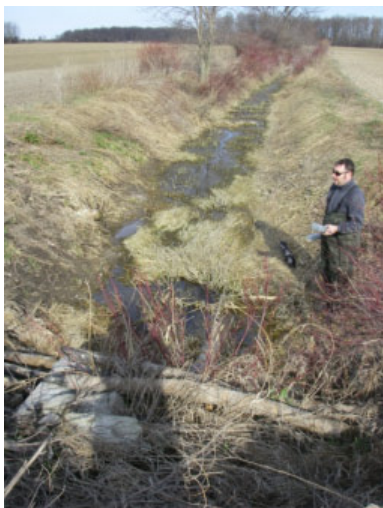
Photo 25: Carpenter Drain - Facing downstream (northwest). Site is located 1 kilometre northeast of Highway 8 on Manley Line.

Photo 26: Carpenter Drain - Facing upstream (southeast) of the absent creek channel. Site is located 1 kilometre northeast of Highway 8 on Manley Line.

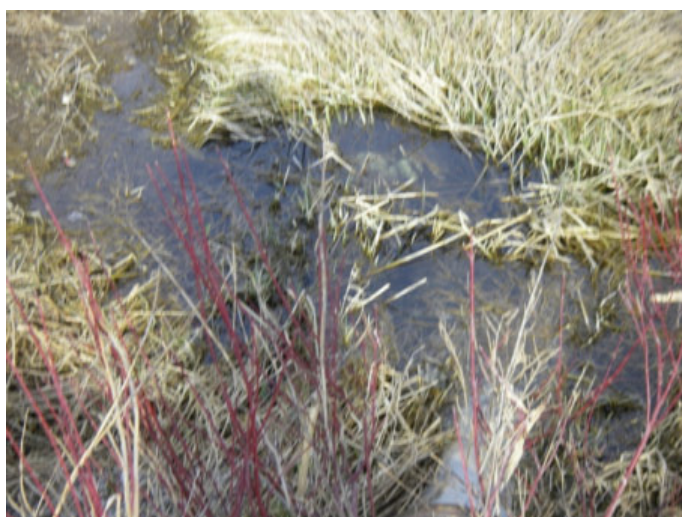
Photo 27: Carpenter Drain - Existing substrate conditions. Site is located 1 kilometre northeast of Highway 8 on Manley Line.

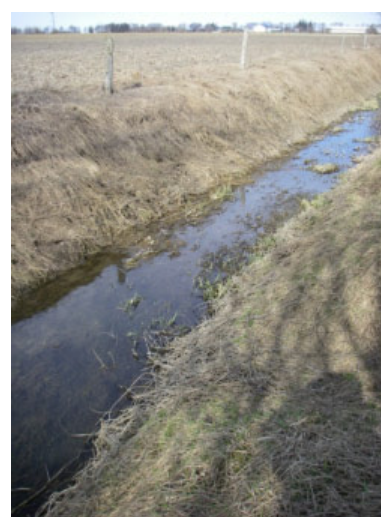
Photo 28: Woods Drain C - Facing upstream (southeast). Site is located on Bridge Road, northwest of Perth Road 180.

Photo 29: Woods Drain C - Facing downstream (northwest). Site is located on Bridge Road, northwest of Perth Road 180.

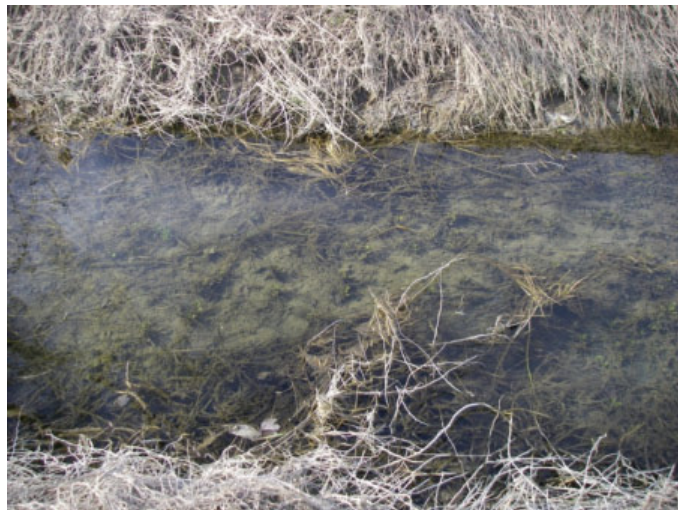
Photo 30: Woods Drain C - Existing substrate conditions. Site is located on Bridge Road, northwest of Perth Road 180.
