**Stage 1 Background Study and Property Inspection  
Stage 2 Property Assessment**

**St. Columban 1 Electrical Interconnection Line  
and Electrical Interconnection Facilities  
Municipality of East Huron (Geographic Townships of McKillop and Grey),  
Municipality of Morris-Turnberry (Geographic Township of Turnberry), and  
Township of Howick, Huron County, Ontario**

**FIT-F1PW818**

December 22, 2011  
(Revised January 17, 2012)

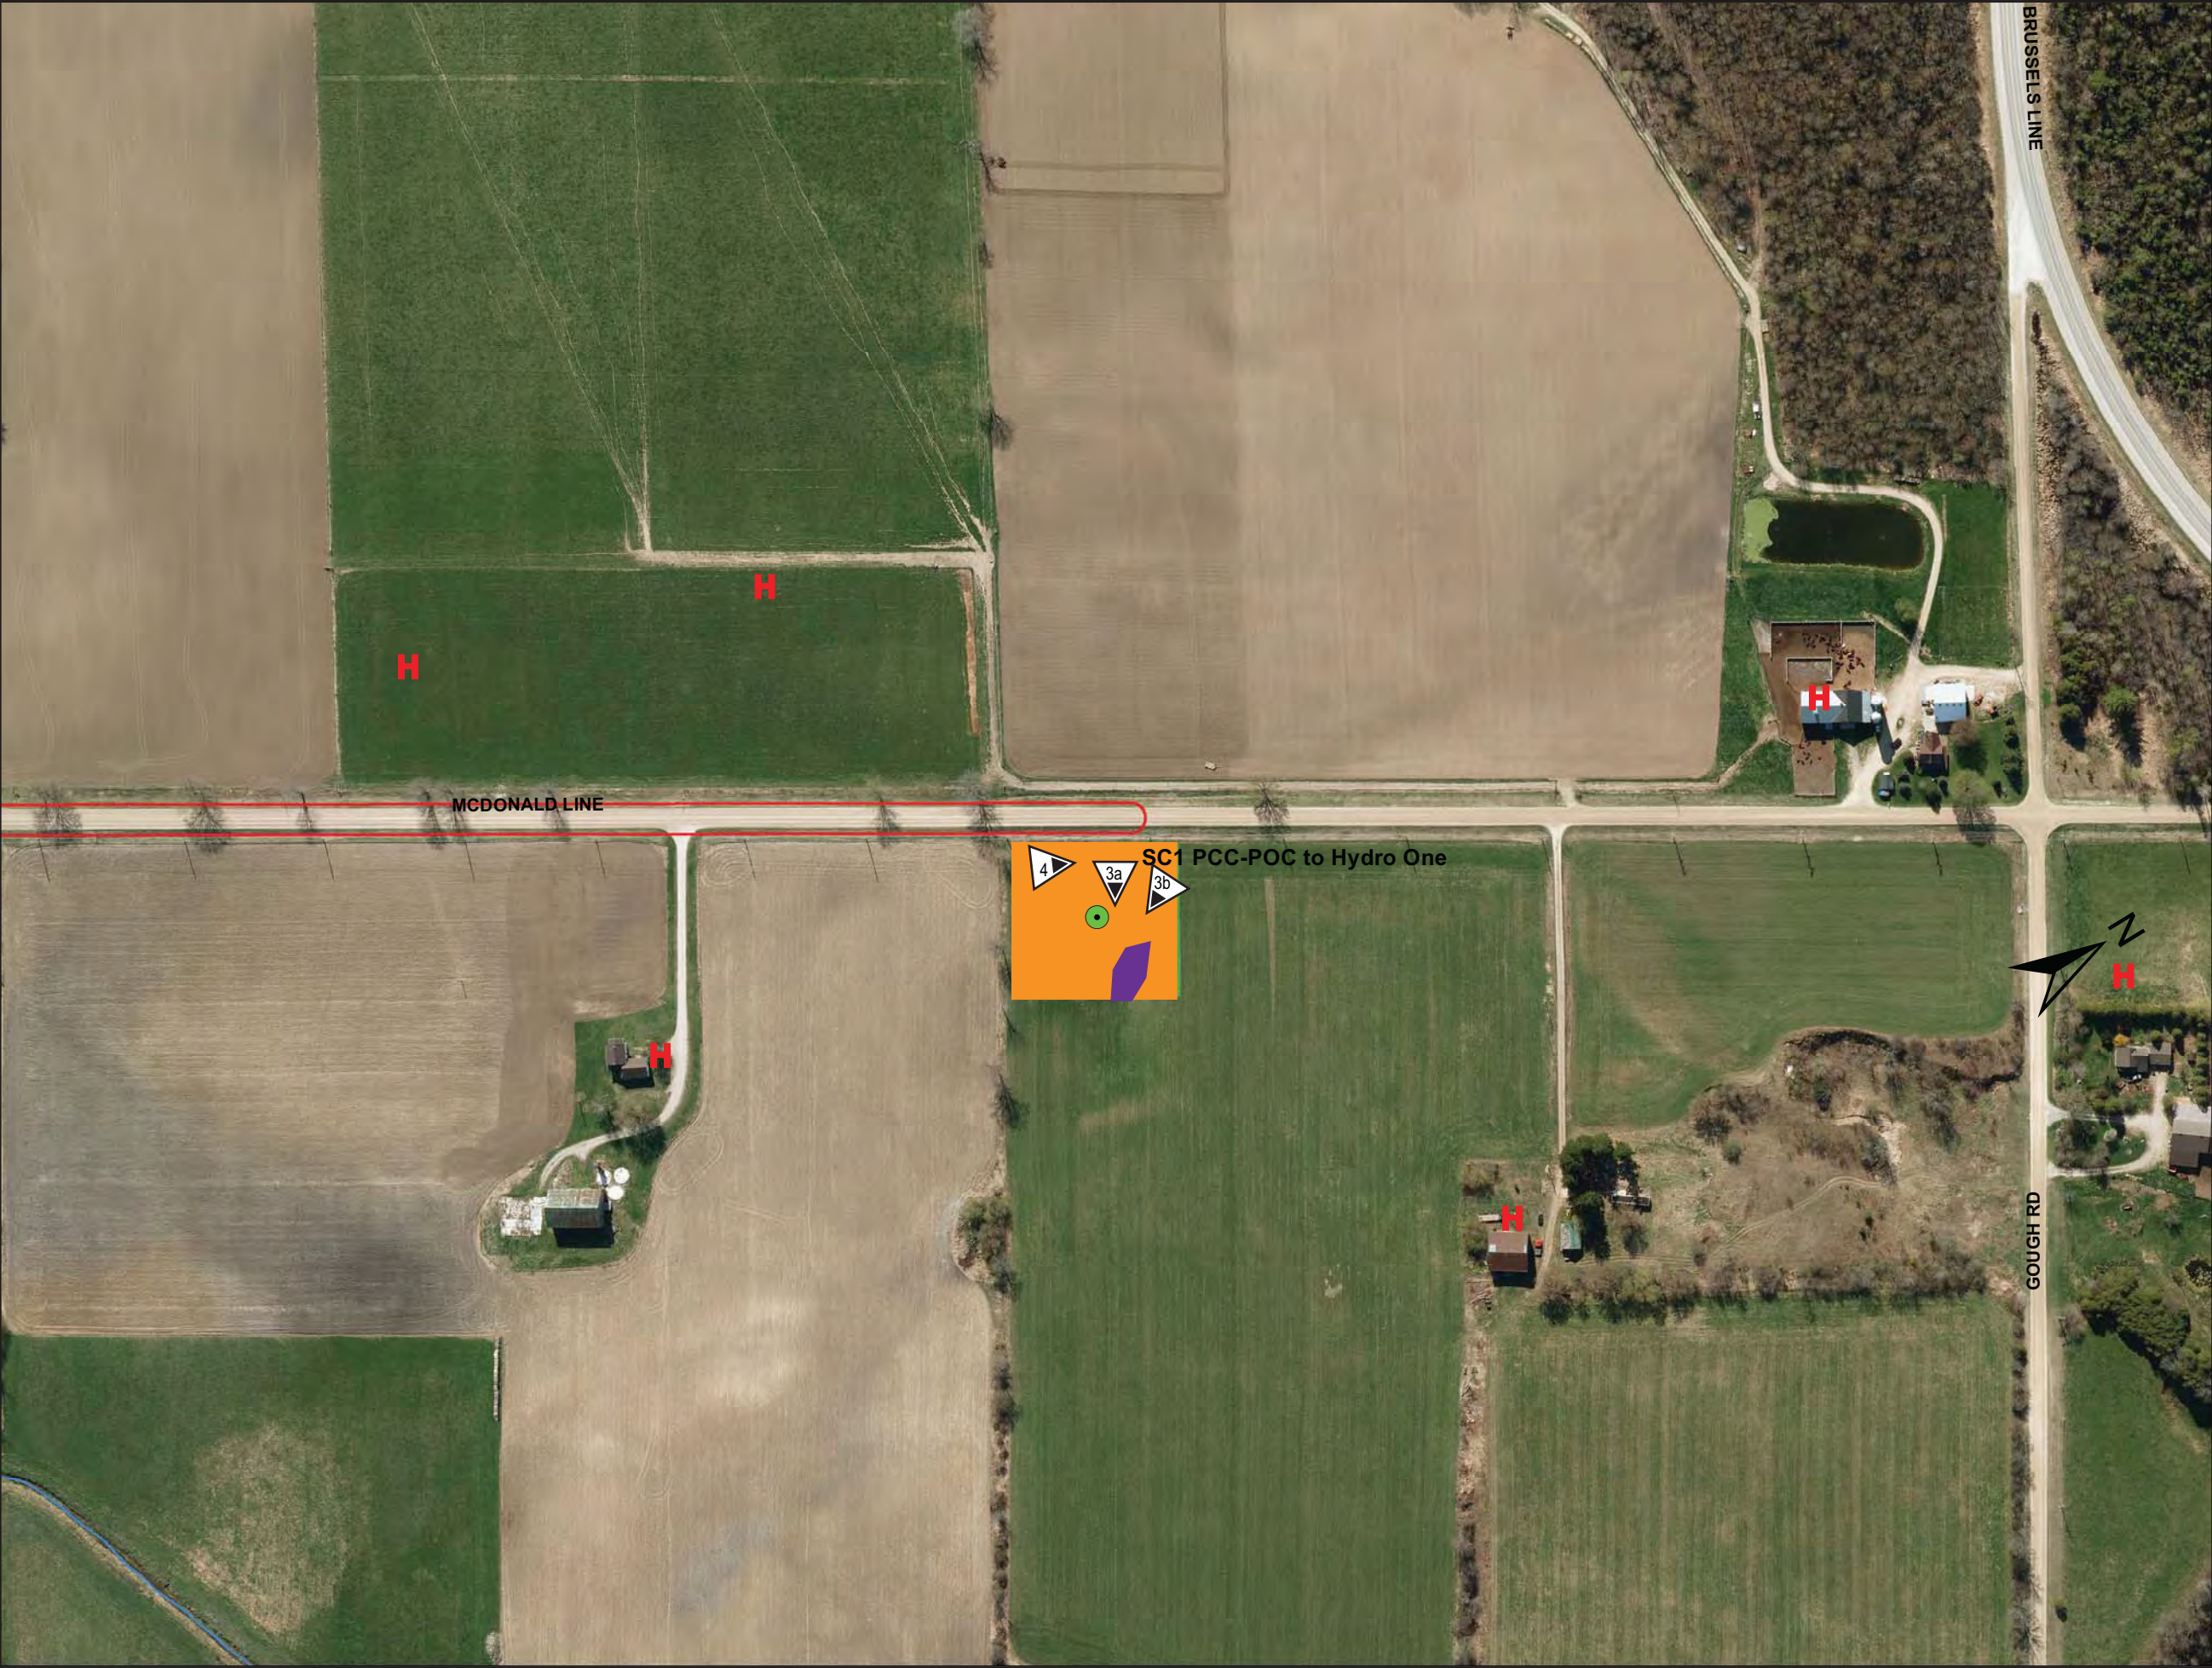
Figure 13: St Columban 1 Electrical Interconnection Line & Electrical Interconnection Facilities – Study Area for SC1 PCC – POC to Hydro One

The three small study areas for the electrical interconnection facilities are all situated adjacent to the road ROW in active agricultural fields. An ample area of 46 x 92 m (150 x 300 feet) was designated as the study area for each of the two southerly proposed electrical interconnection facilities. In both cases, previously assessed access roads comprise a portion of the study area (ASI 2011) (Figures 11-12). For the electrical interconnection facility at the north end of the electrical interconnection line, an ample area 61 x 61 m was designated as the study area (Figure 13). Together the three small study areas total 1.2 ha.

The three study areas for the electrical interconnection facilities are within agricultural fields (Figures 11-13). The survey areas were ploughed deep enough to provided total topsoil exposure, but not deeper than previous ploughing. Pedestrian survey was only conducted on lands with acceptable survey conditions, e.g., ground surface visibility of 90%, and after thorough weathering. All three survey areas were assessed by pedestrian survey at 5 m intervals, with the exception of one corner of the north site (SC1 PCC-POC to Hydro One) where there was no potential for sites due to the wet ground conditions (Plate 3).

Three small study areas, totalling 1.2 ha, for the proposed electrical interconnection facility sites were assessed by pedestrian survey under suitable survey conditions. Field results are indicated in Figures 11-13, and photo-documented in Section 9, Plates 1-4. One corner of the north survey area was determined to be wet with no potential for sites (Figure 13; Plate 3). For the proposed electrical interconnection facility sites, 96% of the total area was pedestrian surveyed at 5 m intervals, and 4% was not surveyed since it was wet with no potential for sites. No archaeological resources were recovered.

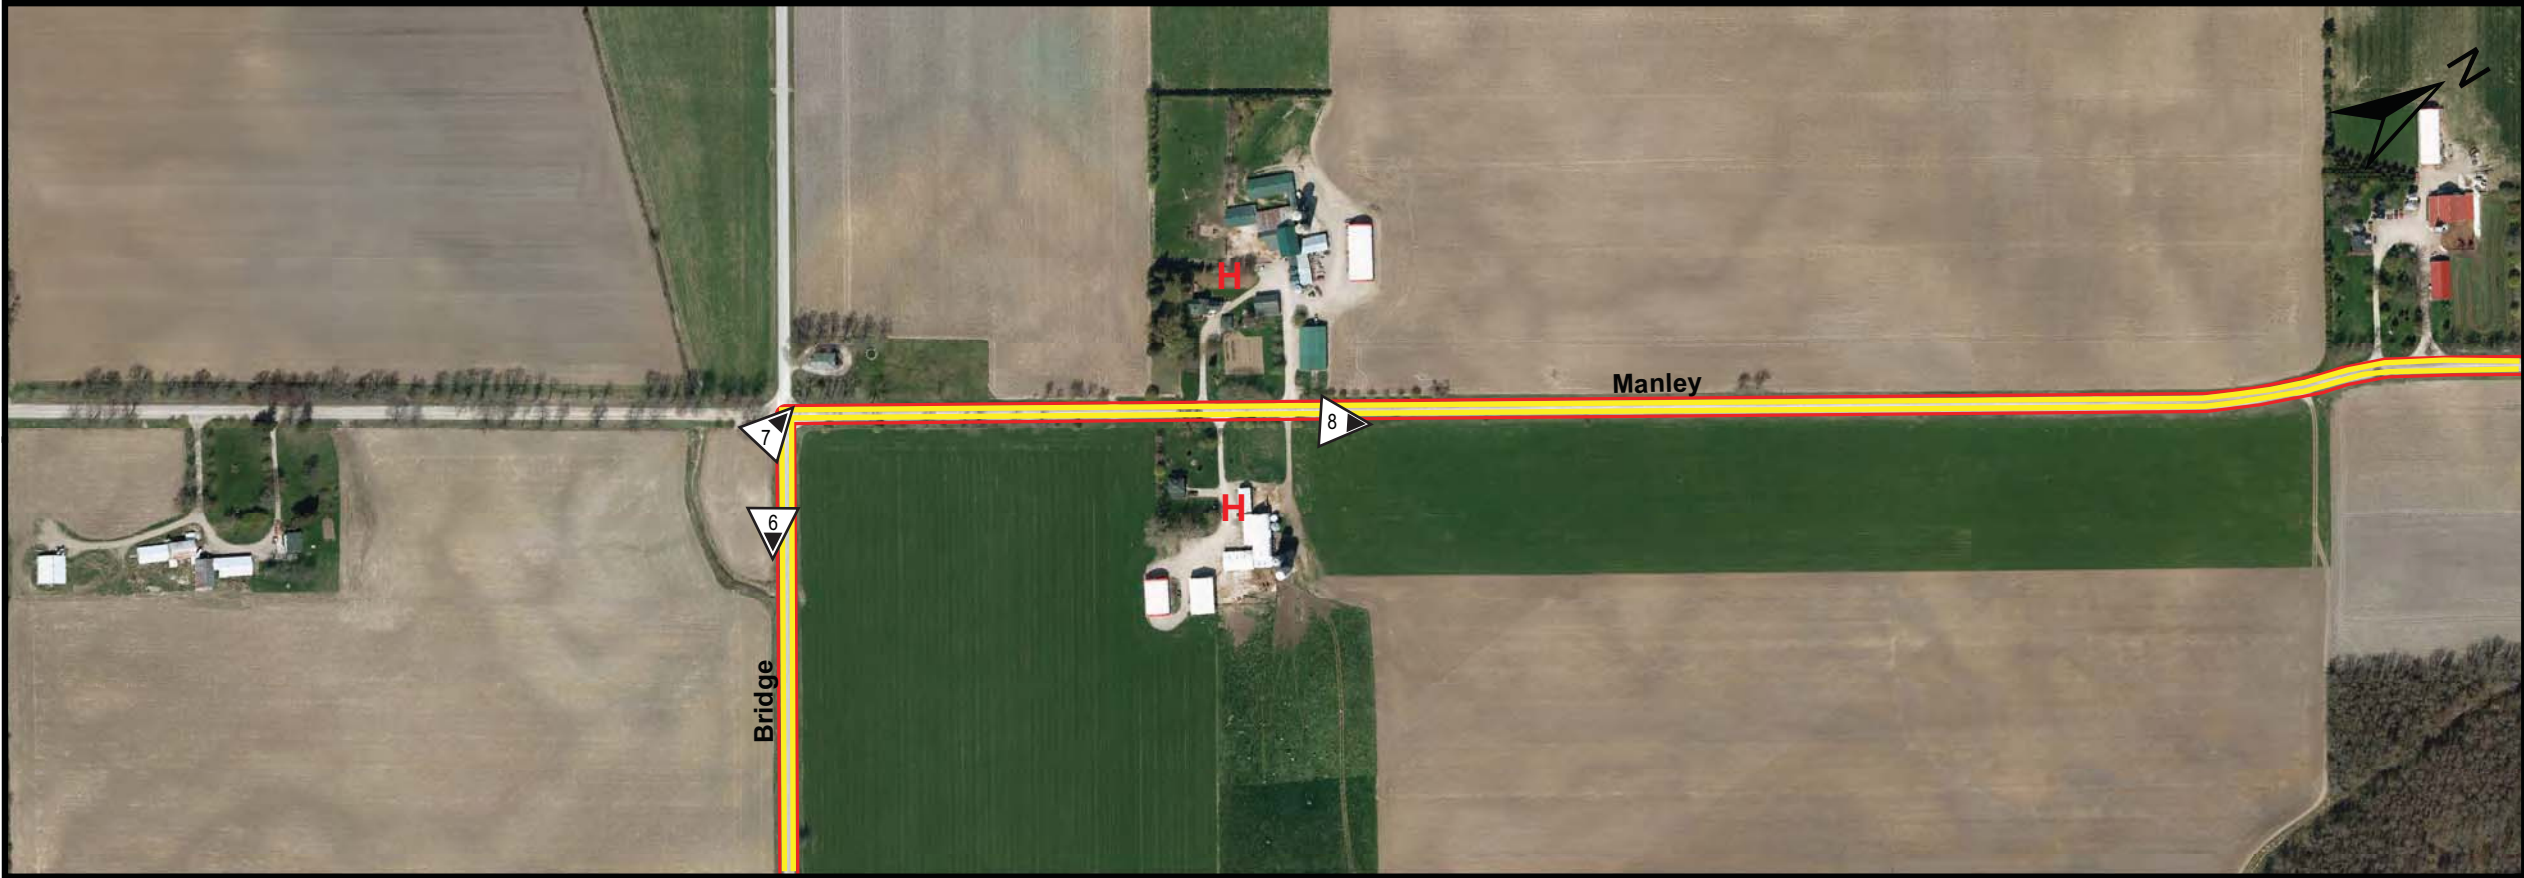
Figure 14: St Columban 1 Line Routing Project – Results of Stage 1 – 2 Archaeological Assessment (Sheets 1 & 2)

- Bridge Road (SC 1 PCC-POP to Hydro One facility to Manley Line) (Figure 14);

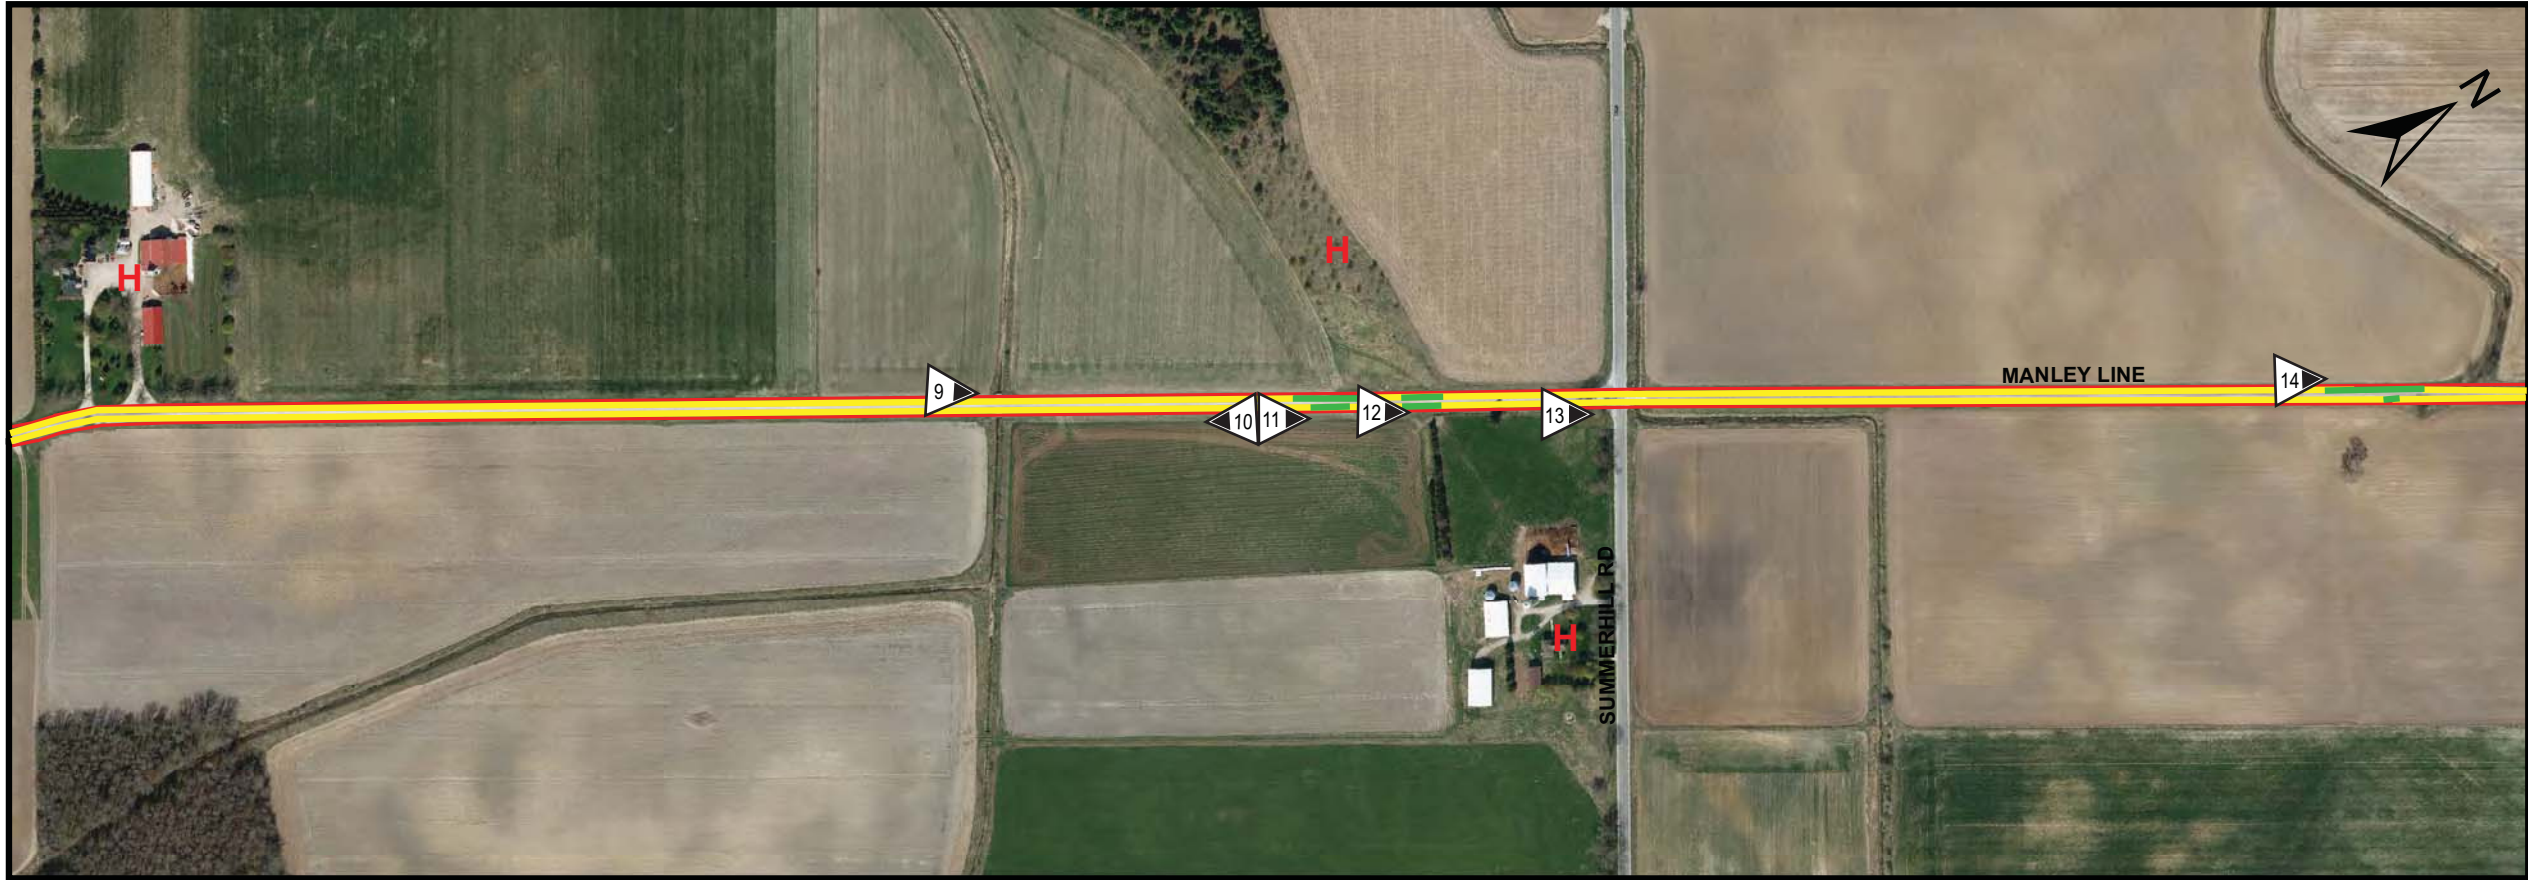
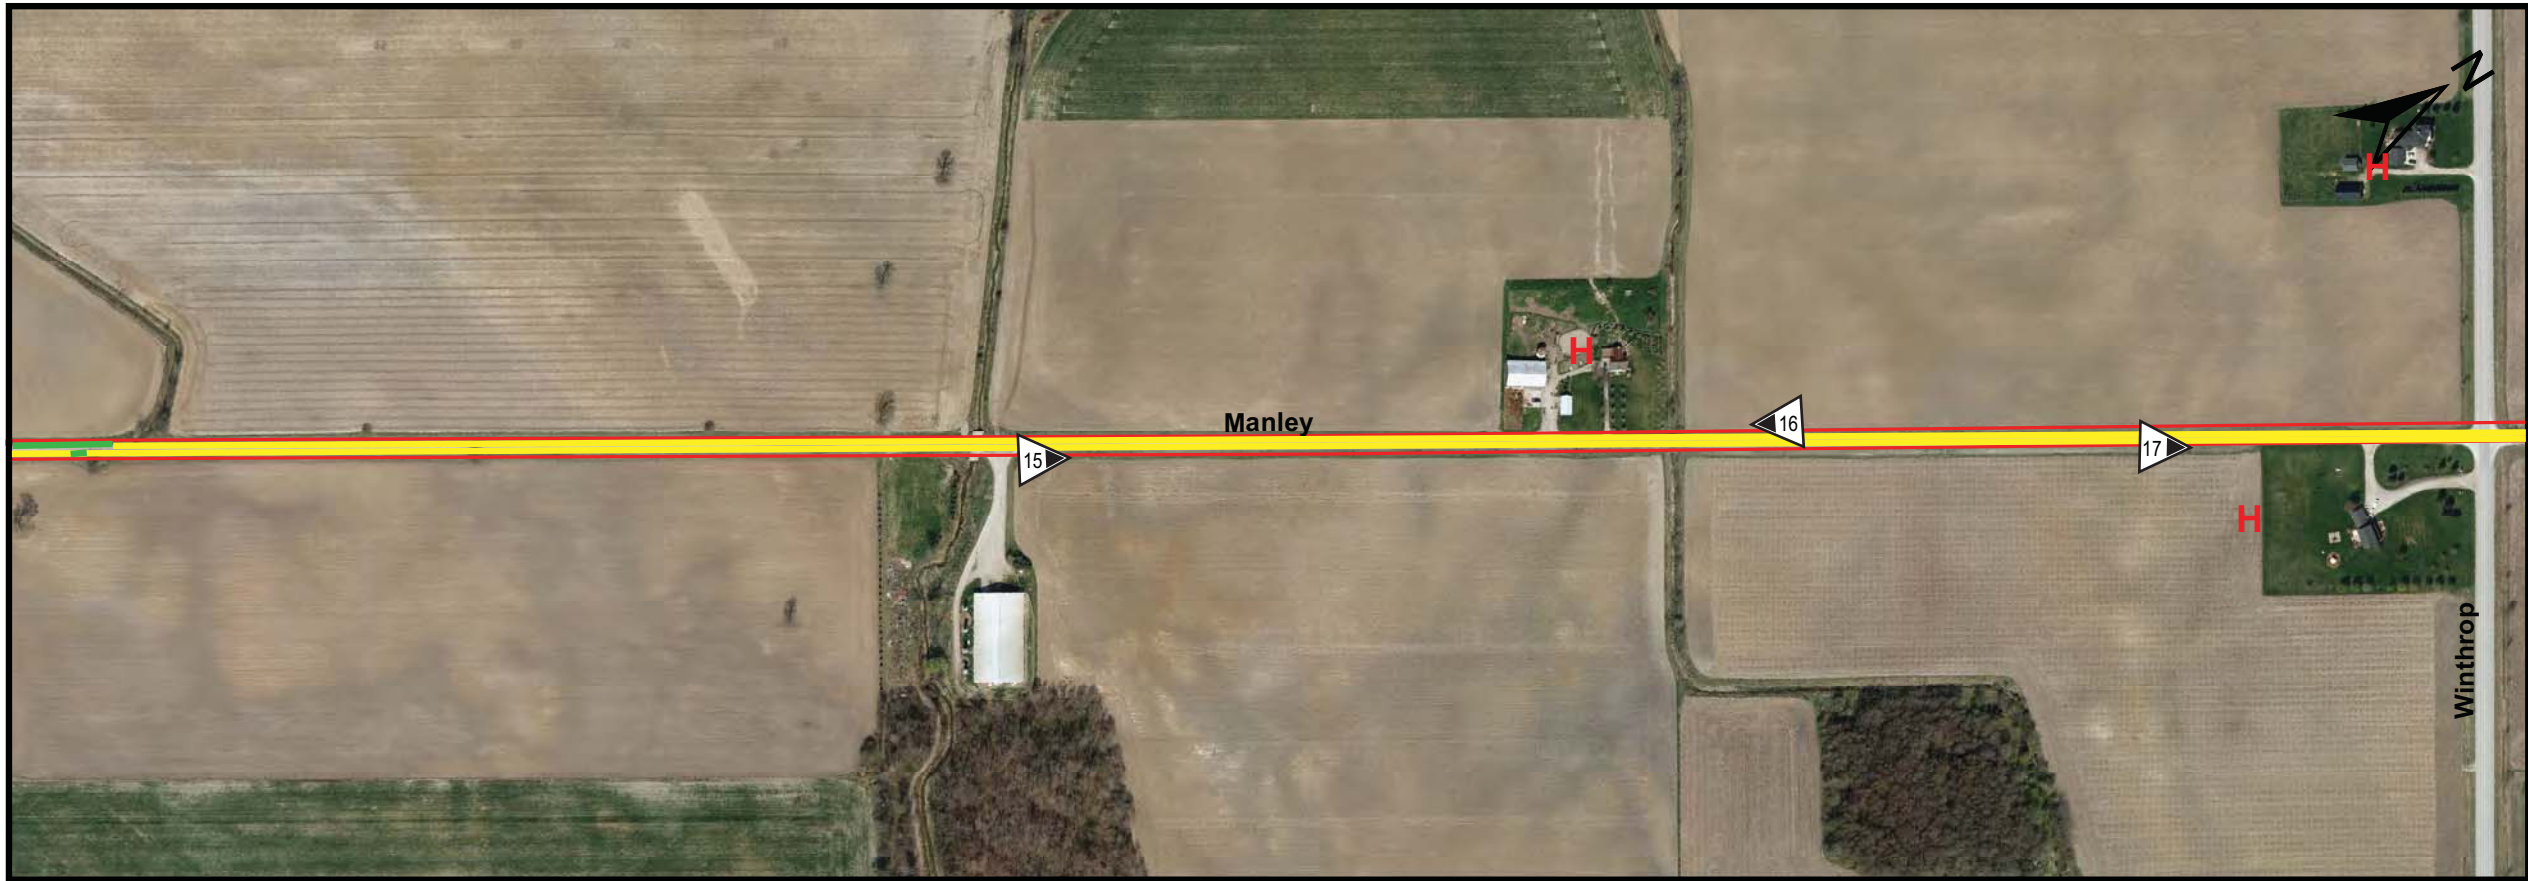
Figure 15: St Columban 1 Line Routing Project – Results of Stage 1 – 2 Archaeological Assessment (Sheets 3 & 4)

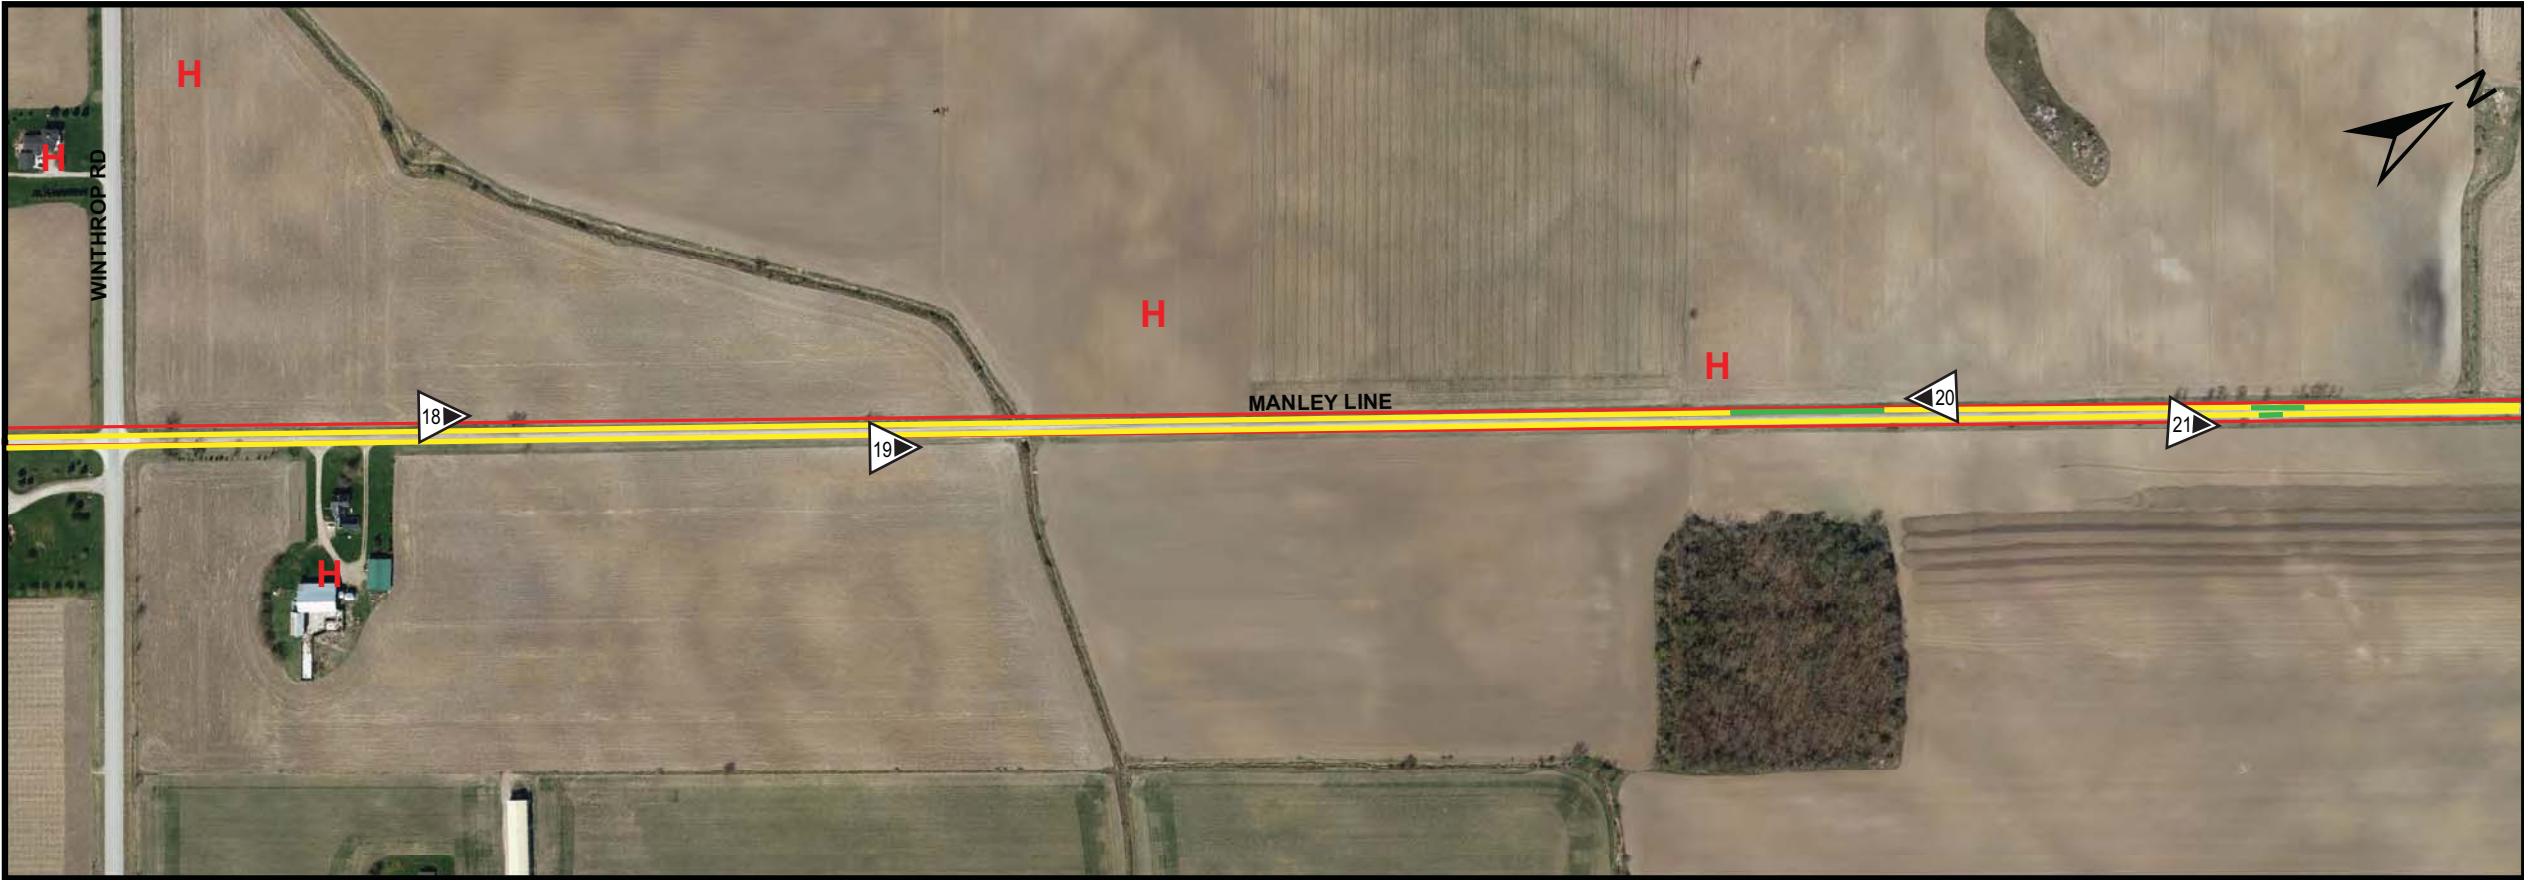
Figure 16: St Columban 1 Line Routing Project – Results of Stage 1 – 2 Archaeological Assessment (Sheets 5 & 6)

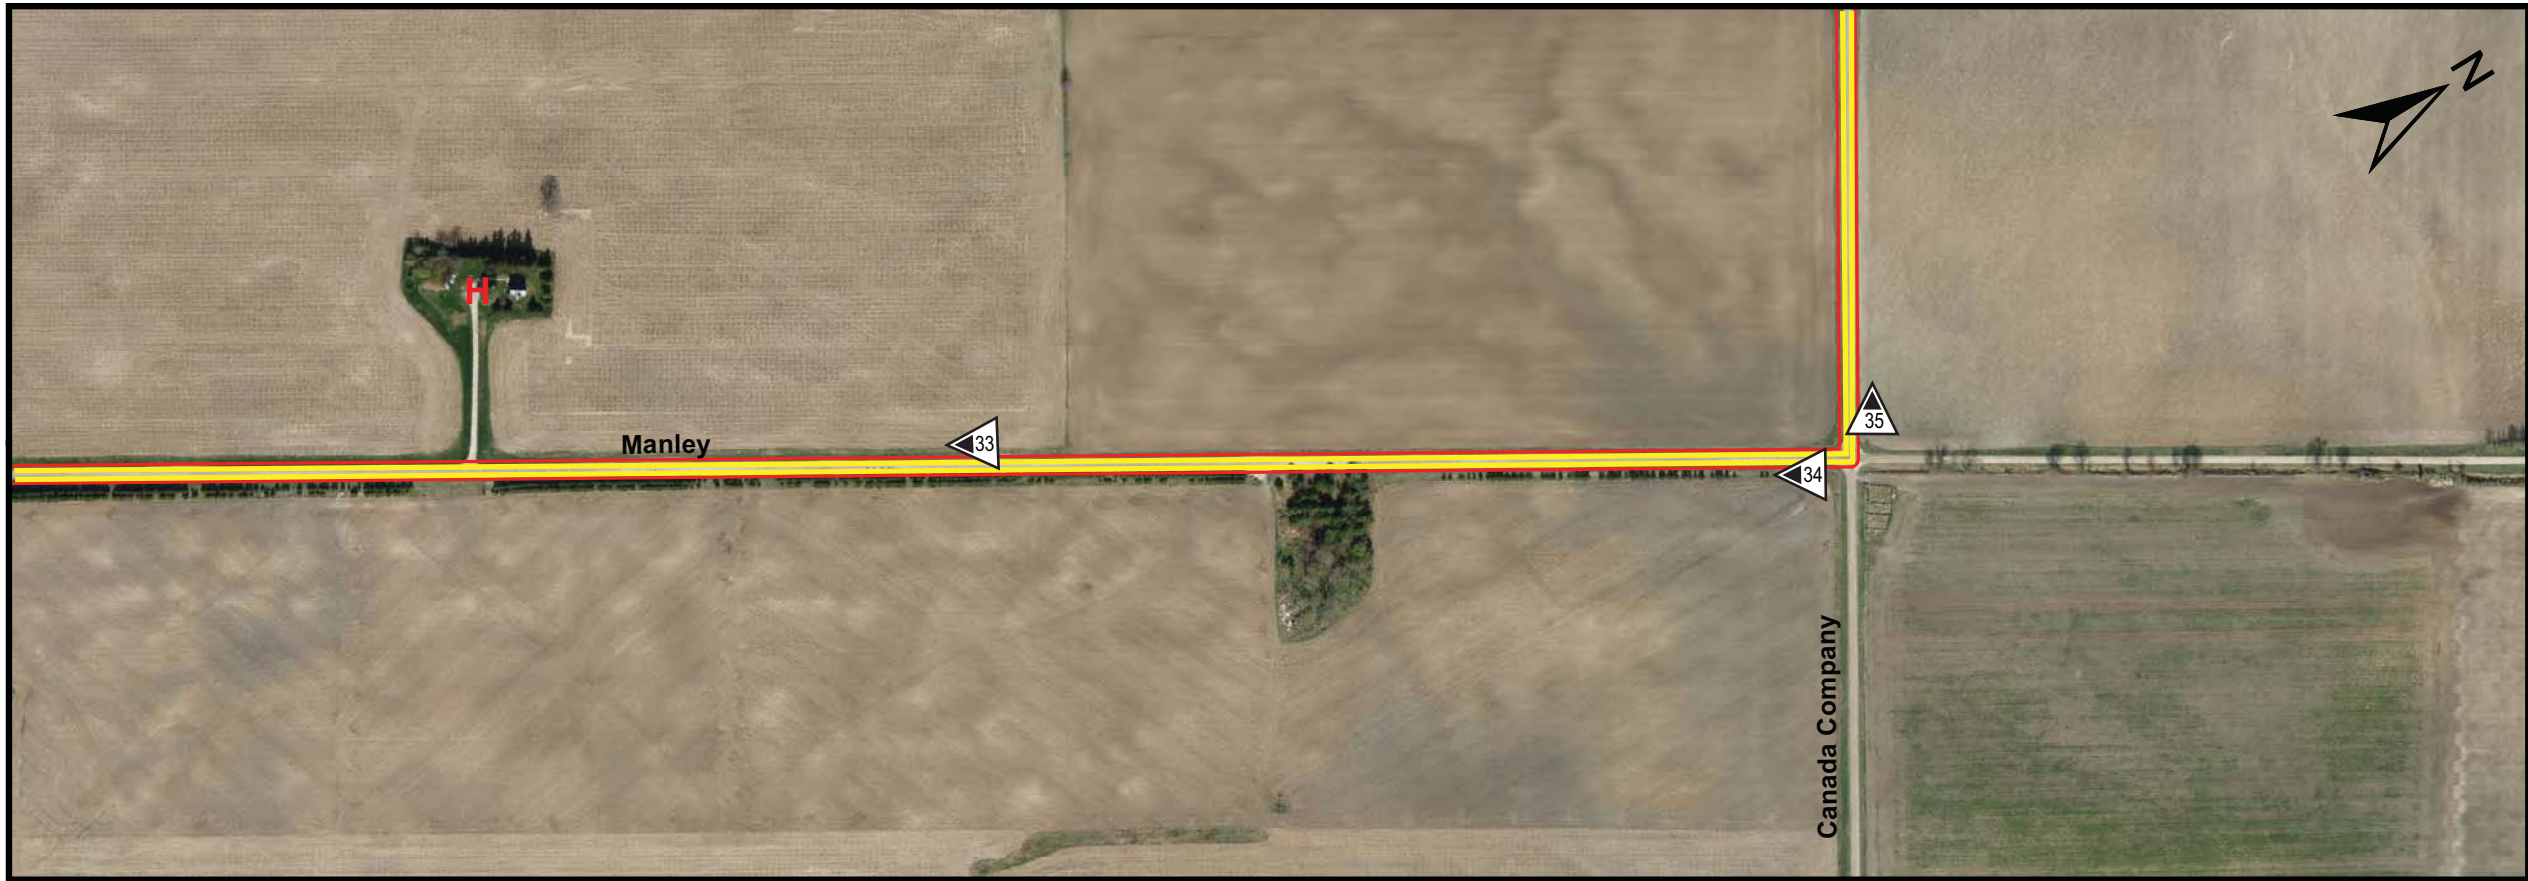
Figure 17: St Columban 1 Line Routing Project – Results of Stage 1 – 2 Archaeological Assessment (Sheets 7 & 8)

- Canada Company Road (Manley Line to Beechwood Line) (Figures 17-18);
- Beechwood Line (Canada Company Road to Blyth Road) (Figures 18-19);
- Blyth Road (Beechwood Line to McNabb Line) (Figure 19);
- McNabb Line (Blyth Road to St. Michaels Road) (Figures 19-20);
- McNabb Line (Fischer Line to Newry) (Figure 22);
- Browntown Road (McNabb Line to Johnston Line) (Figure 24-25);
- Johnston Line (Amberley Road to Centre Line Road) (Figure 26); and
- McDonald Line (Centre Line Road to Operations and Maintenance Building) (Figures 27-28).

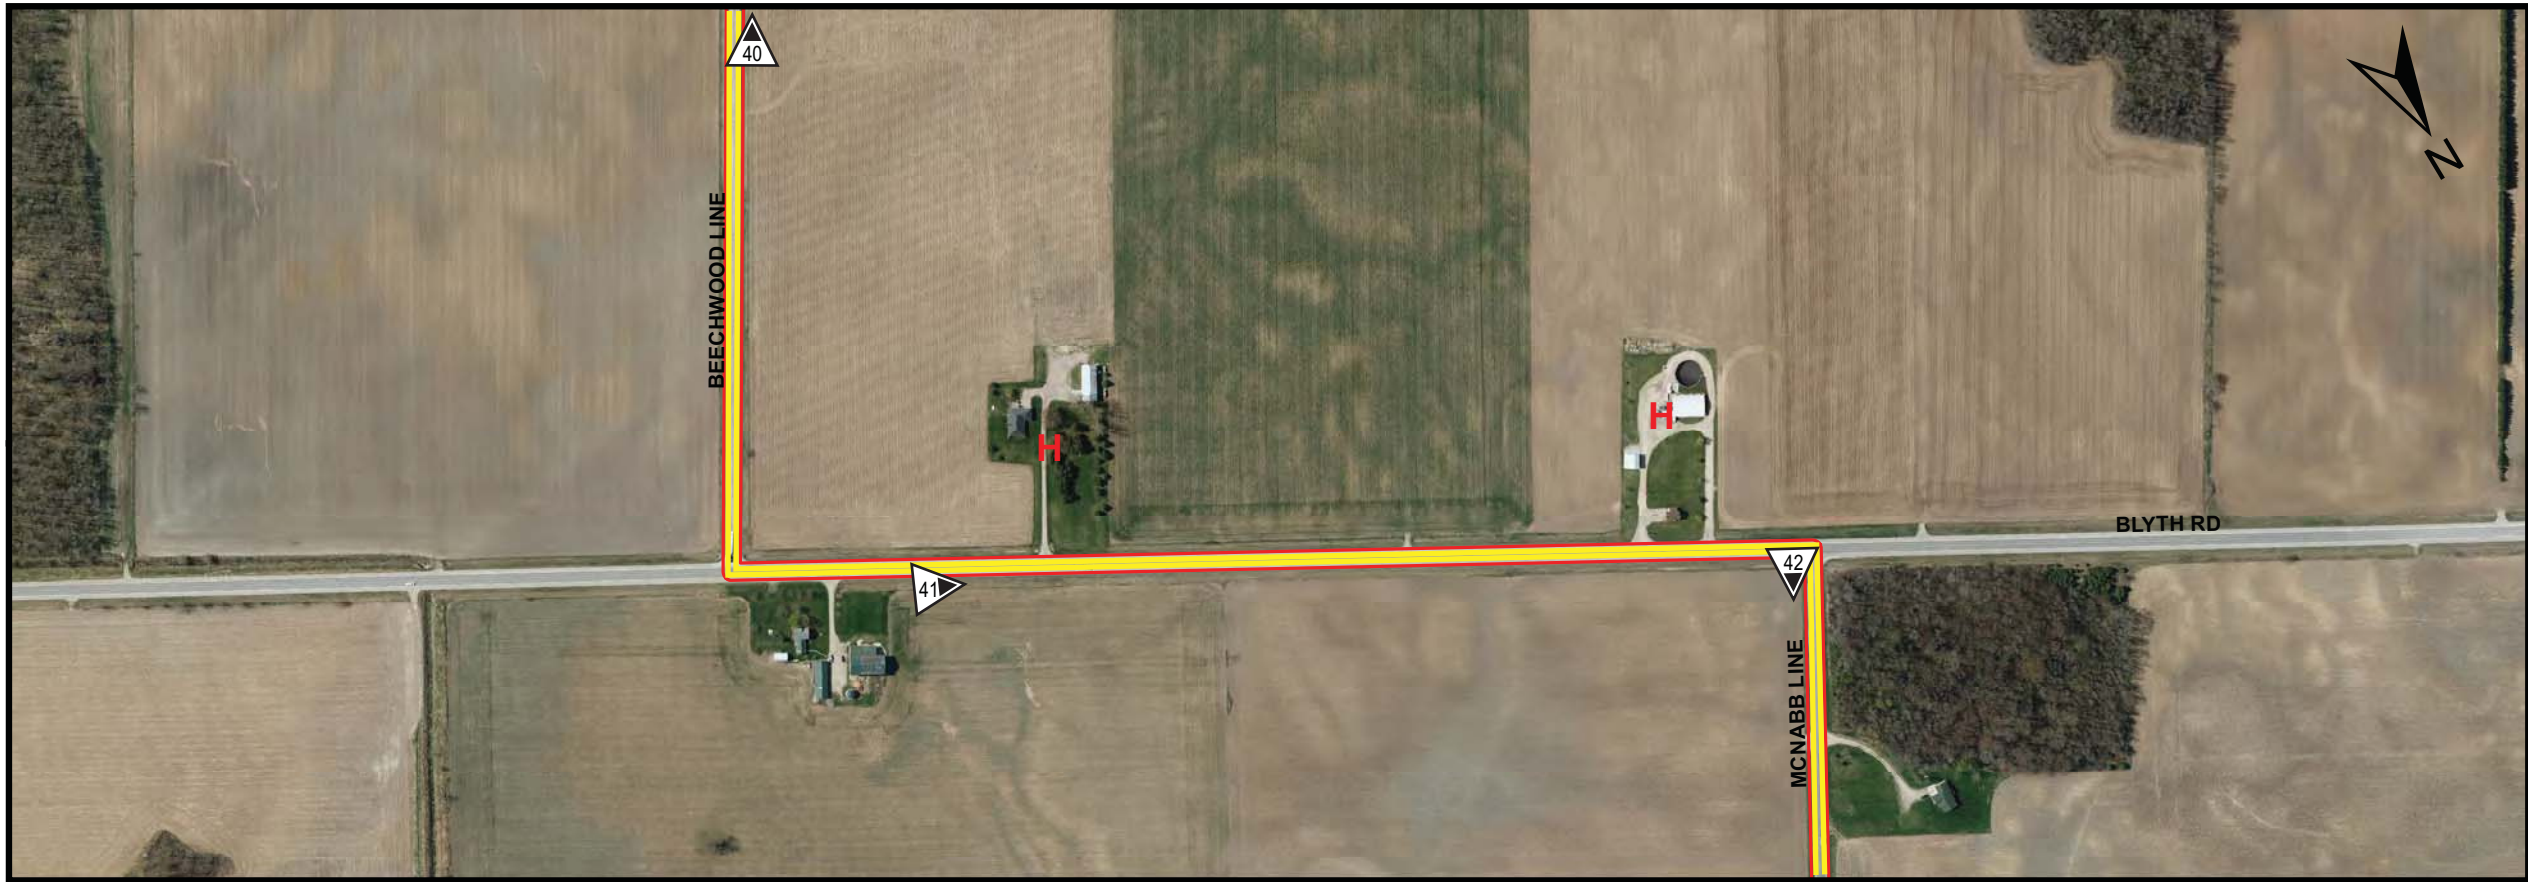
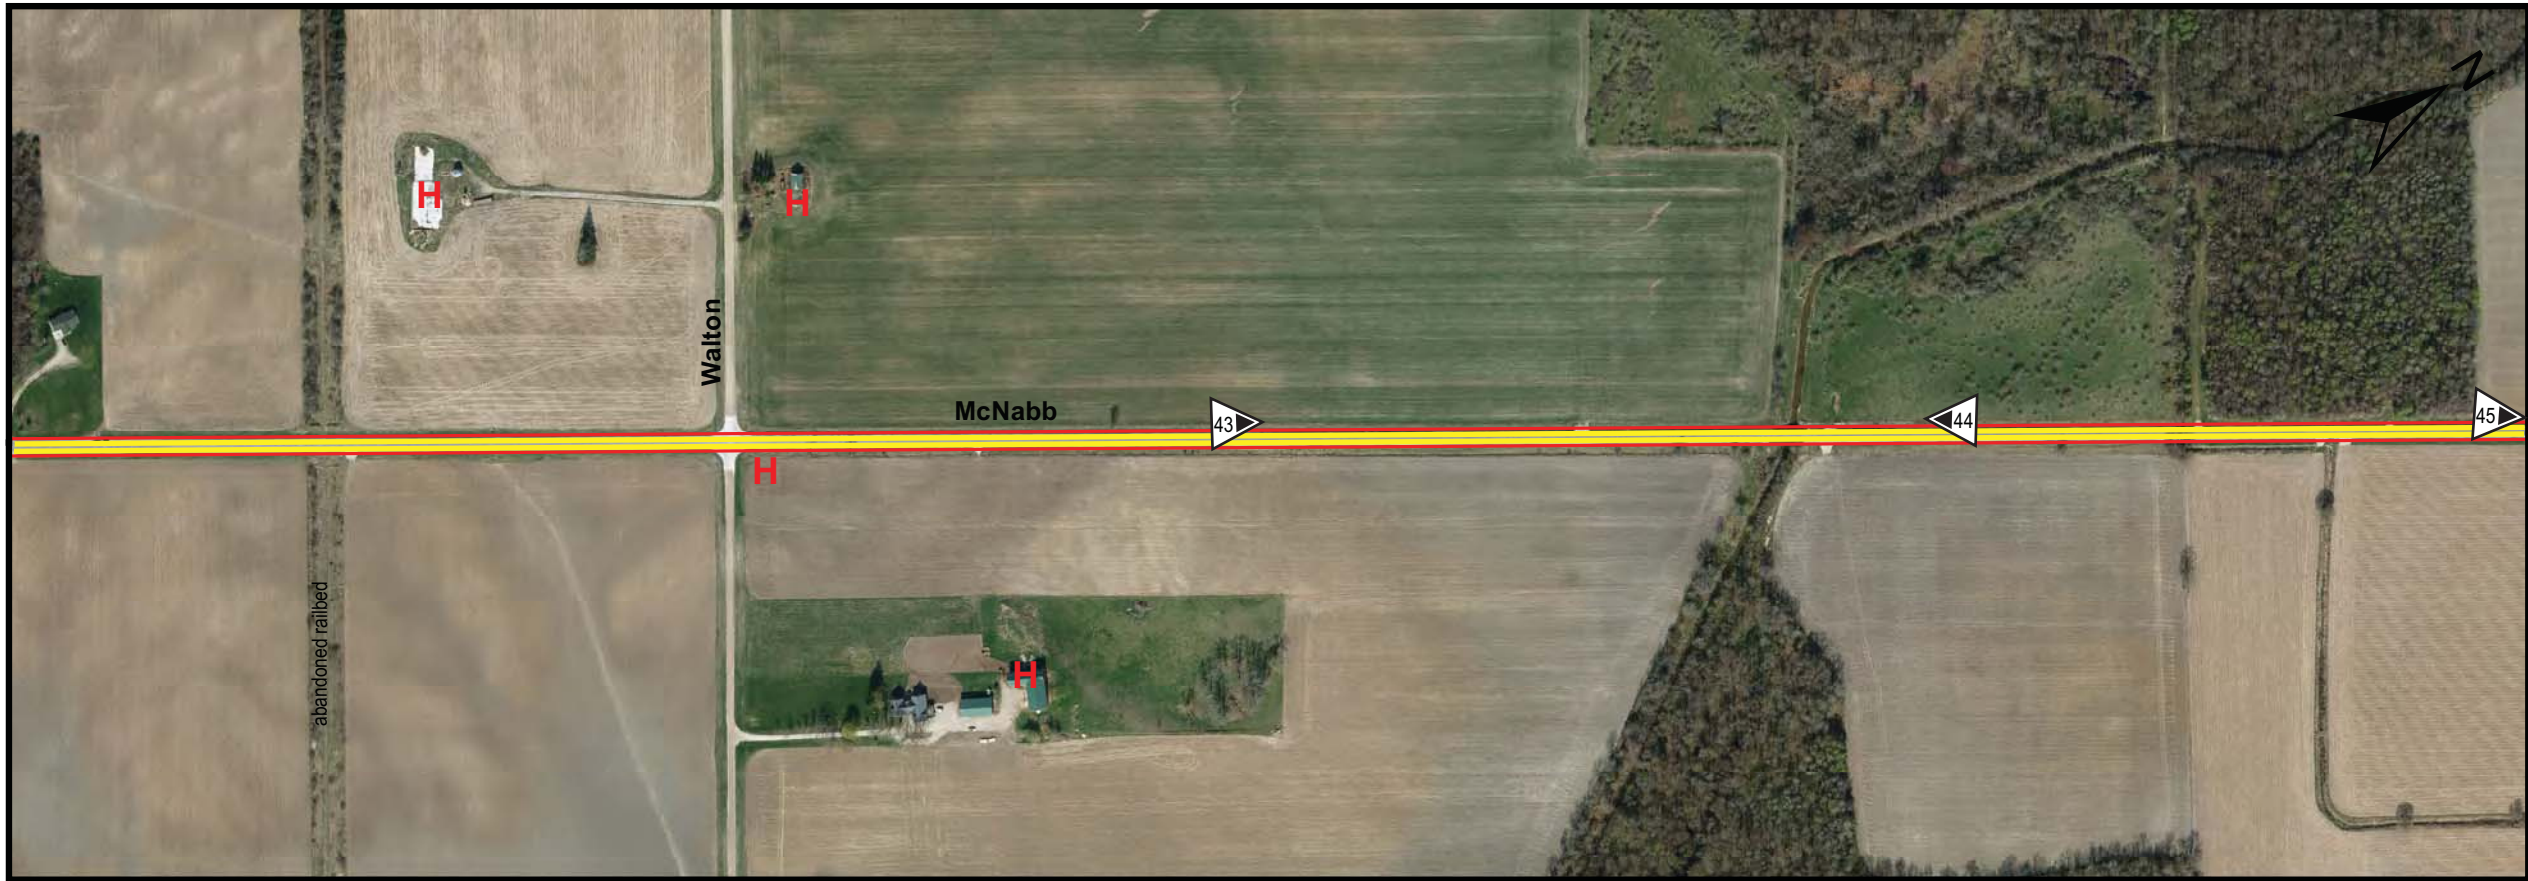
Figure 19: St Columban 1 Line Routing Project – Results of Stage 1 – 2 Archaeological Assessment (Sheets 11 & 12)
