**Stage 1 Background Study and Property Inspection  
Stage 2 Property Assessment**

**St. Columban 1 Electrical Interconnection Line  
and Electrical Interconnection Facilities  
Municipality of East Huron (Geographic Townships of McKillop and Grey),  
Municipality of Morris-Turnberry (Geographic Township of Turnberry), and  
Township of Howick, Huron County, Ontario**

**FIT-F1PW818**

December 22, 2011  
(Revised January 17, 2012)

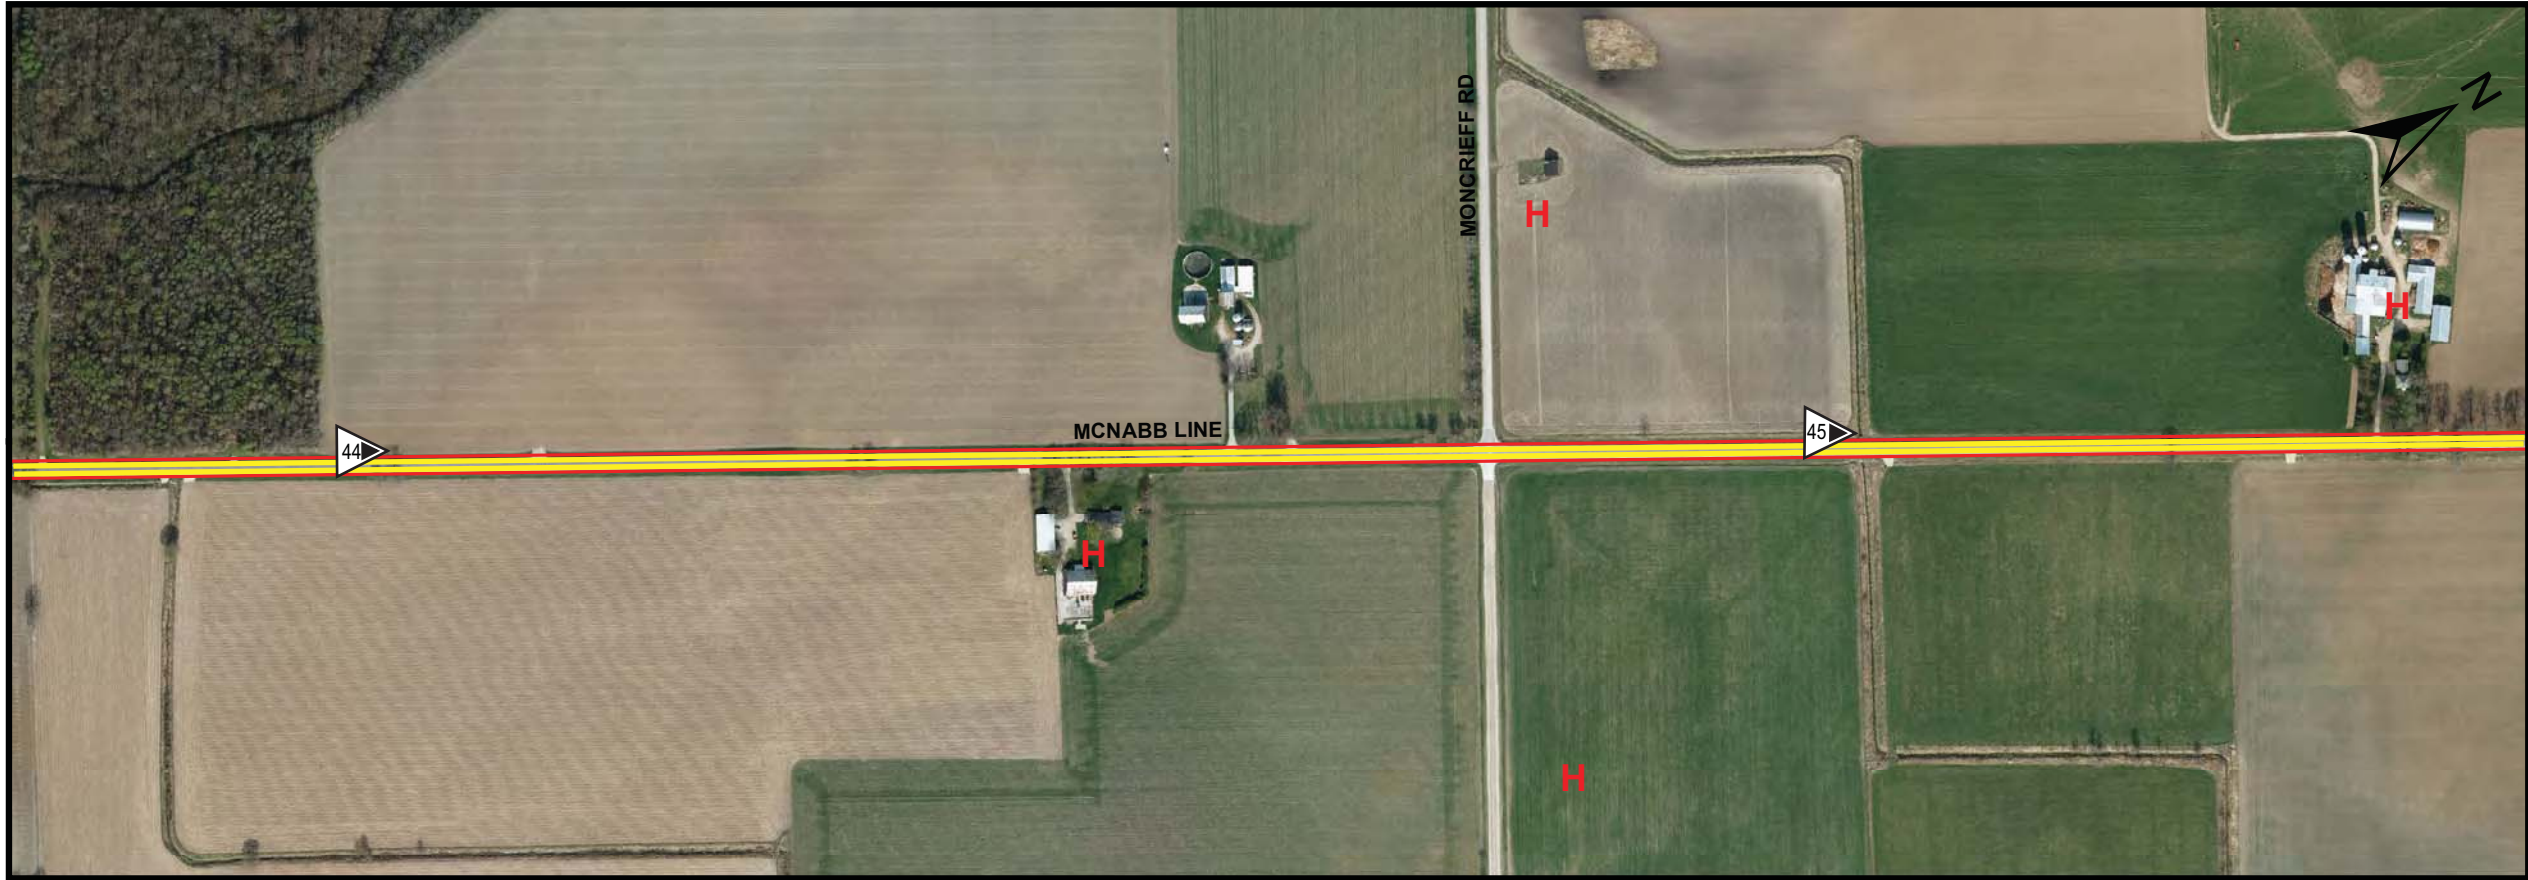
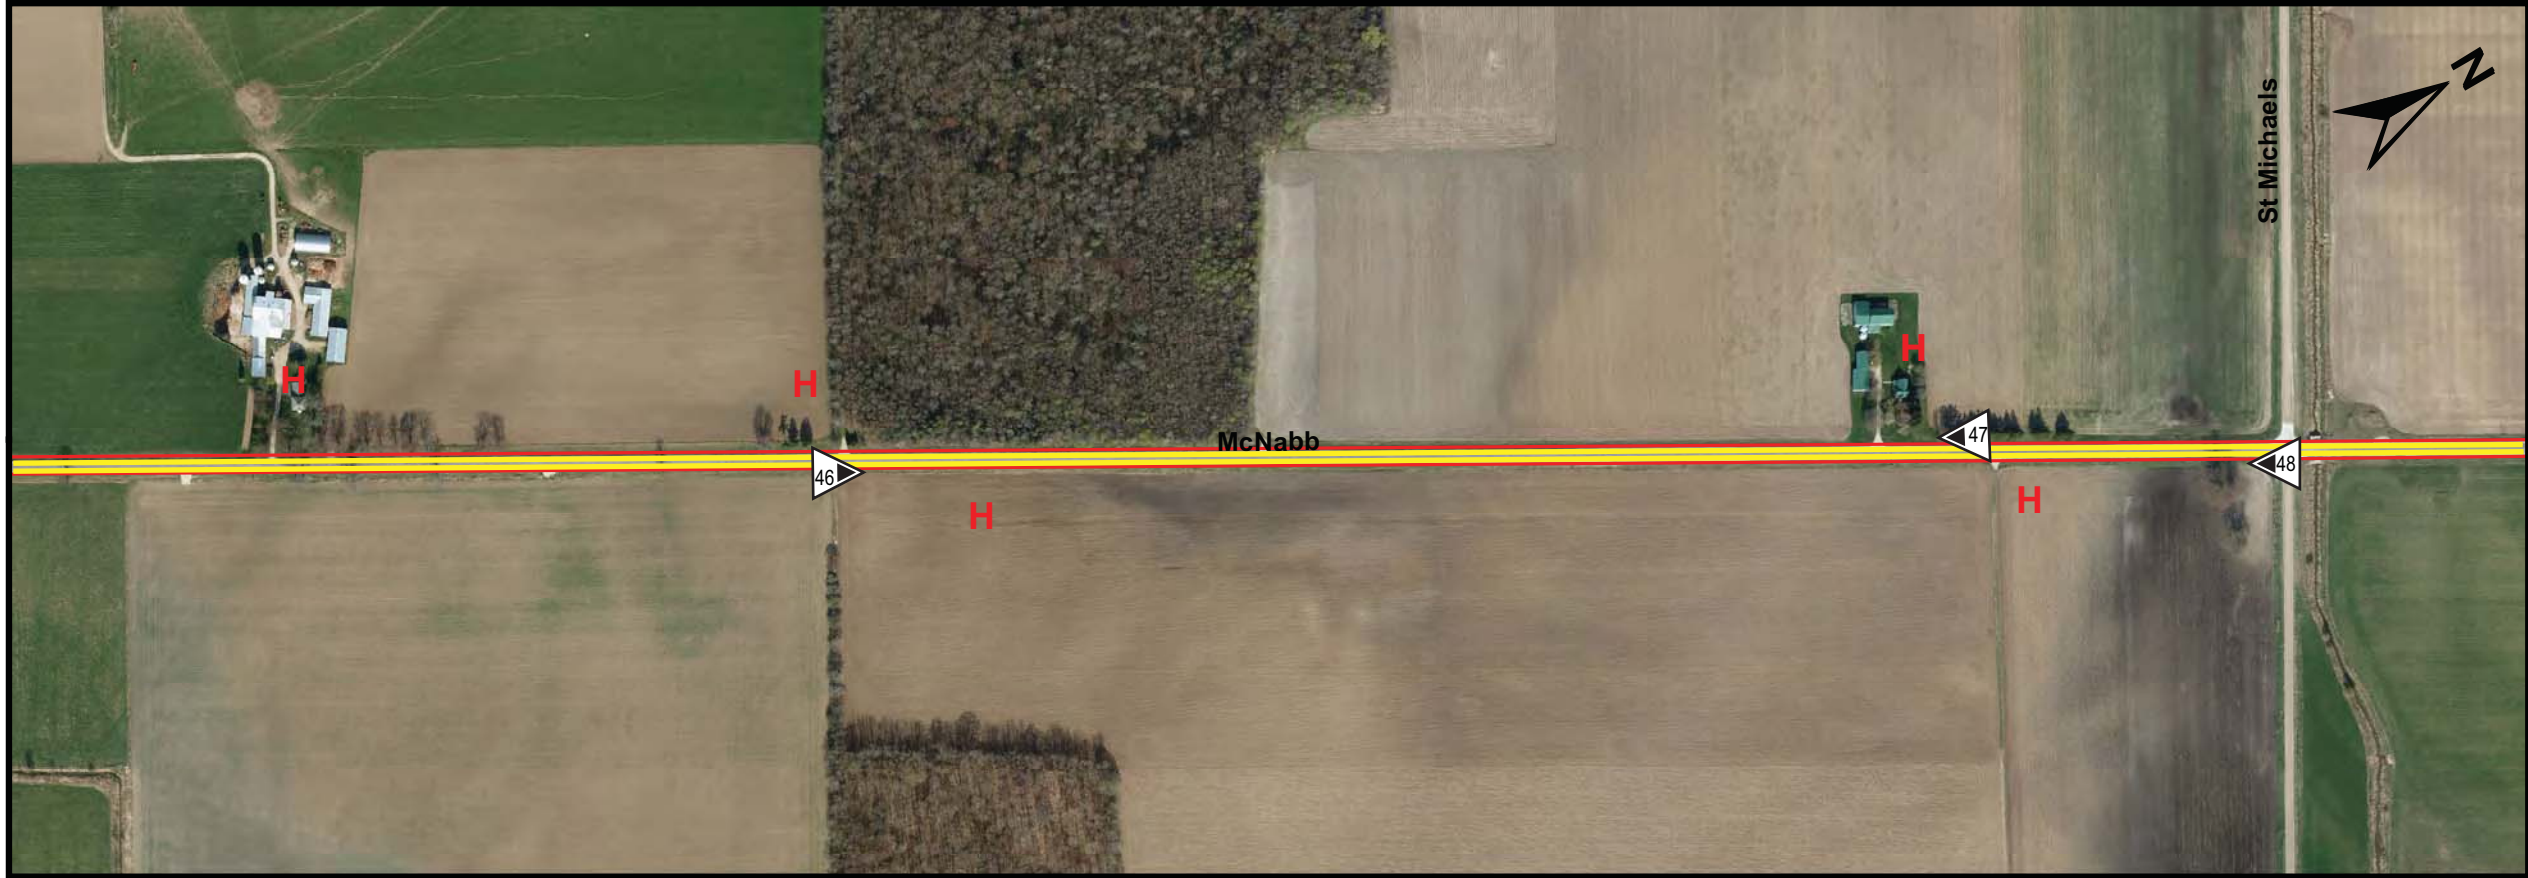
Figure 20: St Columban 1 Line Routing Project – Results of Stage 1 – 2 Archaeological Assessment (Sheets 13 & 14)

- Canada Company Road (Manley Line to Beechwood Line) (Figures 17-18);
- Beechwood Line (Canada Company Road to Blyth Road) (Figures 18-19);
- Blyth Road (Beechwood Line to McNabb Line) (Figure 19);
- McNabb Line (Blyth Road to St. Michaels Road) (Figures 19-20);
- McNabb Line (Fischer Line to Newry) (Figure 22);
- Browntown Road (McNabb Line to Johnston Line) (Figure 24-25);
- Johnston Line (Amberley Road to Centre Line Road) (Figure 26); and
- McDonald Line (Centre Line Road to Operations and Maintenance Building) (Figures 27-28).

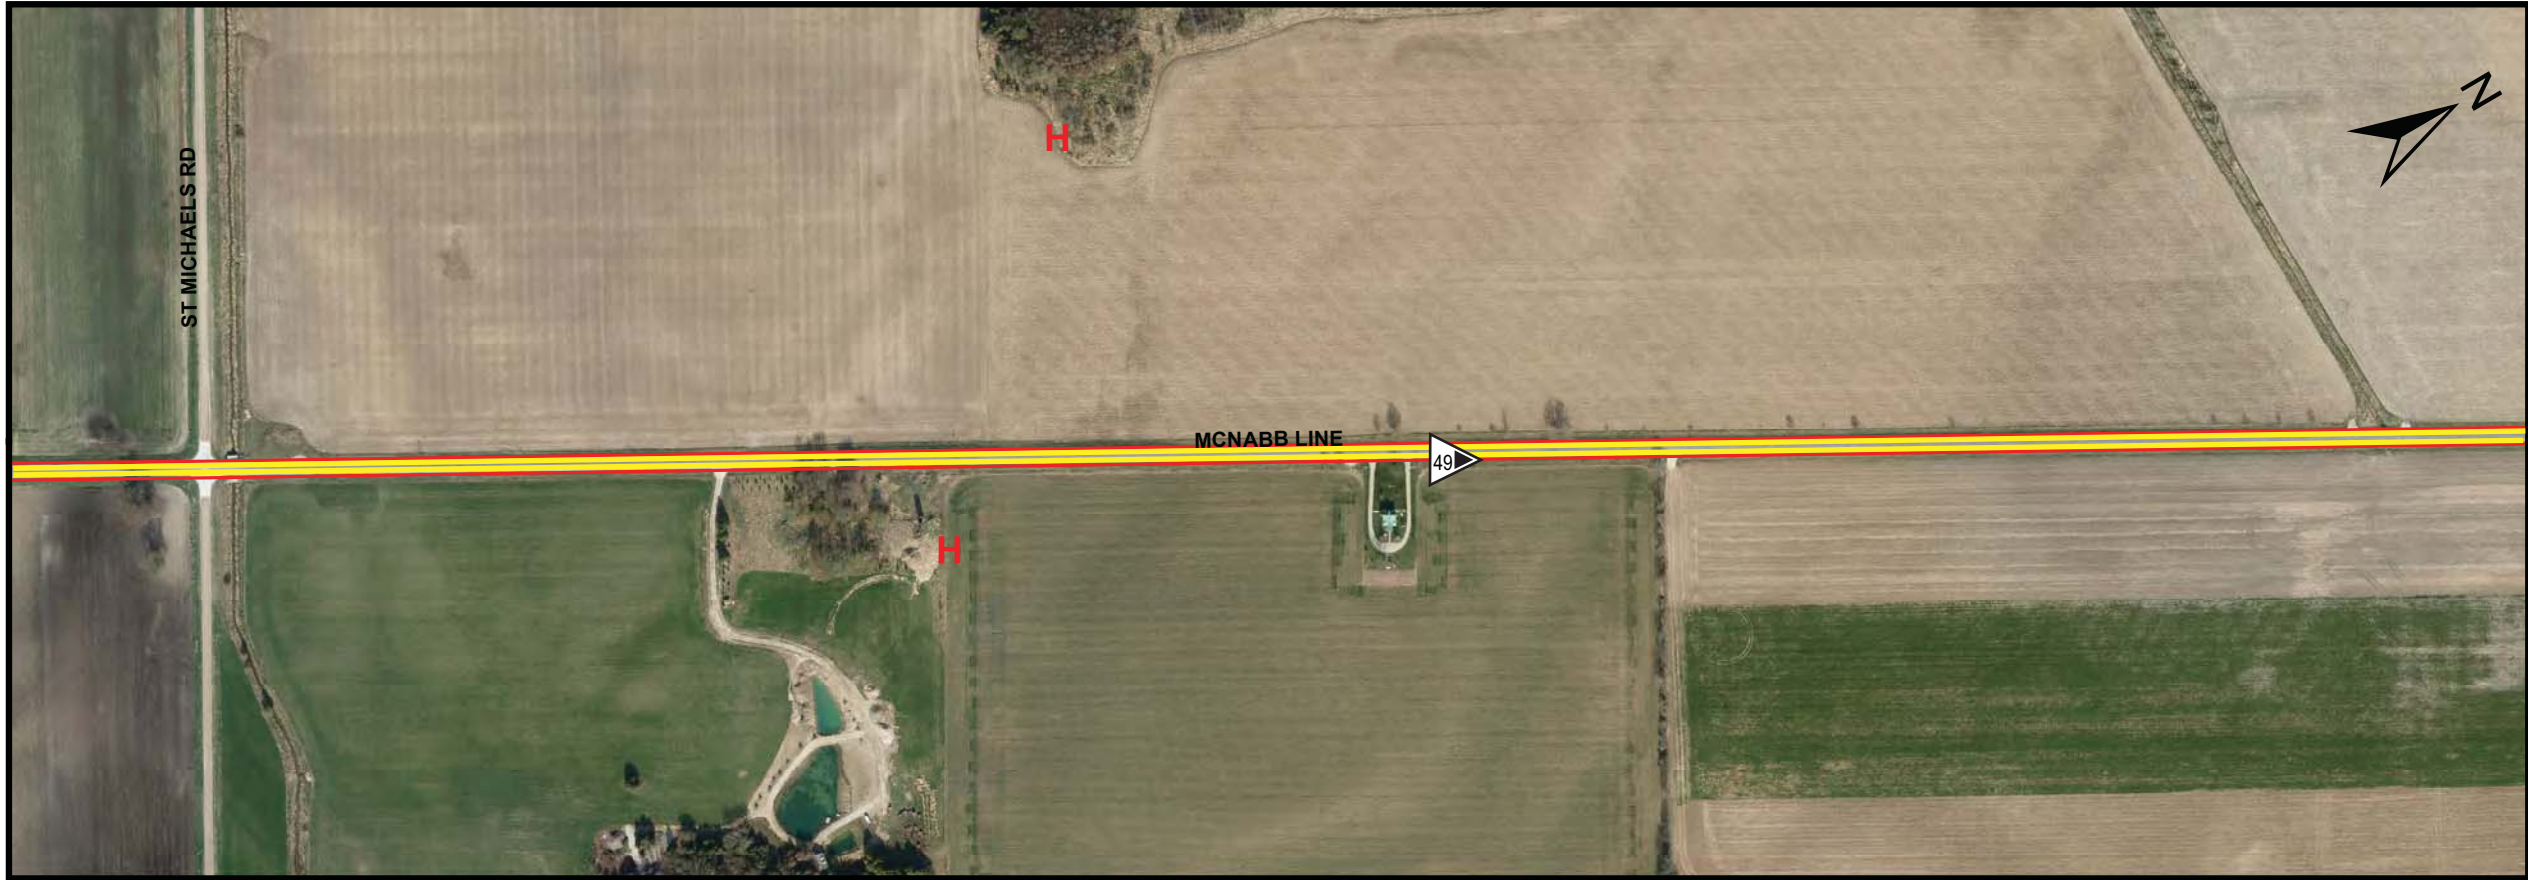
Figure 21: St Columban 1 Line Routing Project – Results of Stage 1 – 2 Archaeological Assessment (Sheets 15 & 16)

Undisturbed soil profiles were identified in a few scattered locations along the electrical interconnection line study corridor. Topsoil occurrences were often as isolated or a thin layer between gravel and subsoil. These locations were defined by excavating test pits at 5 m intervals. The locations of 5 m interval test pitting and undisturbed soils are indicated in Figures 21, 23, 24, 26, and 27. No archaeological resources were recovered.

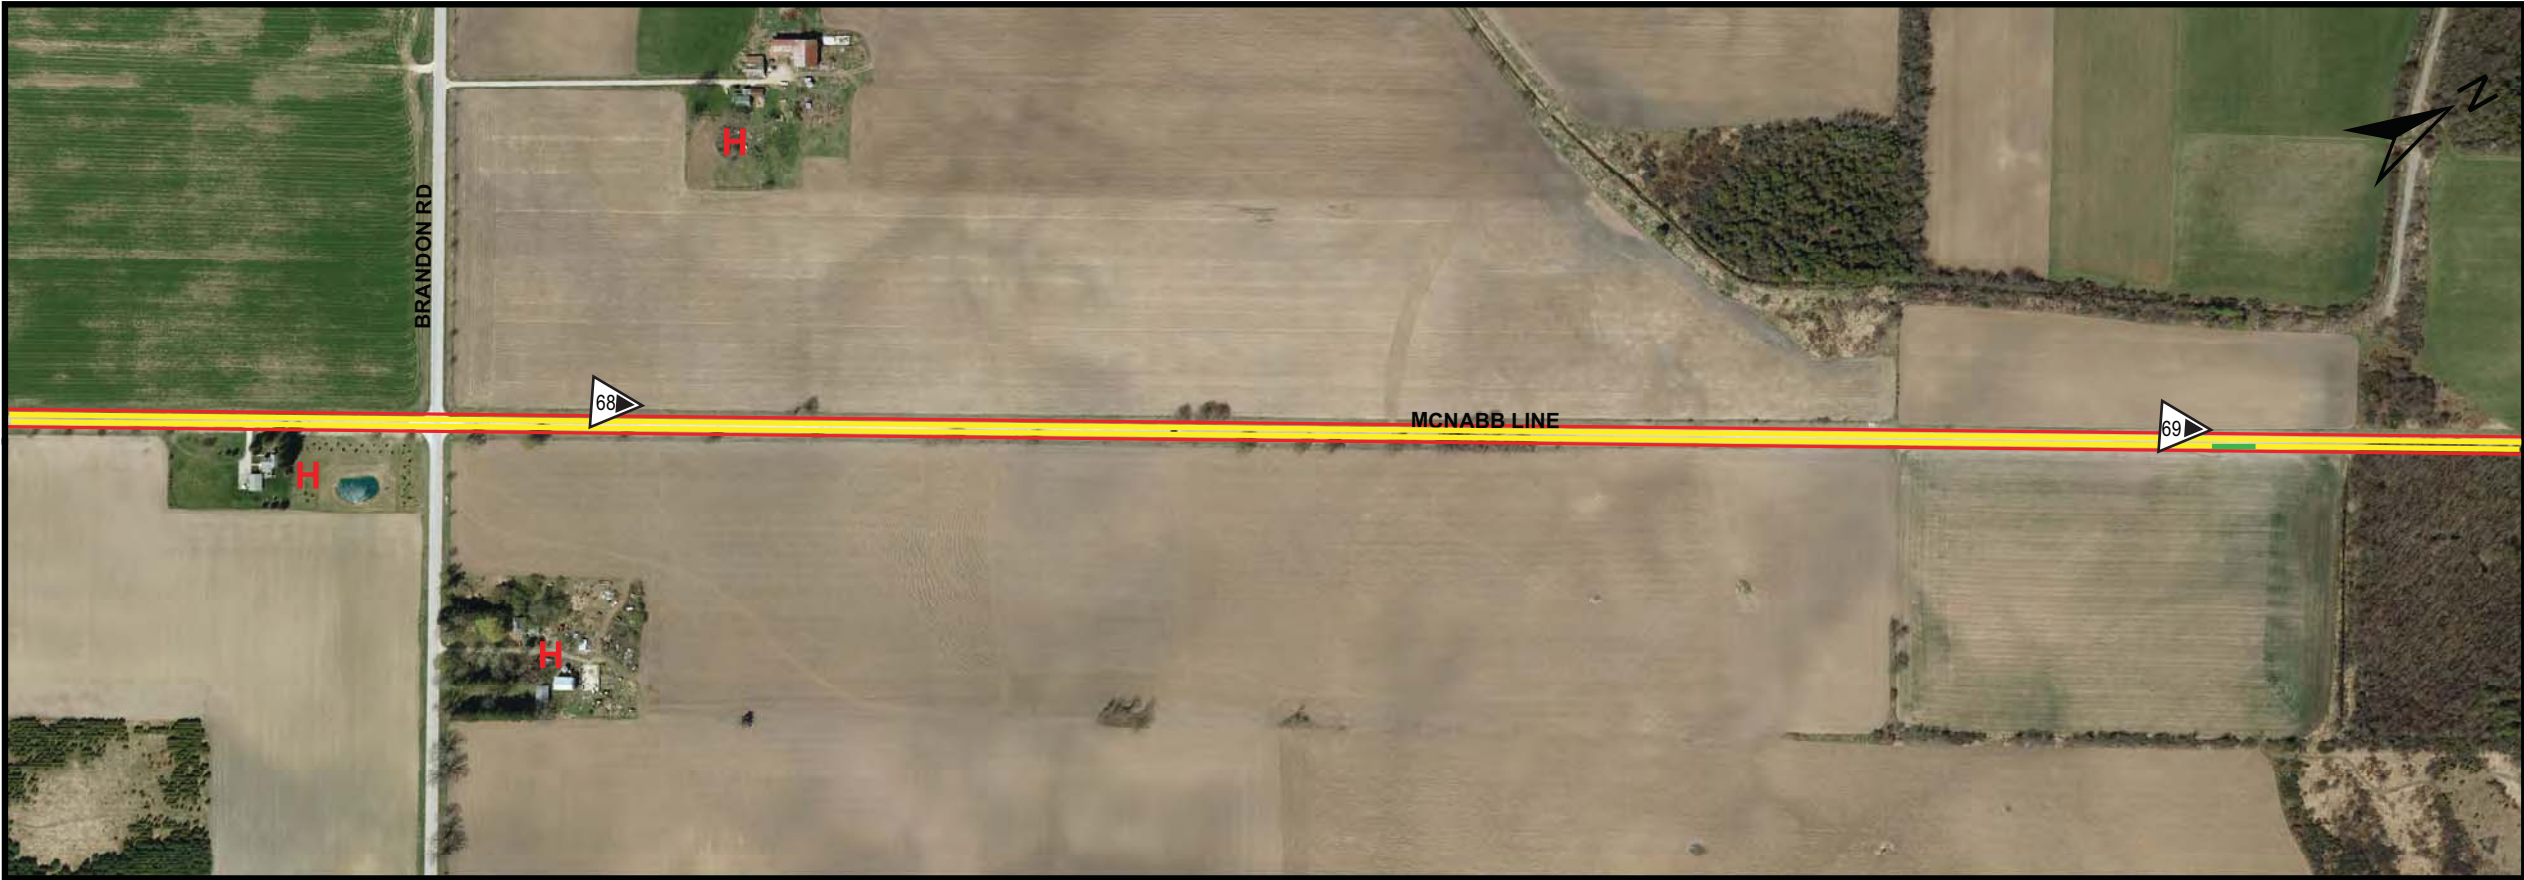
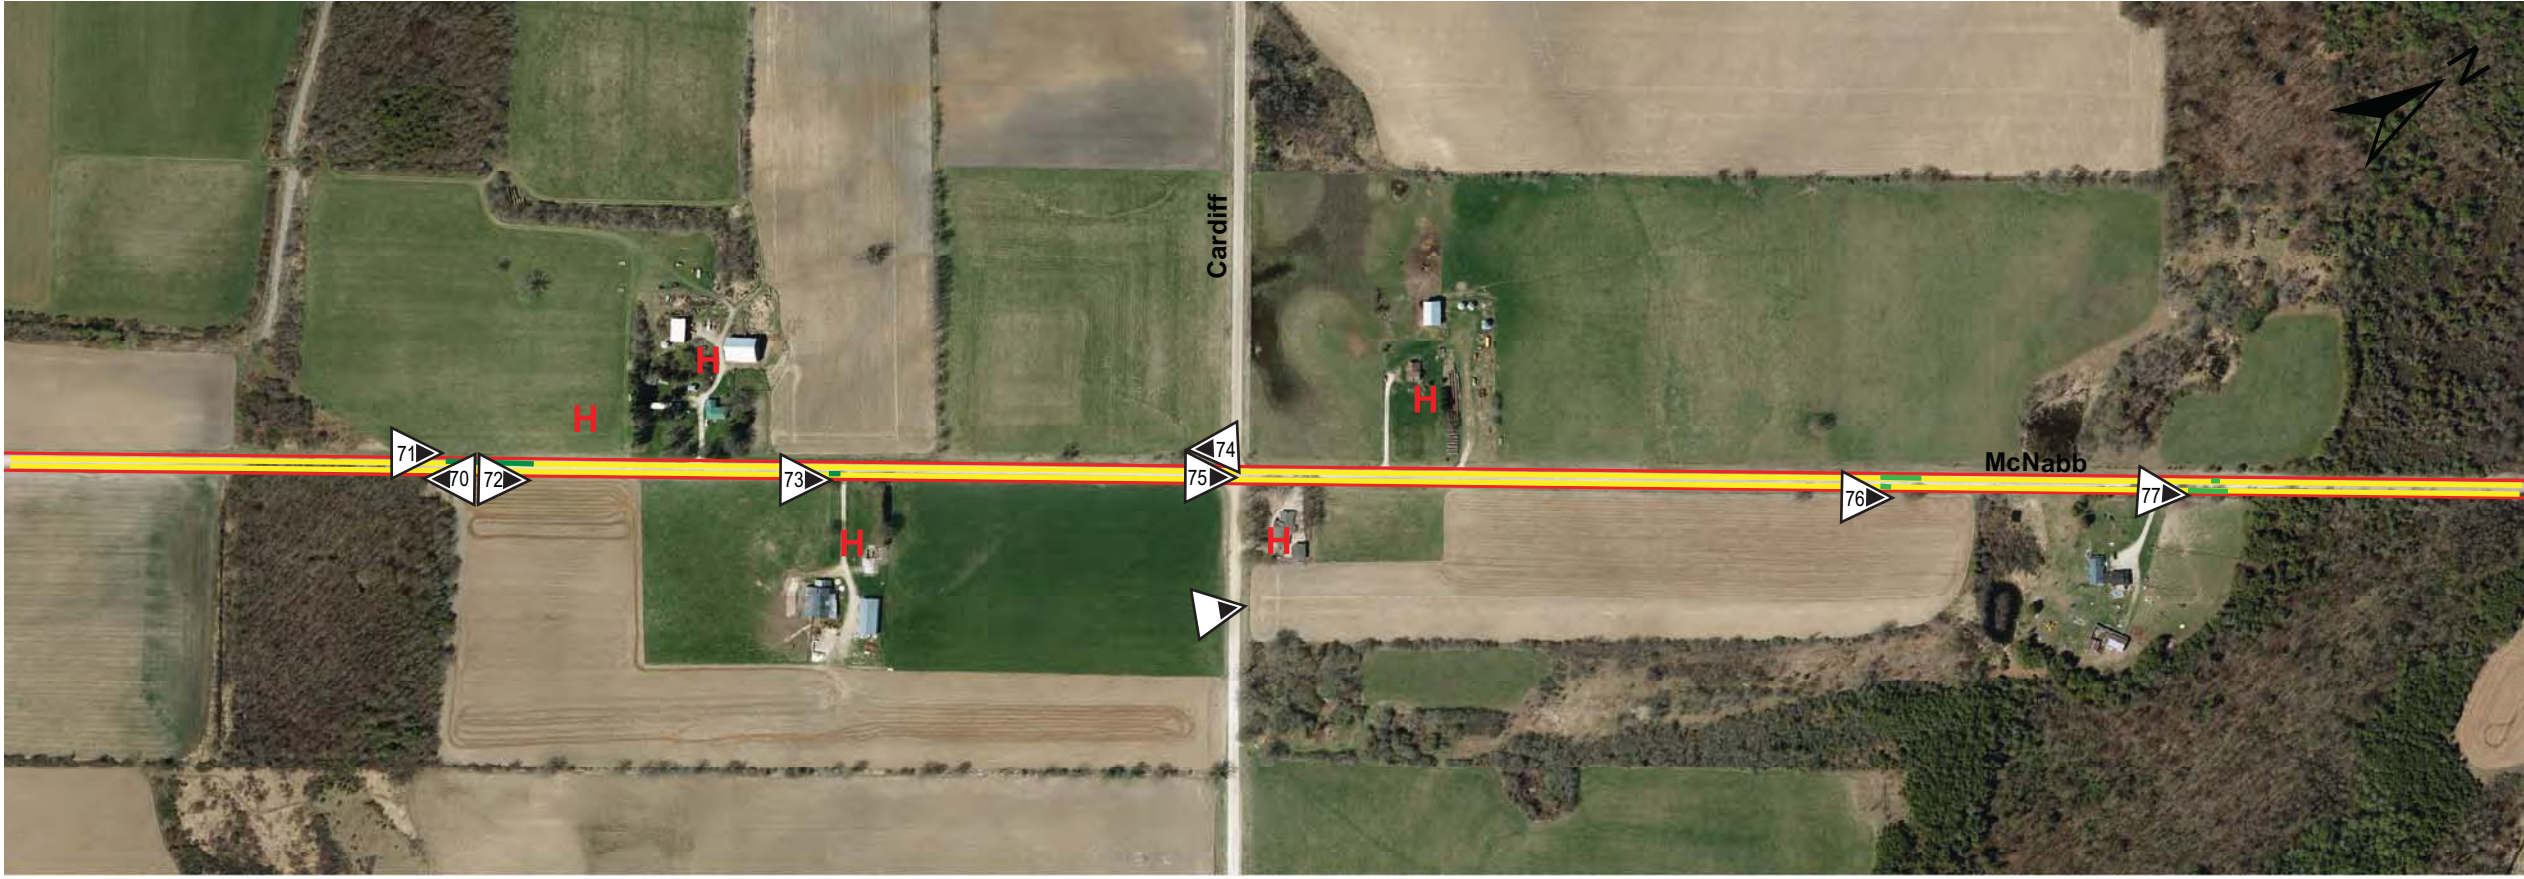
Figure 22: St Columban 1 Line Routing Project – Results of Stage 1 – 2 Archaeological Assessment (Sheets 17 & 18)

- SC1 Layout - Rev 3
- Study Area Operations and Maintenance Building
  - Study Corridor
  - Assessed: Pedestrian Survey 5m
  - Assessed: Test Pit Survey 5m
  - Assessed: Test Pit Survey Judgmental (10m) - No Potential: Disturbed
  - No Potential: Low and Wet
  - No Potential: Disturbed
  - H Historic Structure (Belden 1879)
  - Water source
  - 2 Photo location and orientation

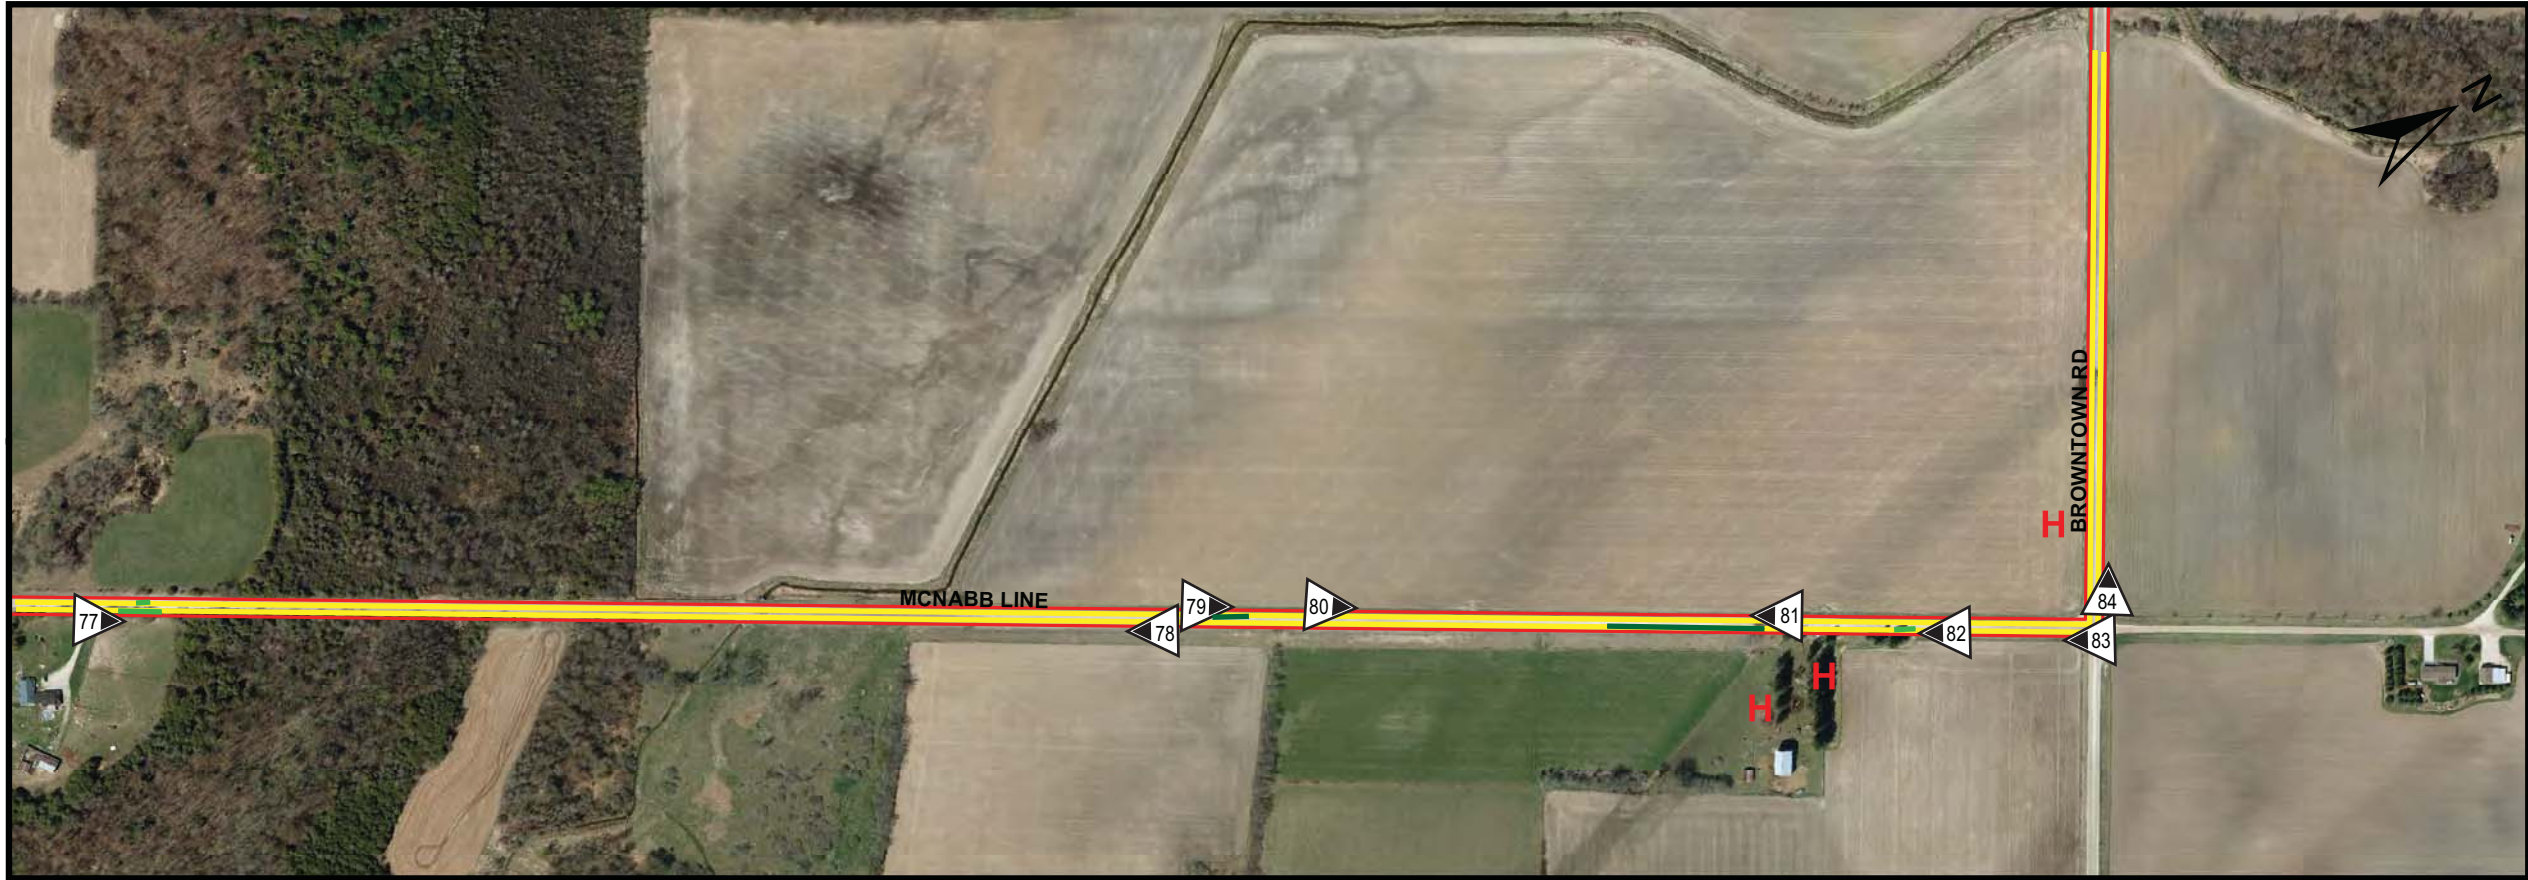
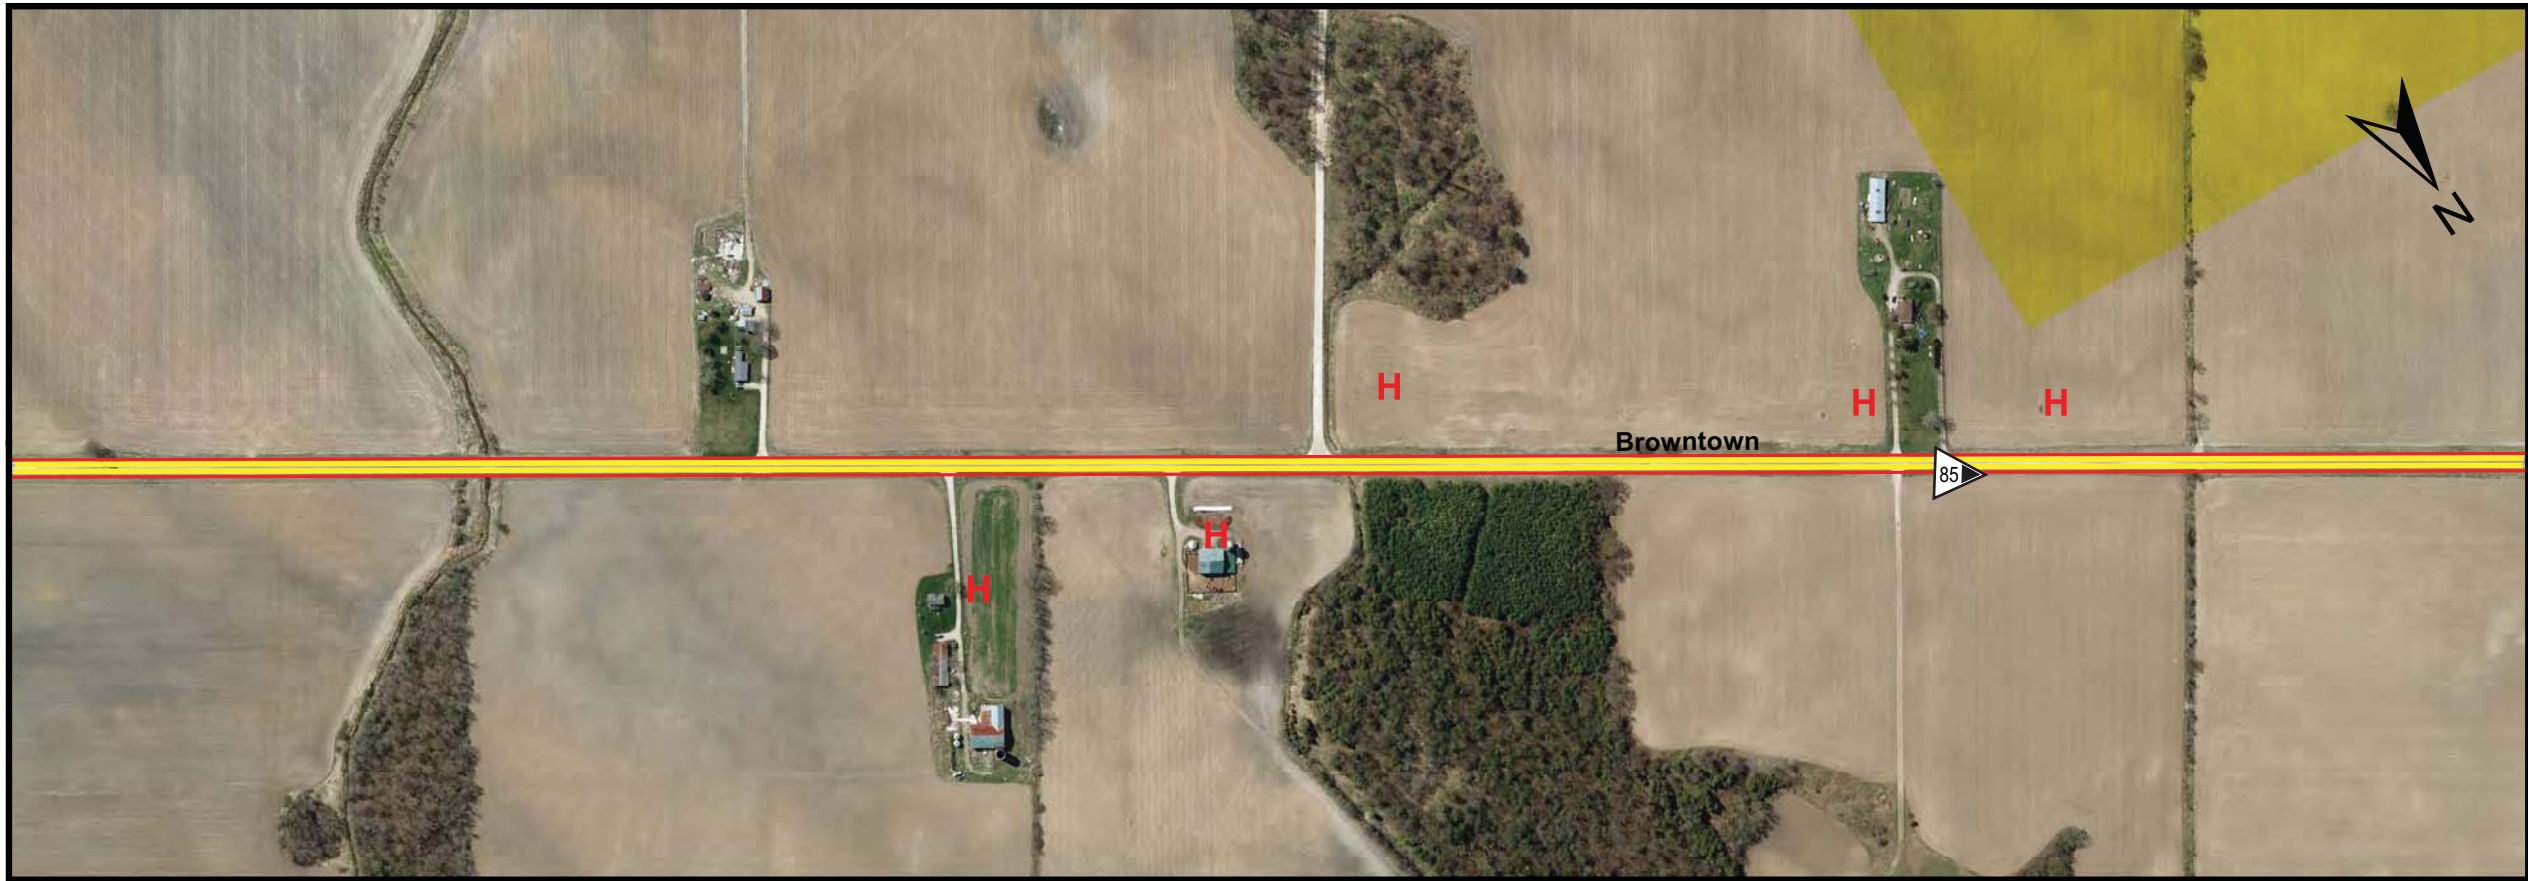
Figure 23: St Columban 1 Line Routing Project – Results of Stage 1 – 2 Archaeological Assessment (Sheets 19 & 20)

- SC1 Layout - Rev 3
- Study Area Operations and Maintenance Building
  - Study Corridor
  - Assessed: Pedestrian Survey 5m
  - Assessed: Test Pit Survey 5m
  - Assessed: Test Pit Survey Judgmental (10m) - No Potential: Disturbed
  - No Potential: Low and Wet
  - No Potential: Disturbed
  - H Historic Structure (Belden 1879)
  - Water source
  - 2 Photo location and orientation

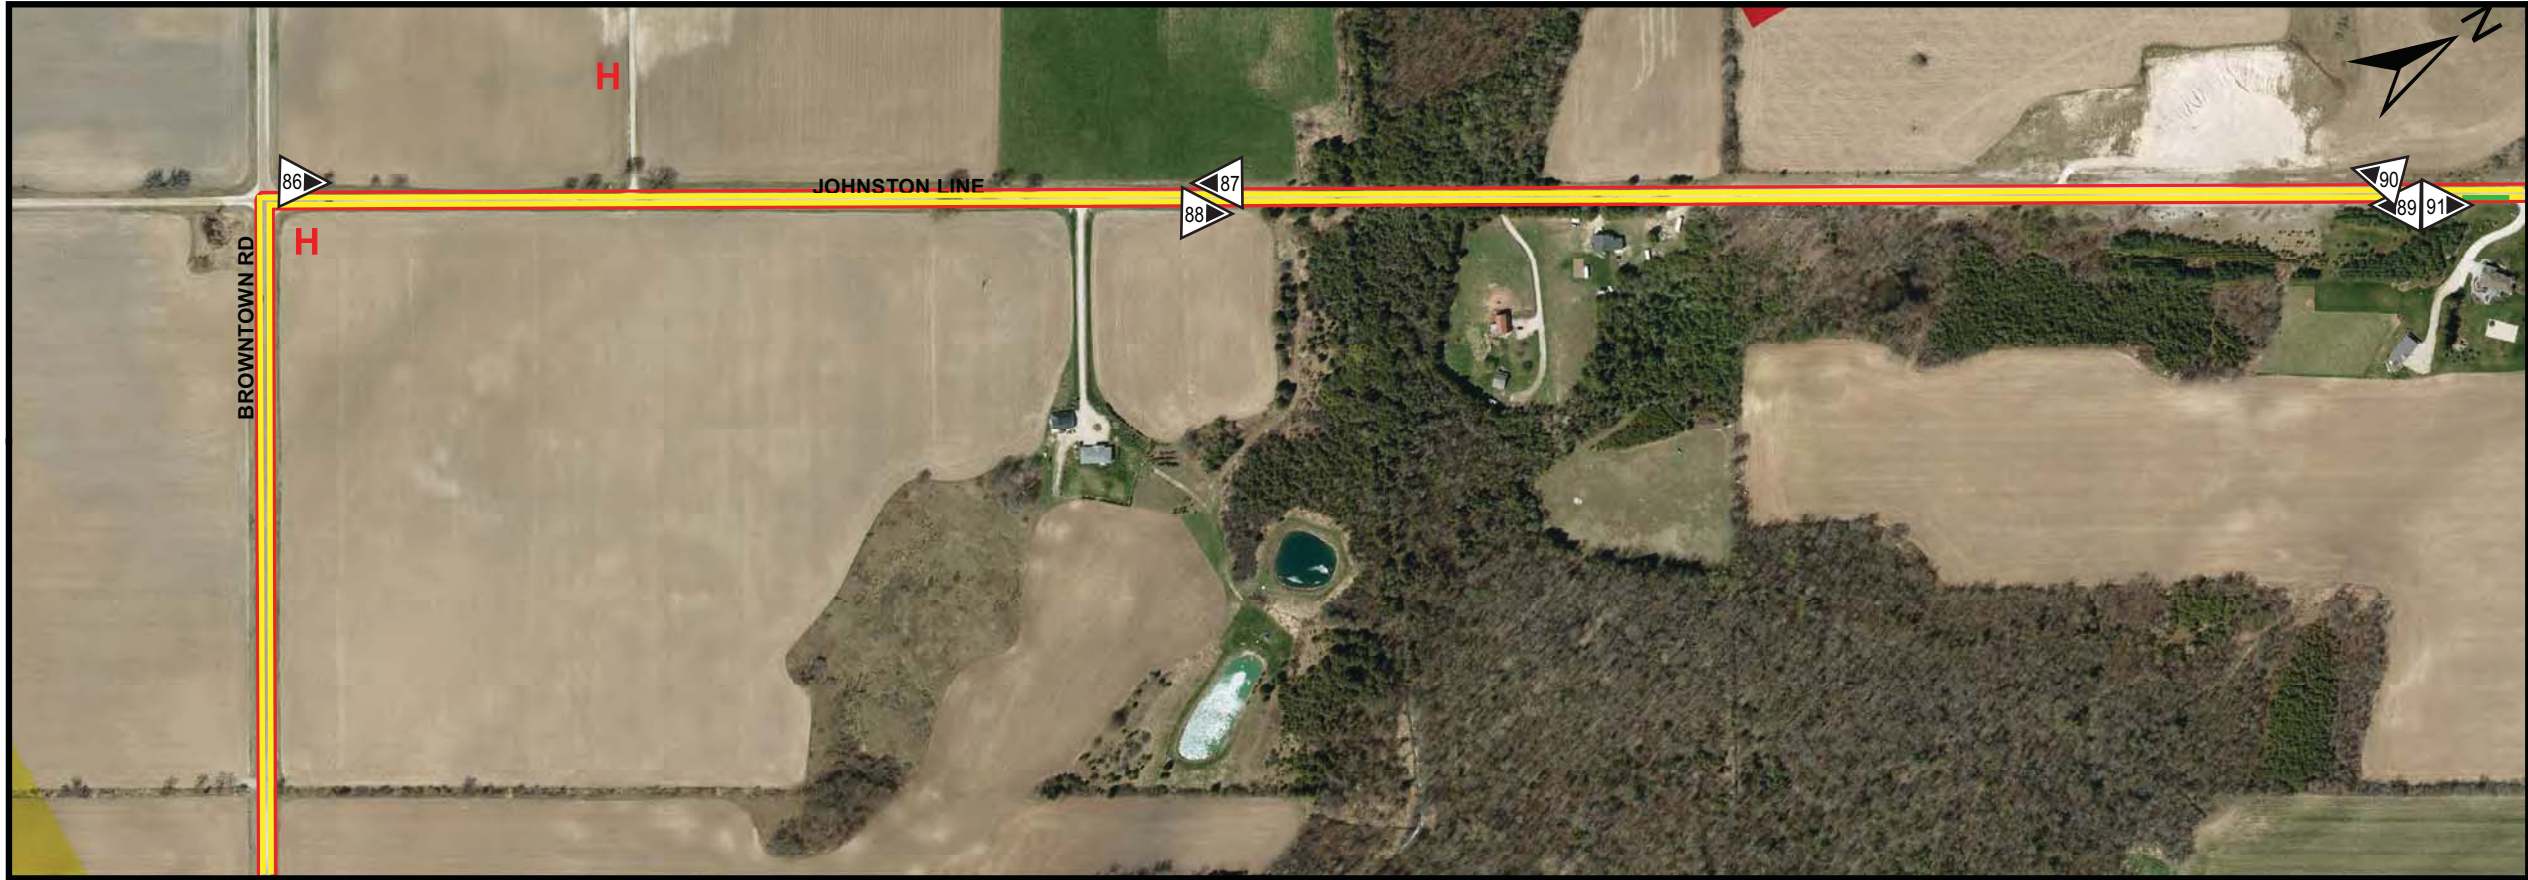
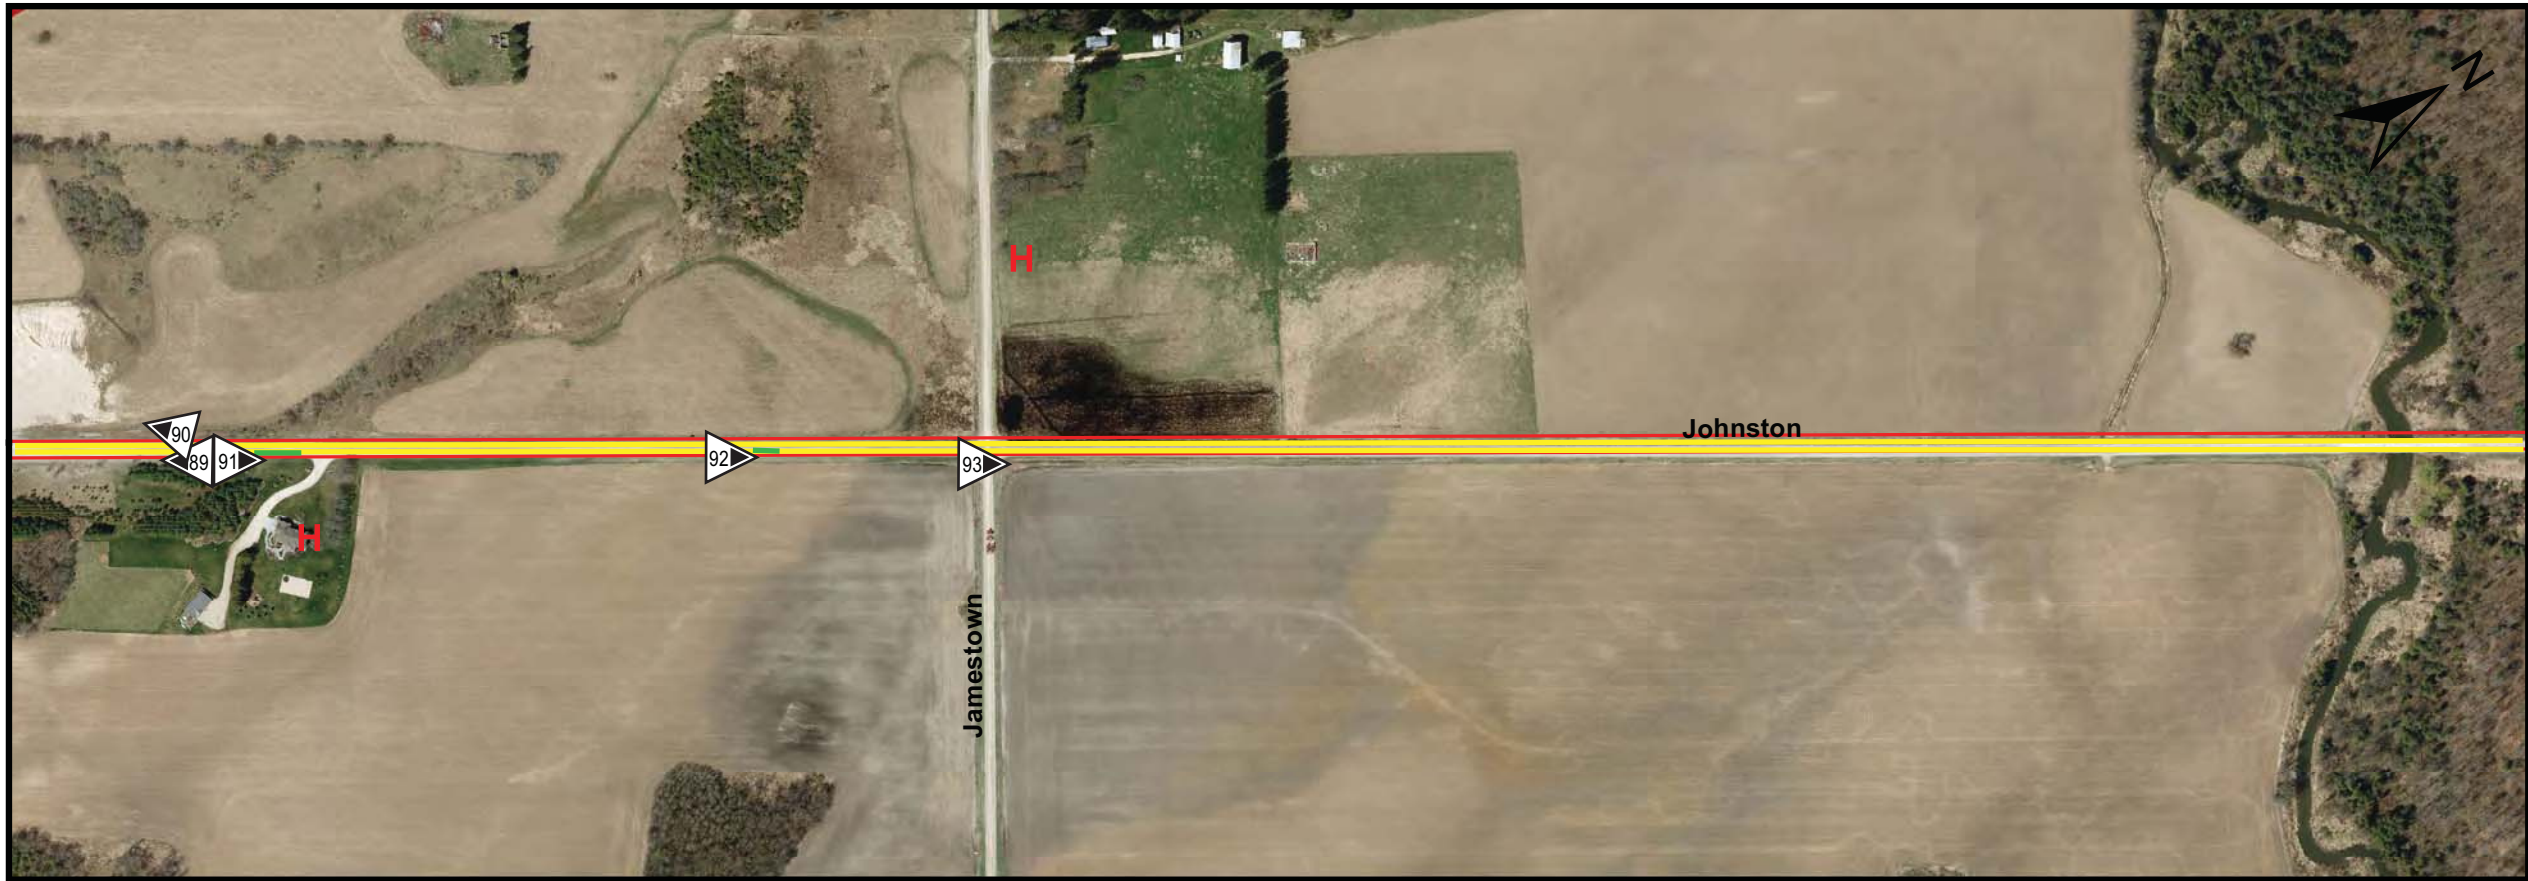
Figure 24: St Columban 1 Line Routing Project – Results of Stage 1 – 2 Archaeological Assessment (Sheets 21 & 22)

- SC1 Layout - Rev 3
- Study Area Operations and Maintenance Building
  - Study Corridor
  - Assessed: Pedestrian Survey 5m
  - Assessed: Test Pit Survey 5m
  - Assessed: Test Pit Survey Judgmental (10m) - No Potential: Disturbed
  - No Potential: Low and Wet
  - No Potential: Disturbed
  - H Historic Structure (Belden 1879)
  - Water source
  - 2 Photo location and orientation
