**Stage 1 Background Study and Property Inspection  
Stage 2 Property Assessment**

**St. Columban 1 Electrical Interconnection Line  
and Electrical Interconnection Facilities  
Municipality of East Huron (Geographic Townships of McKillop and Grey),  
Municipality of Morris-Turnberry (Geographic Township of Turnberry), and  
Township of Howick, Huron County, Ontario**

**FIT-F1PW818**

December 22, 2011  
(Revised January 17, 2012)

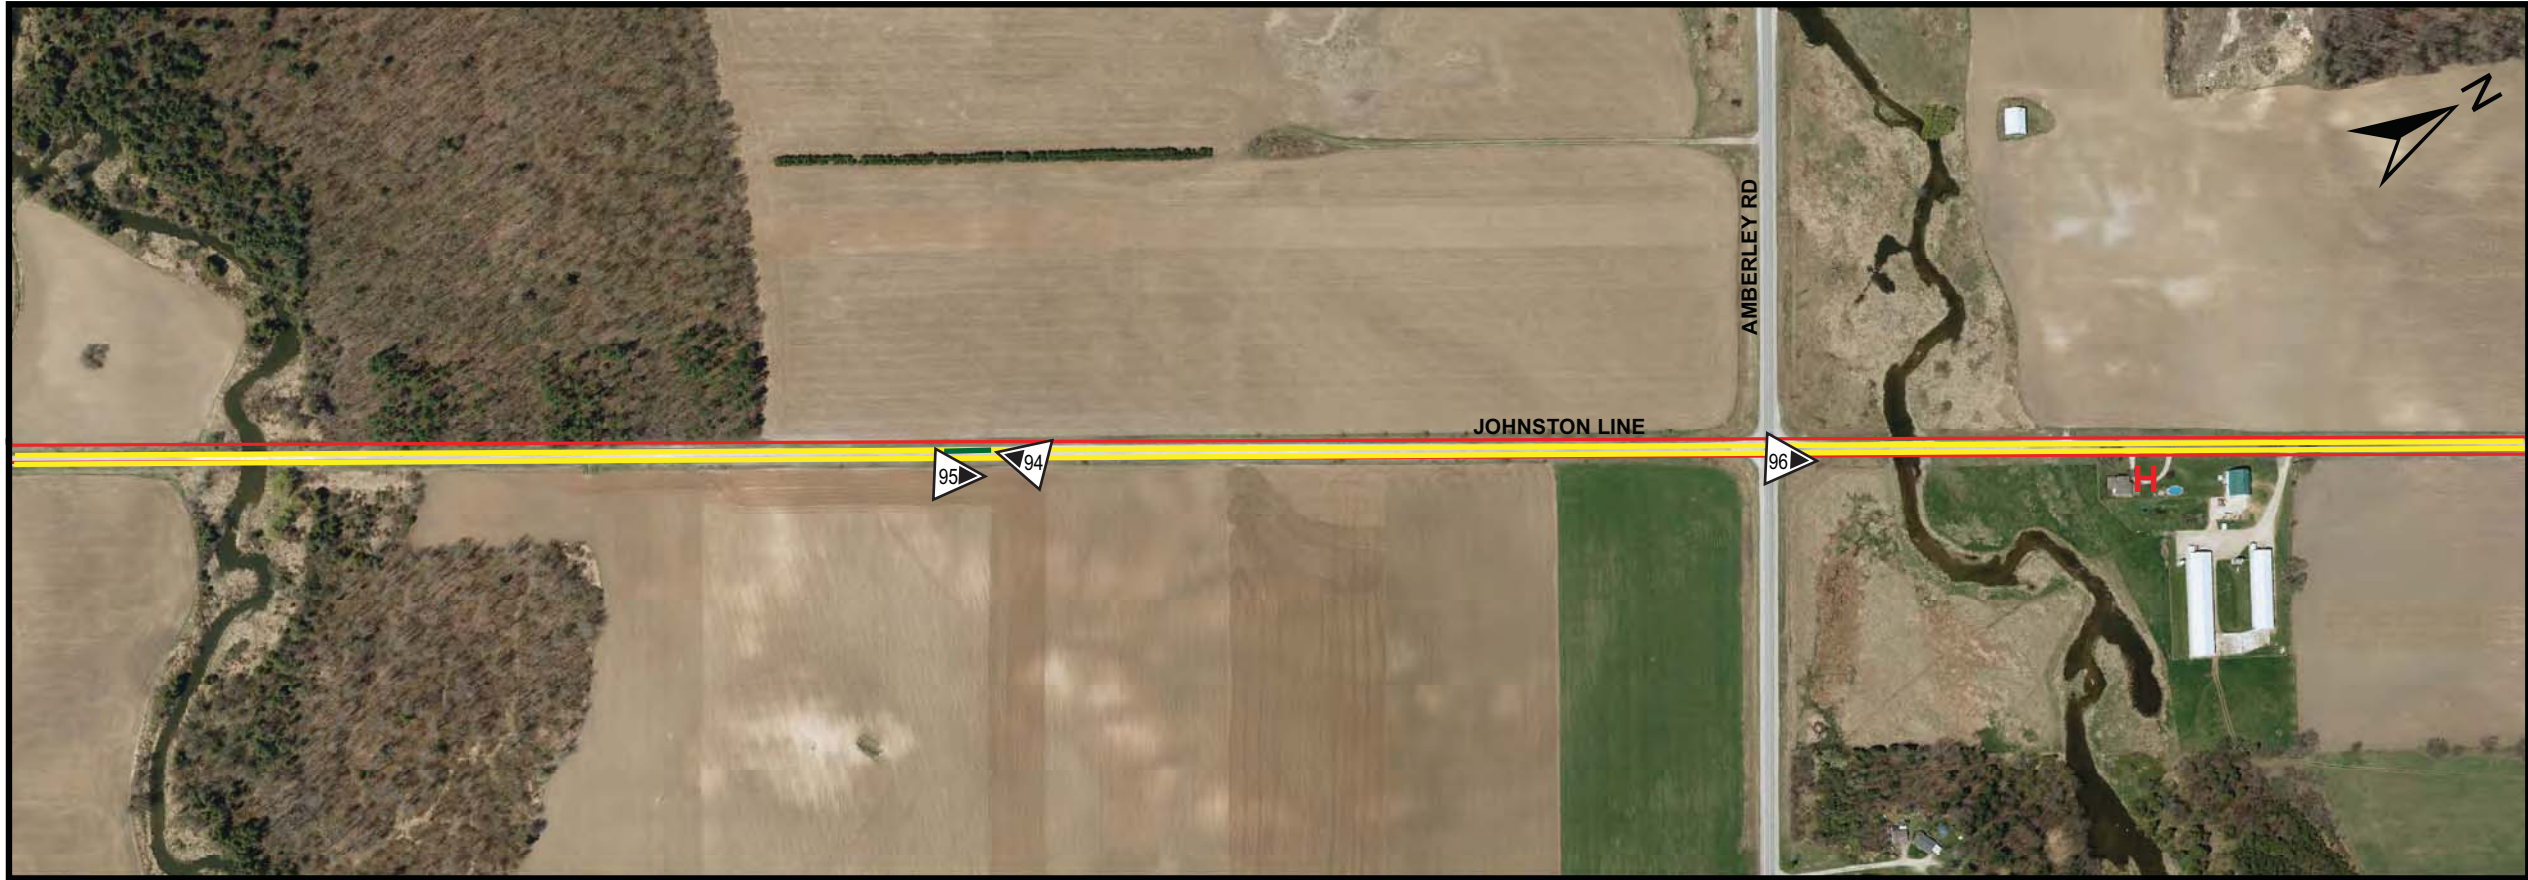
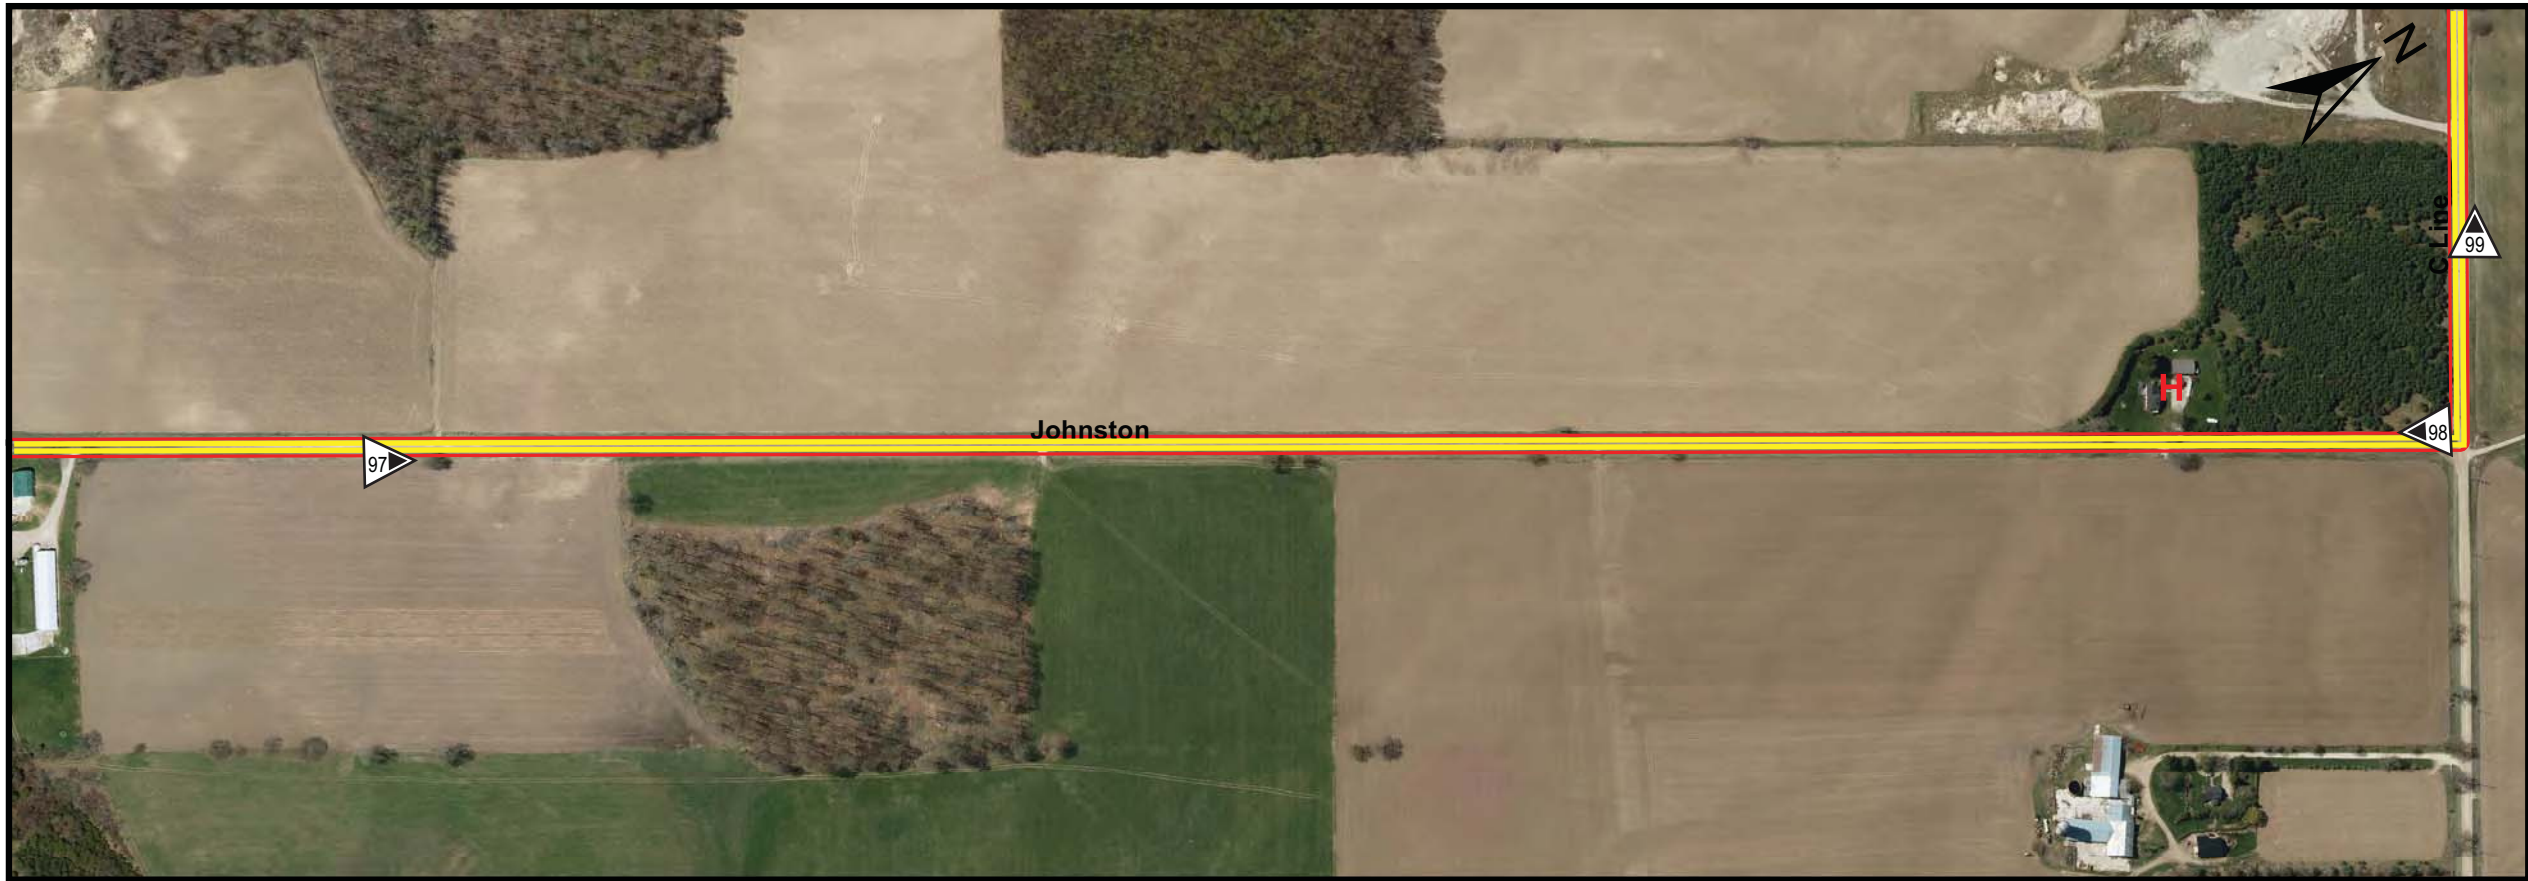
Figure 25: St Columban 1 Line Routing Project – Results of Stage 1 – 2 Archaeological Assessment (Sheets 23 & 24)

- SC1 Layout - Rev 3
- Study Area Operations and Maintenance Building
  - Study Corridor
  - Assessed: Pedestrian Survey 5m
  - Assessed: Test Pit Survey 5m
  - Assessed: Test Pit Survey Judgmental (10m) - No Potential: Disturbed
  - No Potential: Low and Wet
  - No Potential: Disturbed
  - H Historic Structure (Belden 1879)
  - Water source
  - 2 Photo location and orientation

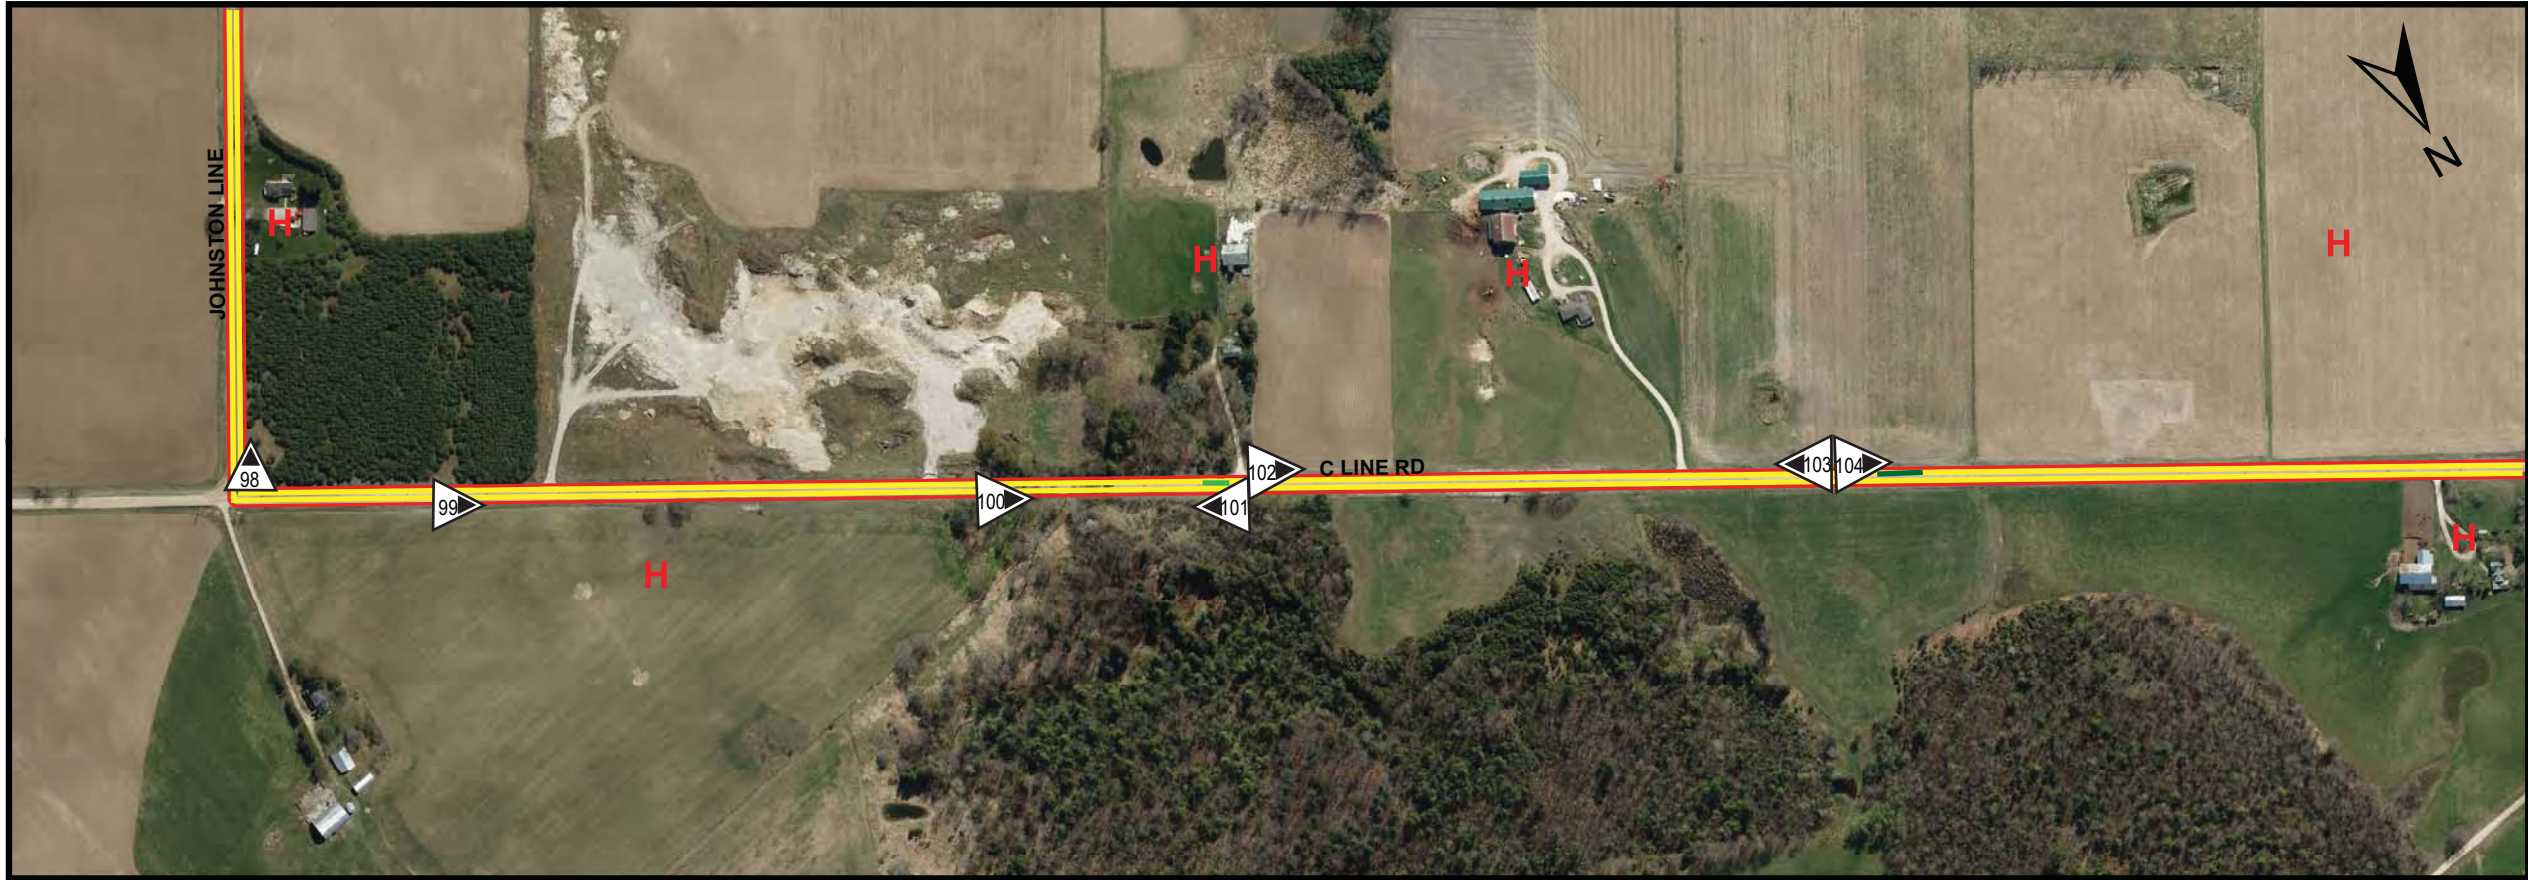
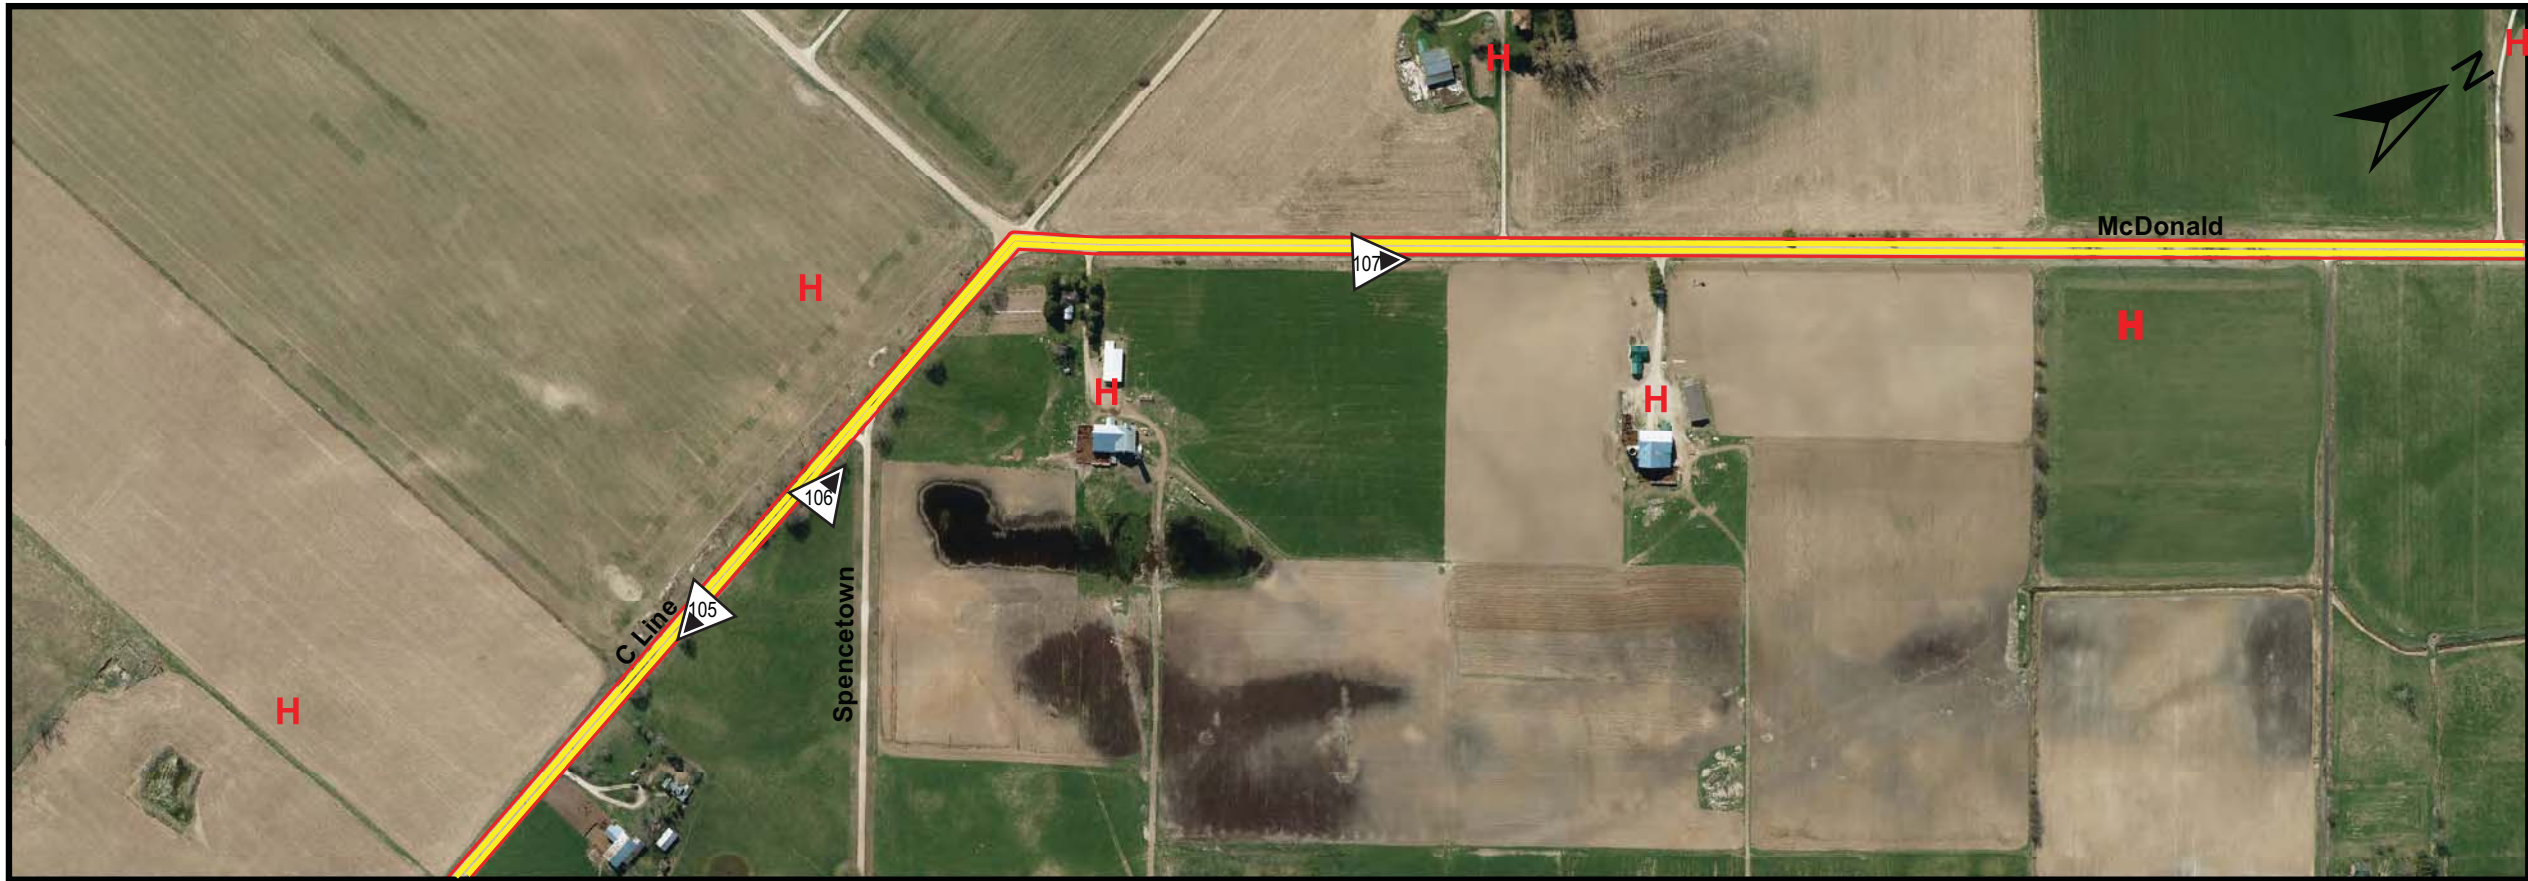
Figure 26: St Columban 1 Line Routing Project – Results of Stage 1 – 2 Archaeological Assessment (Sheets 25 & 26)

- SC1 Layout - Rev 3
- Study Area Operations and Maintenance Building
  - Study Corridor
  - Assessed: Pedestrian Survey 5m
  - Assessed: Test Pit Survey 5m
  - Assessed: Test Pit Survey Judgmental (10m) - No Potential: Disturbed
  - No Potential: Low and Wet
  - No Potential: Disturbed
  - H Historic Structure (Belden 1879)
  - Water source
  - 2 Photo location and orientation

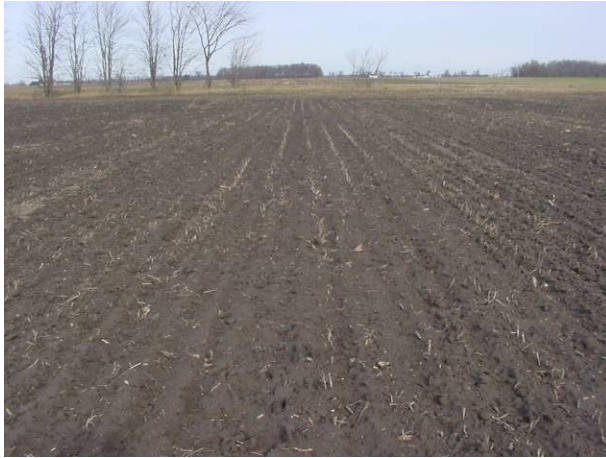
**Plate 1:** view northeast, SC1 Operations and Maintenance Building site study area. Bridge Road and drainage ditch at tree line.

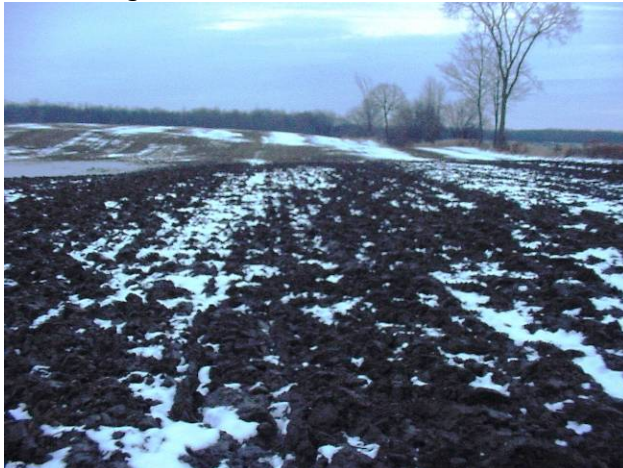
**Plate 3a:** view to east, ploughed and weathered study area was pedestrian surveyed at 5 m intervals. Water is a small pocket of the undulating terrain.

The three study areas for the electrical interconnection facilities are within agricultural fields (Figures 11-13). The survey areas were ploughed deep enough to provided total topsoil exposure, but not deeper than previous ploughing. Pedestrian survey was only conducted on lands with acceptable survey conditions, e.g., ground surface visibility of 90%, and after thorough weathering. All three survey areas were assessed by pedestrian survey at 5 m intervals, with the exception of one corner of the north site (SC1 PCC-POC to Hydro One) where there was no potential for sites due to the wet ground conditions (Plate 3).

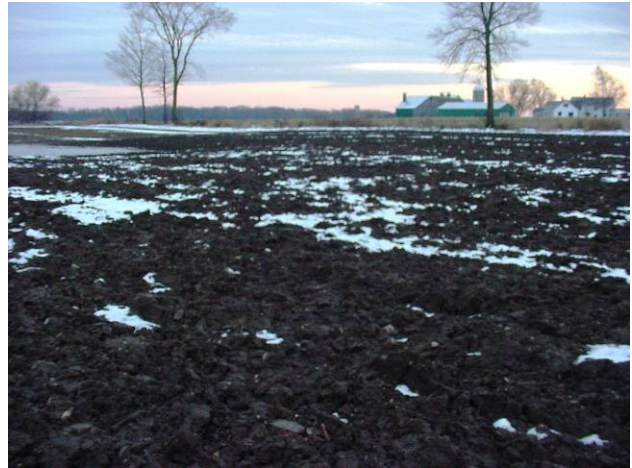
**Plate 4b:** view to southeast, ploughed and weathered study area was pedestrian surveyed at 5 m intervals. Note wet pocket in northwest portion of study area.

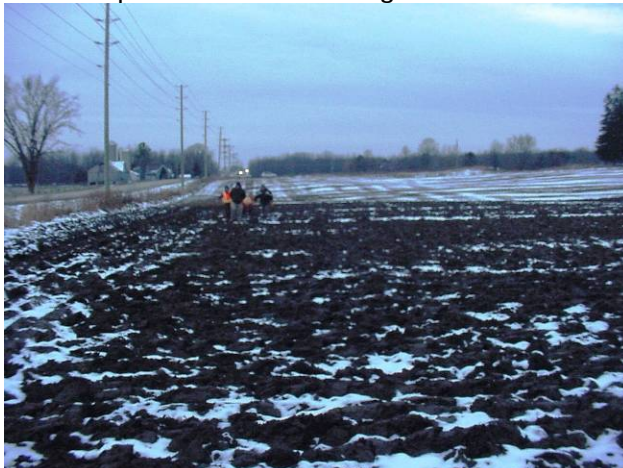
**Plate 5:** view to north, ploughed and weathered study area was pedestrian surveyed at 5 m intervals.

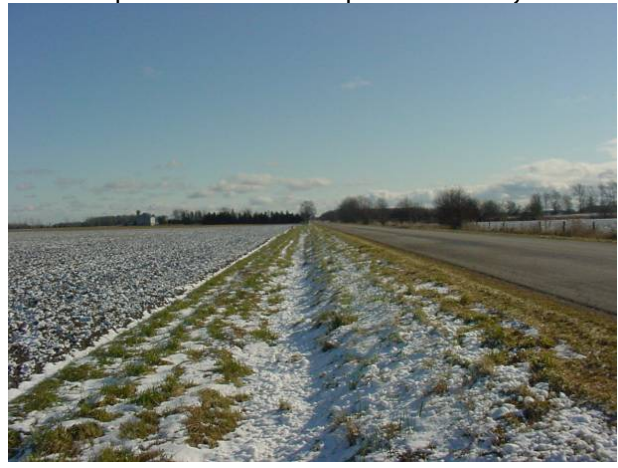
**Plate 6:** View southeast, fill slope and ditch disturbance along Bridge Road. Level terrain.

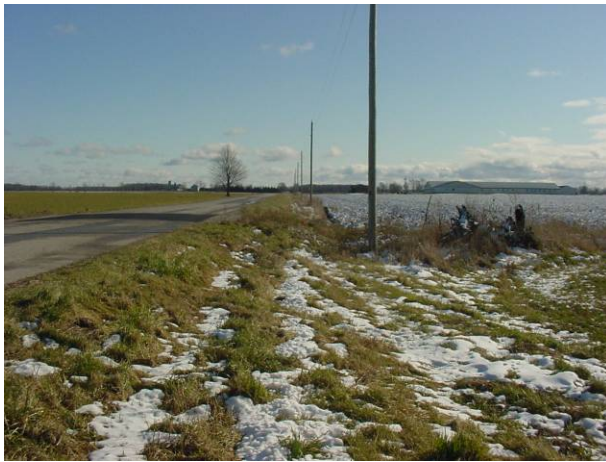
**Plate 7:** view southeast, fill slope disturbance along paved and improved Bridge Road.

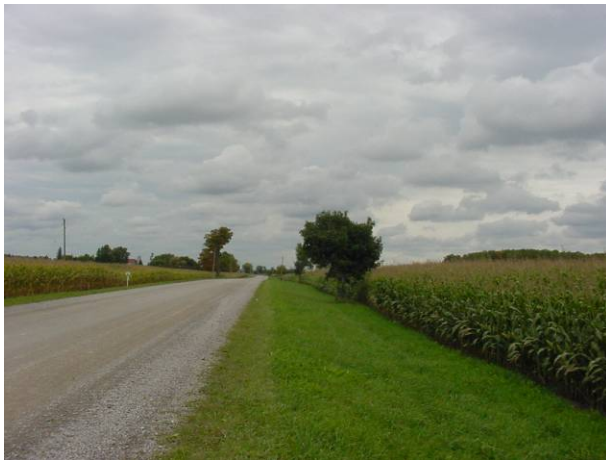
**Plate 9:** view to northeast, fill slope disturbance along Manley Line. Level terrain near farmstead.

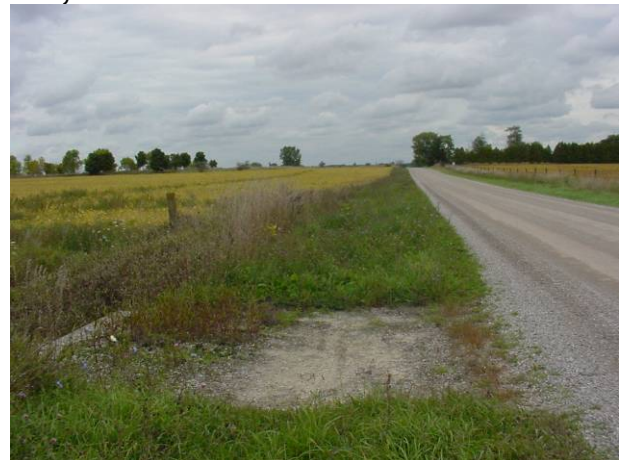
**Plate 10:** view to northeast, fill slope disturbance & channelized stream crossing along Manley Line.

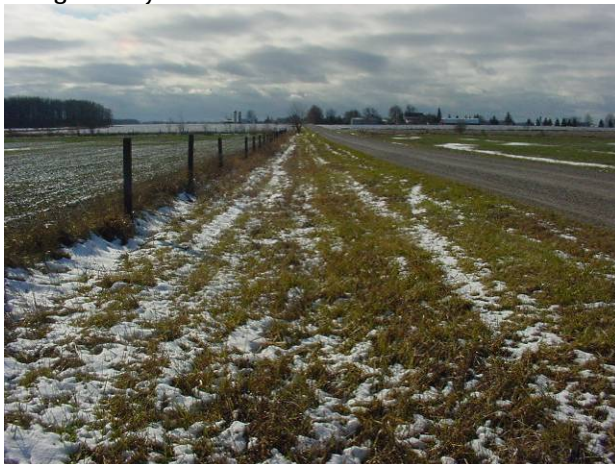
**Plate 11:** view to southwest, fill slope disturbance along Manley Line.

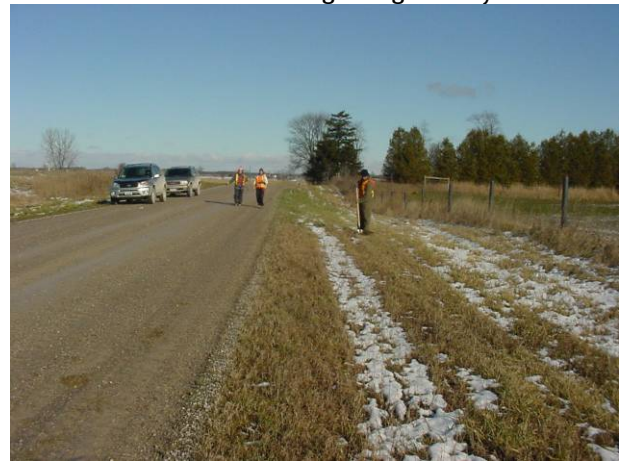
**Plate 12:** view to northeast, judgmental test pitting determined ROW disturbance on small rises just south of esker.

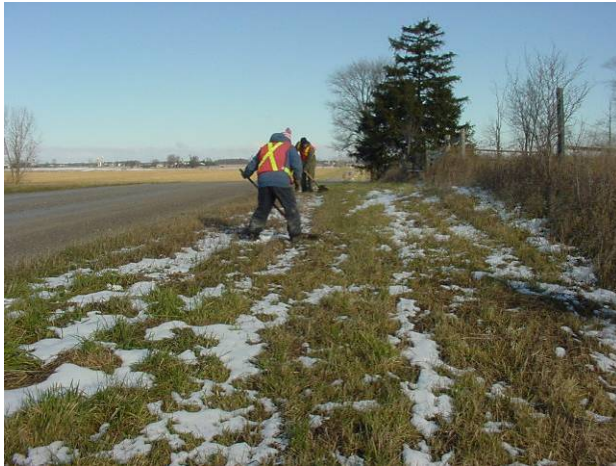
**Plate 13:** view to northeast, judgmental test pitting identified disturbance where Manley Line intersects an esker.

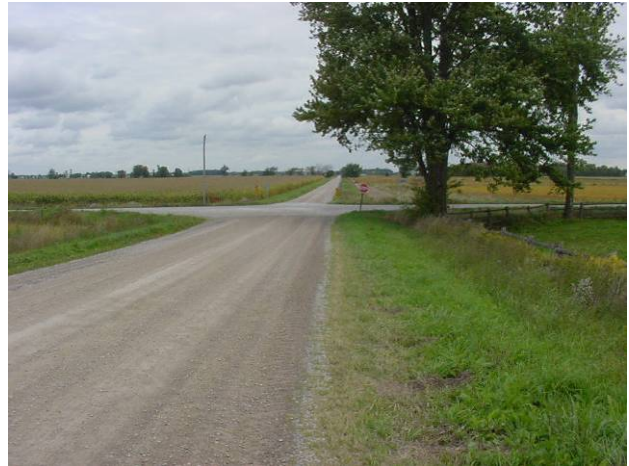
**Plate 14:** view to northeast along Manley. Study corridor comprises fill slope in the vicinity of intersection with Summerhill Line.

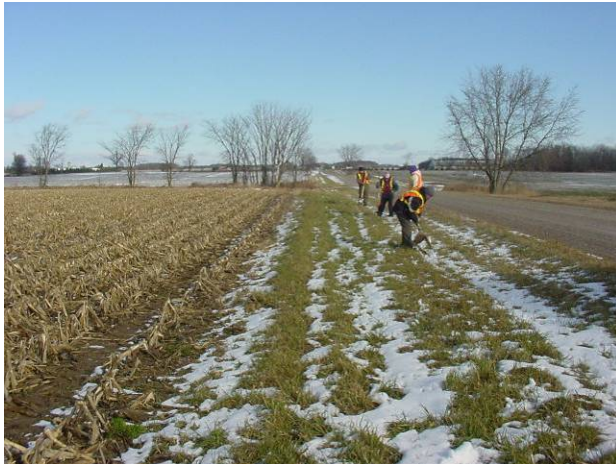
**Plate 15:** view to northeast where judgmental test pitting identified disturbance on wide, gentle fill slope on rise south of small creek.

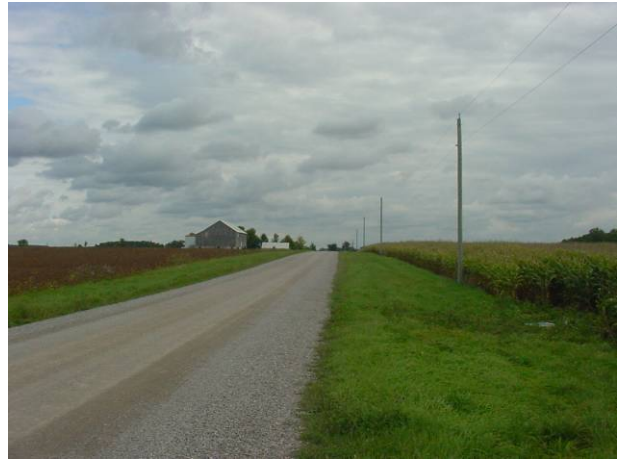
**Plate 16:** view to northeast, wide, gentle fill slope disturbance on southeast side of Manley Line.

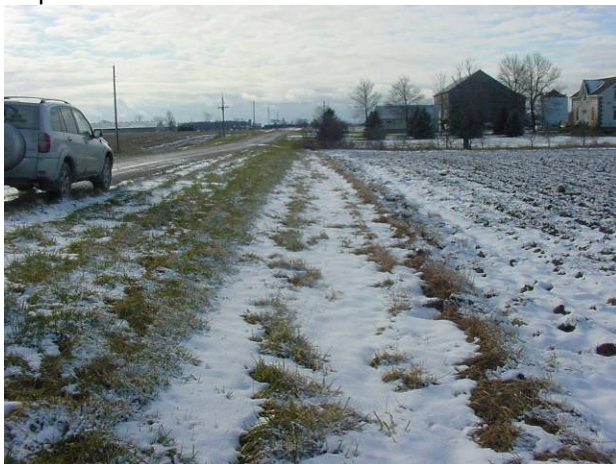
**Plate 17:** view to southwest toward historic farmstead, wide, fill slope disturbance along Manley.

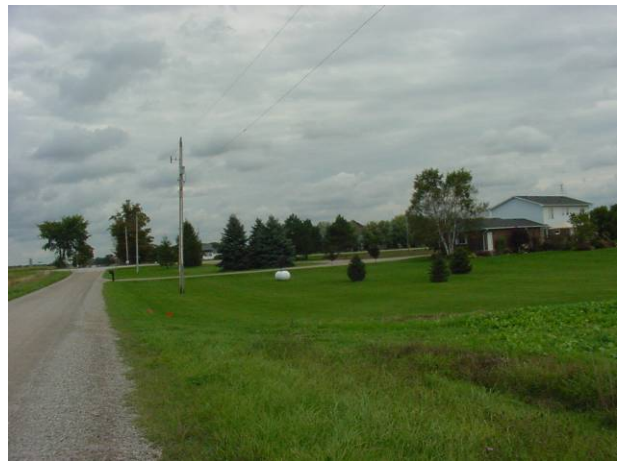
**Plate 18:** view to northeast, fill slope disturbance on northwest side of Manley Line, in vicinity of historic farmstead location.

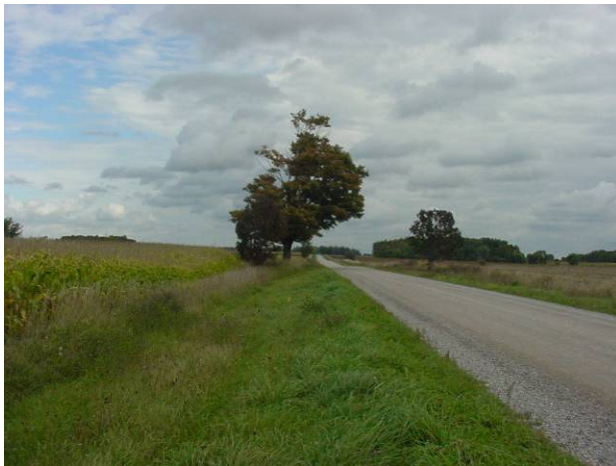
**Plate 19:** view to northeast, shallow ditch and fill slope disturbance along Manley Line in vicinity of creek.

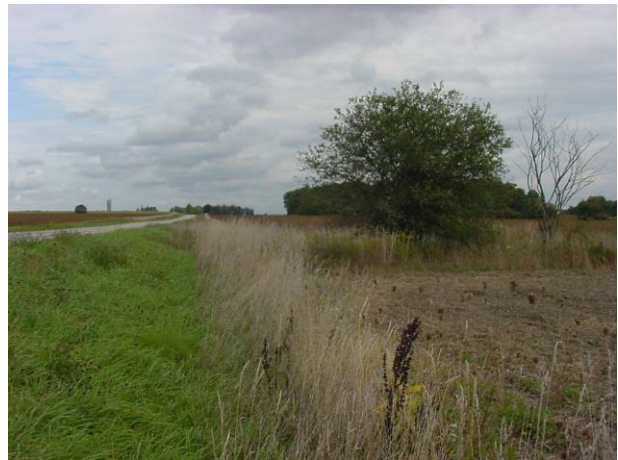
**Plate 20:** view to northeast, fill slope disturbance along Manley Line at channelized stream crossing.

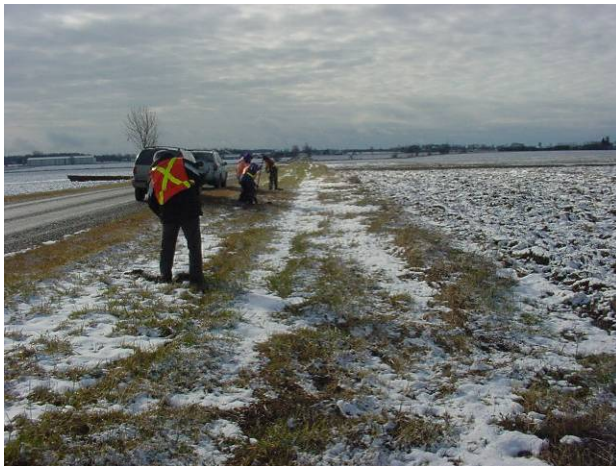
**Plate 21:** view to southwest, judgmental testpitting identified disturbance on low rise in vicinity of former schoolhouse on northwest side of Manley Line. Wet at south end of tested area.

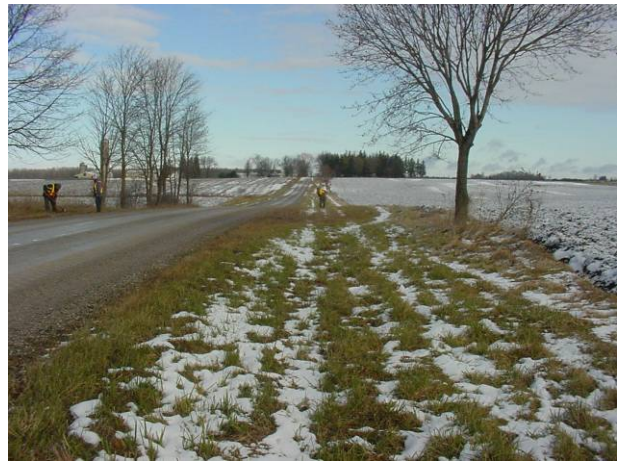
**Plate 22:** view to northeast, judgmental test pitting of low rise identified disturbance both sides of Manley Line.

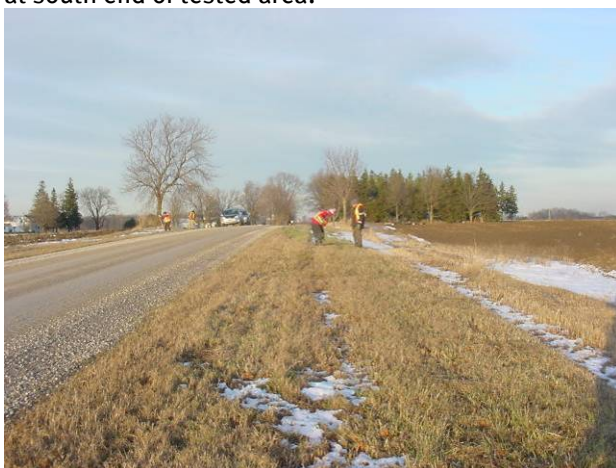
**Plate 23:** view to northeast, judgmental test pits on low rise near homestead identified disturbance.

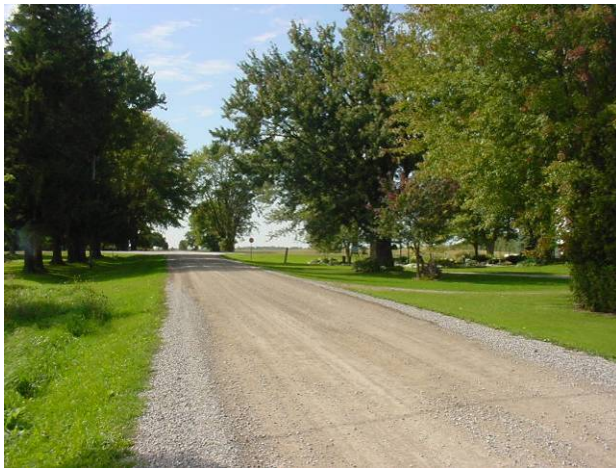
**Plate 24:** view to northeast, fill slope disturbance along Manley Line.

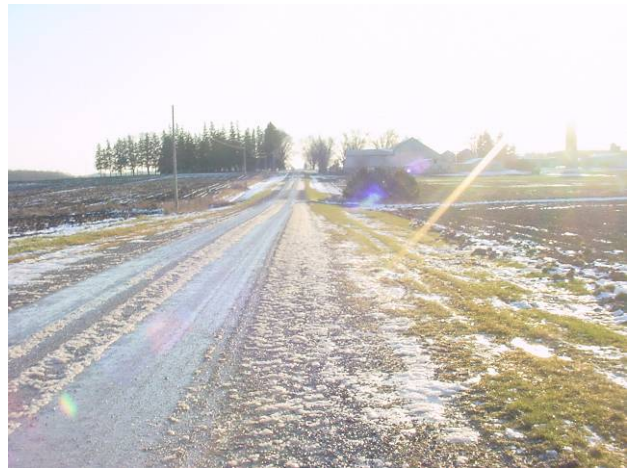
**Plate 25:** view to southwest, fill slope disturbance along Manley near historic farmstead.

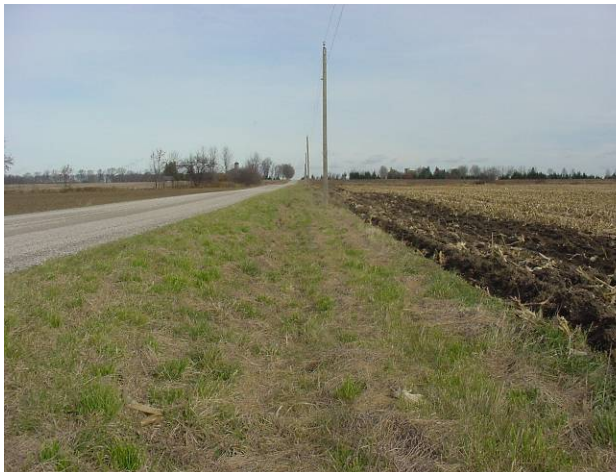
**Plate 26:** view to southwest along Manley Line. Judgmental test pitting on this rise near small creek confirmed disturbance.

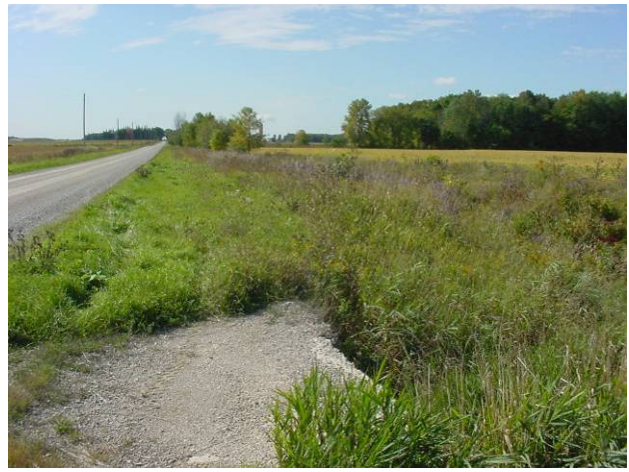
**Plate 27:** view to northeast, fill slope disturbance along Manley Line.

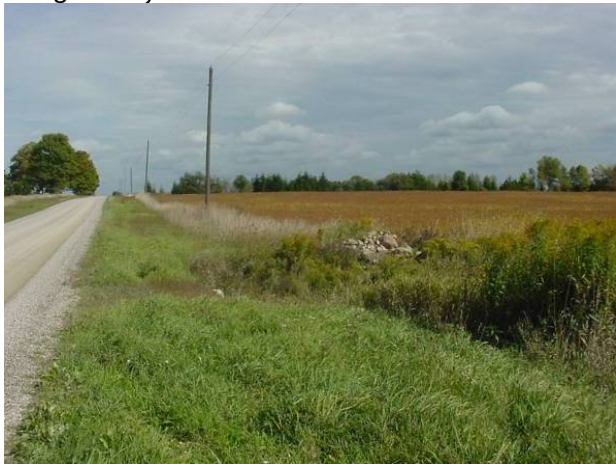
**Plate 28:** view to southwest, fill slope disturbance and deep drainage ditch along Manley Line.

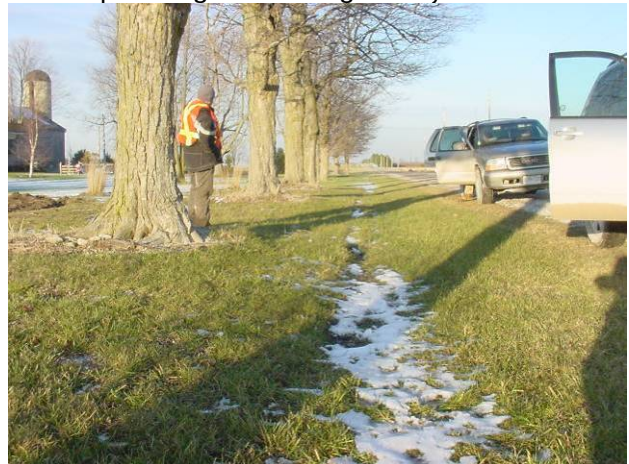
**Plate 29:** view to northeast along Manley line, disturbance at drainage ditch crossing and on fill slope.

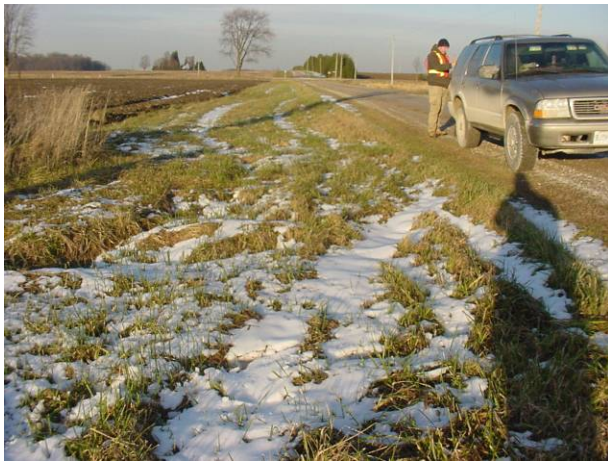
**Plate 30:** view to northeast, study corridor disturbed by ditching and fill slope on northwest side Manley in vicinity of historic farmstead.

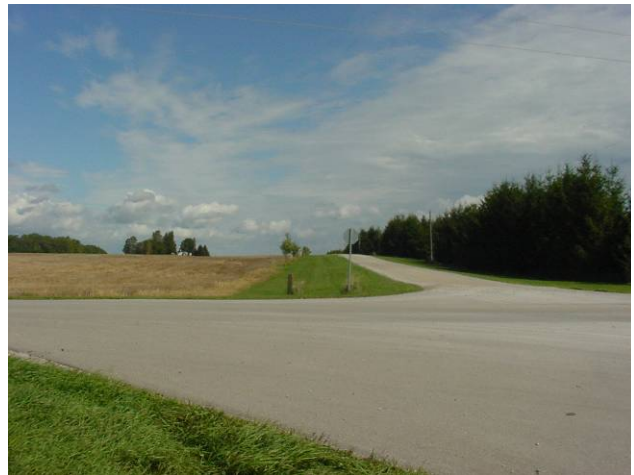
**Plate 31:** view to northeast, wide, gentle fill slope along Manley Line.

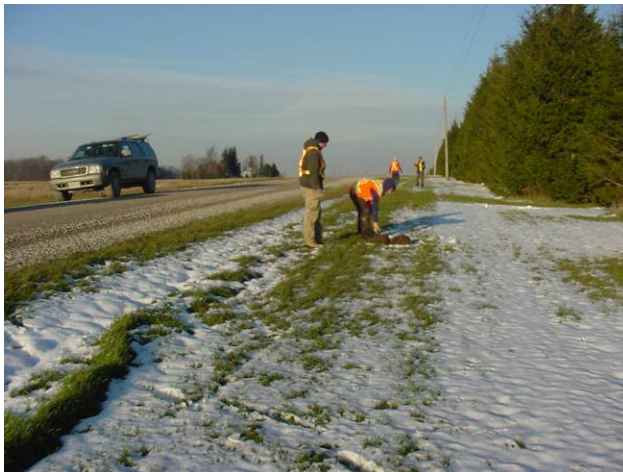
**Plate 32:** view to northeast, visible fill slope disturbance, adjacent to northwest side of Manley Line.

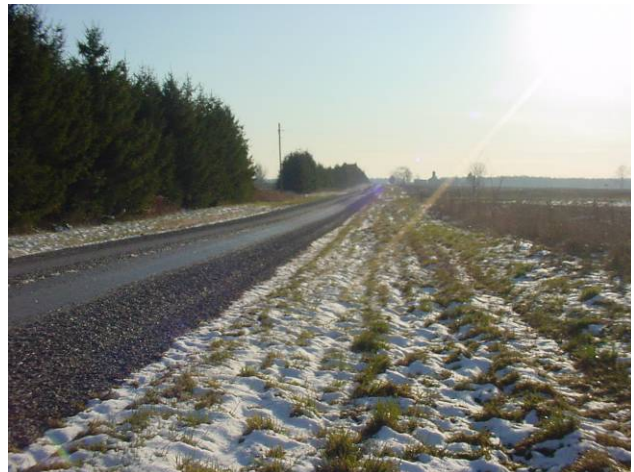
**Plate 33:** view to northeast, judgmental test pitting along southeast side of Manley determined that the vicinity was disturbed.

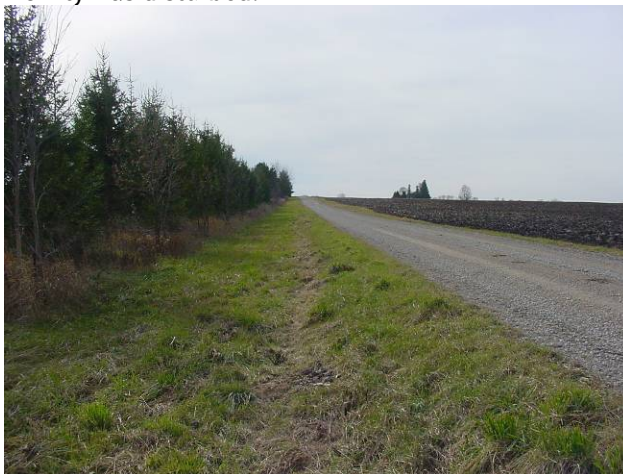
**Plate 34:** view to southwest, disturbed fill slope adjacent to Manley Line, on the top of the broad rise.

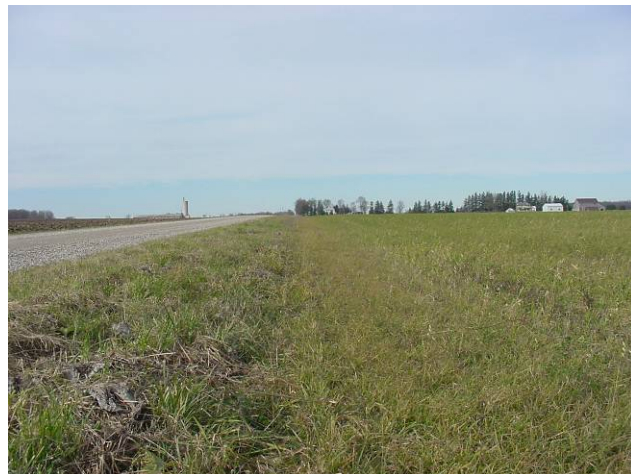
**Plate 35:** view to southwest, disturbed fill slope along Manley Line.

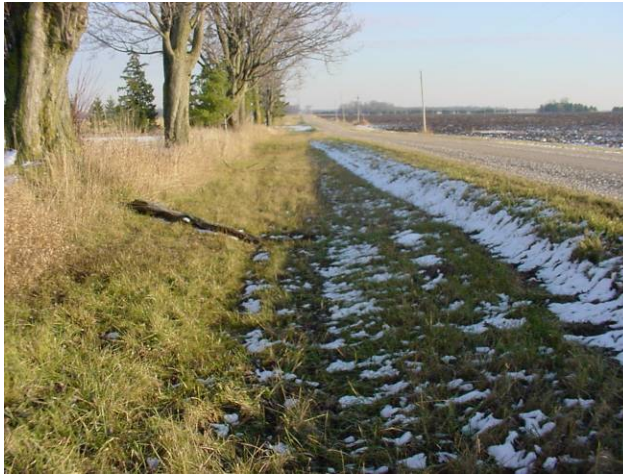
**Plate 36:** view to northwest, disturbed fill slope along Canada Company Road.

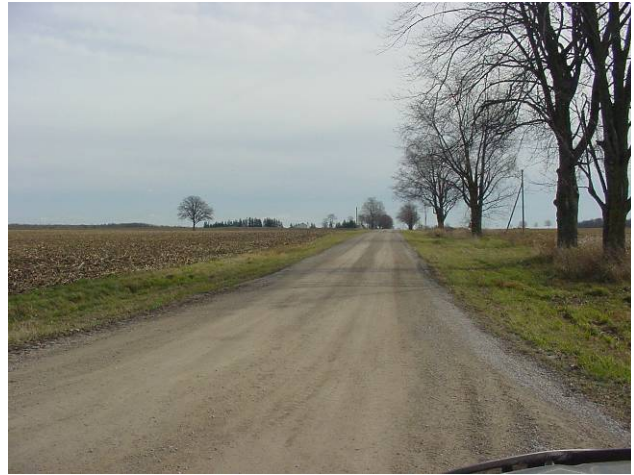
**Plate 37:** view to southeast, ditch and fill slope disturbance along Canada Company Road.

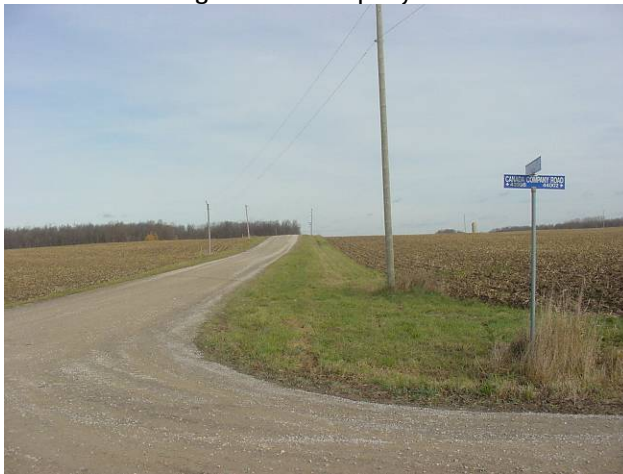
**Plate 38:** view to southeast, fill slope and shallow ditch disturbance along Canada Company Road.

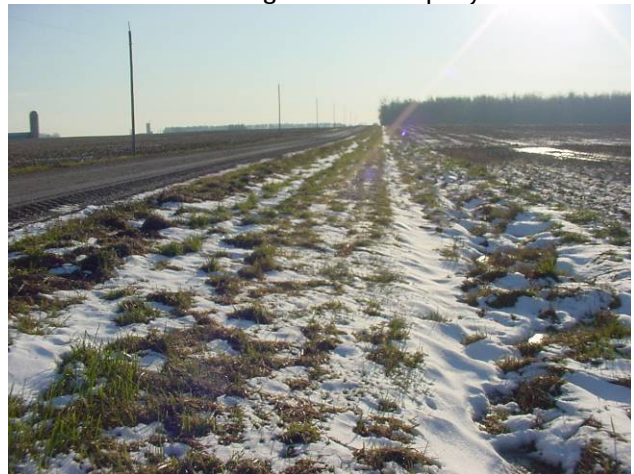
**Plate 39:** View northeast, fill slope disturbance along Beechwood Line.

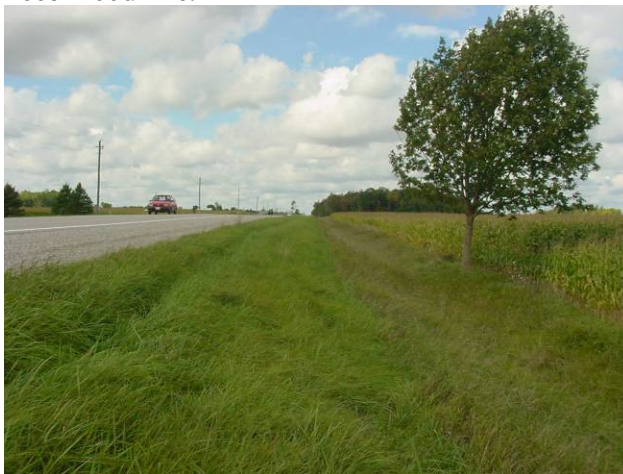
**Plate 40:** view southwest, fill slope and ditch disturbance along Beechwood Line.

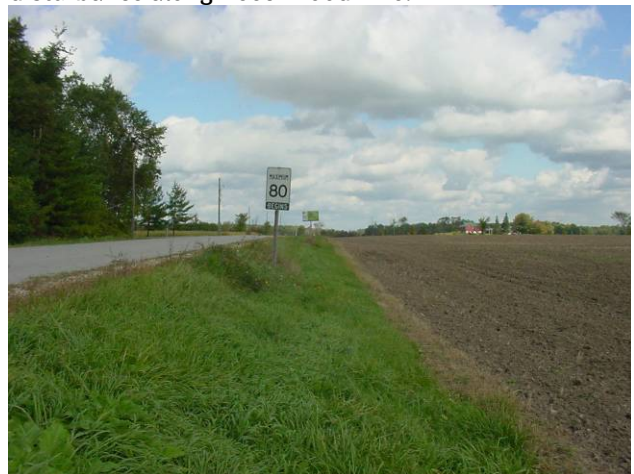
**Plate 41:** View northwest, fill slope and ditch disturbance along paved and improved Blyth Road.

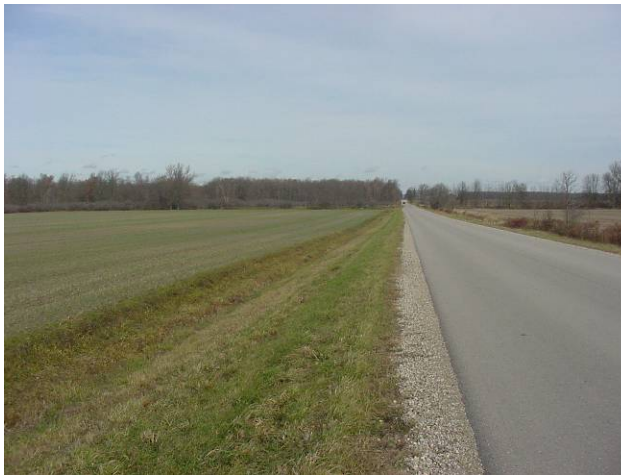
**Plate 42:** View northeast, steep fill slope along paved and improved McNabb Line.

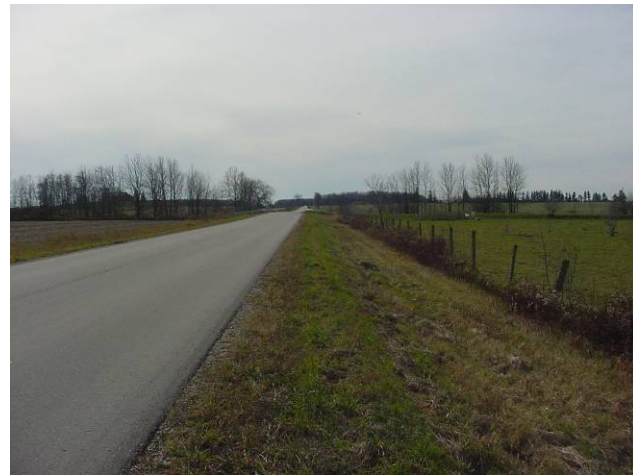
**Plate 43:** view to northeast, fill slope and ditch disturbance along paved and improved McNabb Line.

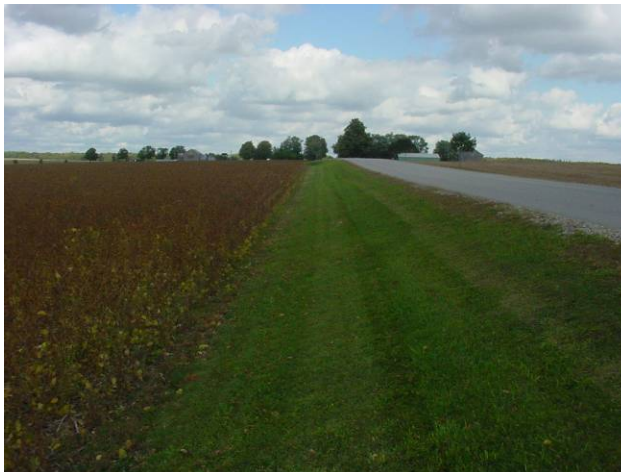
**Plate 44:** view to southwest, fill slope disturbance along paved and improved McNabb. Low and level terrain near channelized stream.
