**Stage 1 Background Study and Property Inspection  
Stage 2 Property Assessment**

**St. Columban 1 Electrical Interconnection Line  
and Electrical Interconnection Facilities  
Municipality of East Huron (Geographic Townships of McKillop and Grey),  
Municipality of Morris-Turnberry (Geographic Township of Turnberry), and  
Township of Howick, Huron County, Ontario**

**FIT-F1PW818**

December 22, 2011  
(Revised January 17, 2012)

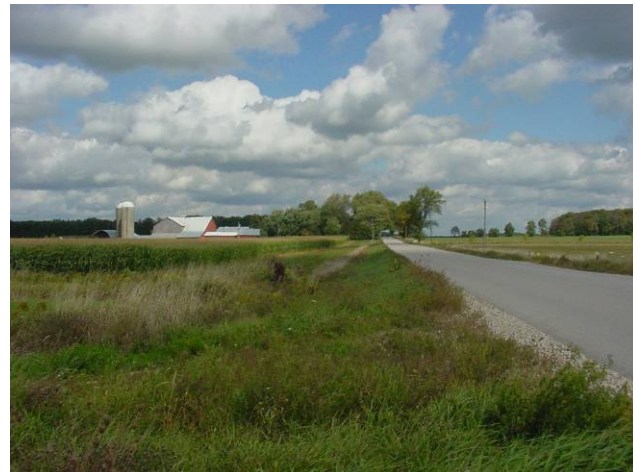
**Plate 45:** view to northeast, fill slope disturbance along paved and improved McNabb Line.

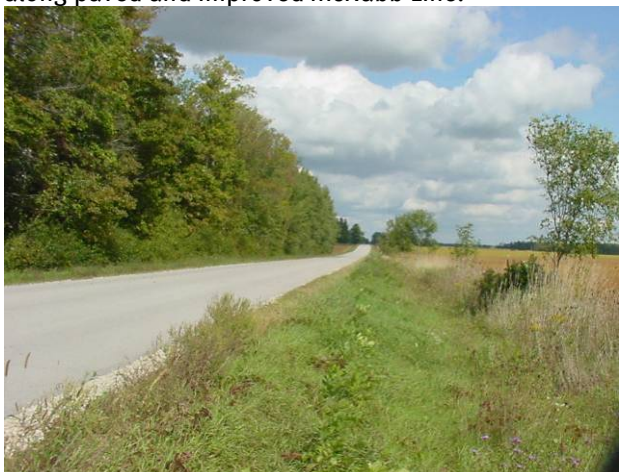
**Plate 46:** view to northeast, fill slope disturbance on low & level terrain near channelized stream.

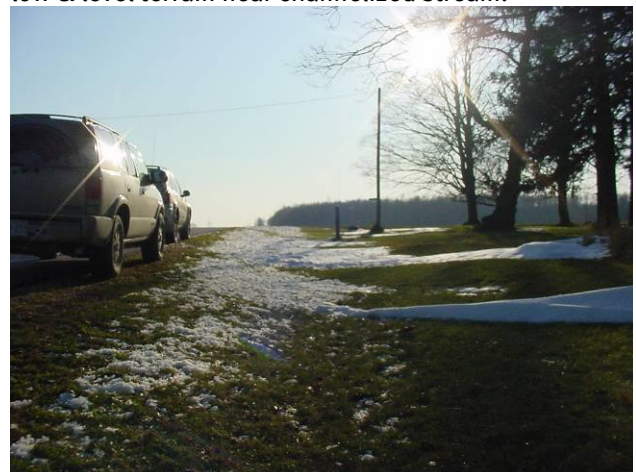
**Plate 47:** view to northeast, ditch and fill slope disturbance along paved and improved McNabb Line.

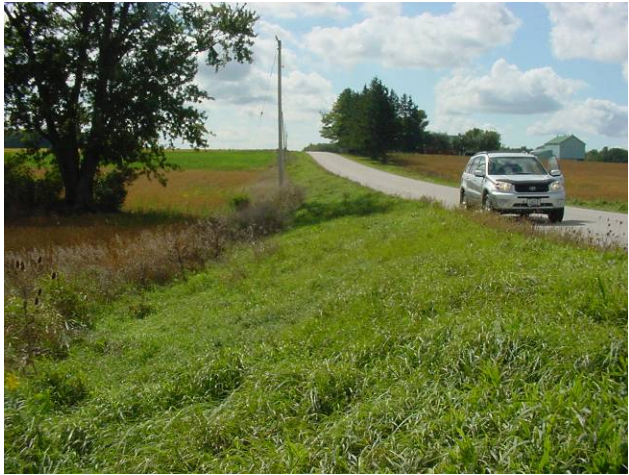
**Plate 48:** view to southwest, fill slope disturbance along northwest side of McNabb Line in vicinity of historic farmstead.

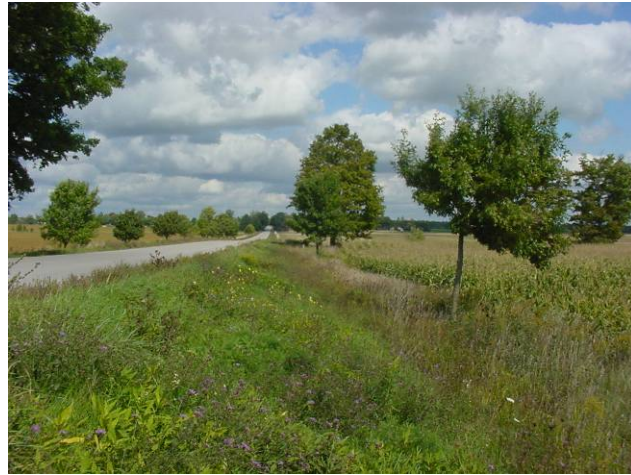
**Plate 49:** view to southwest, fill slope on low ground near drainage ditch at intersection with St. Michaels Road.

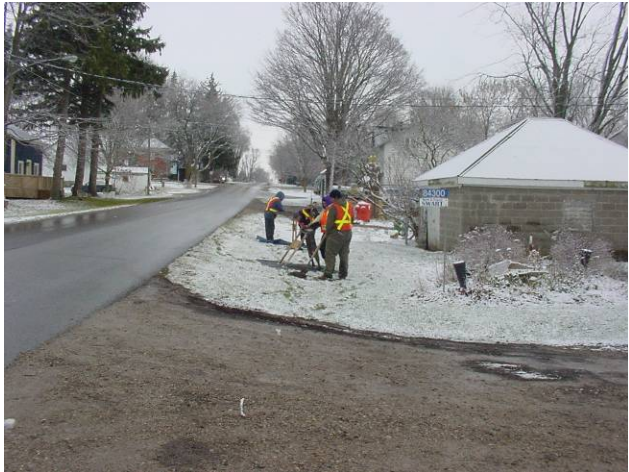
**Plate 50:** view to northeast, fill slope disturbance along paved and improved McNabb Line.

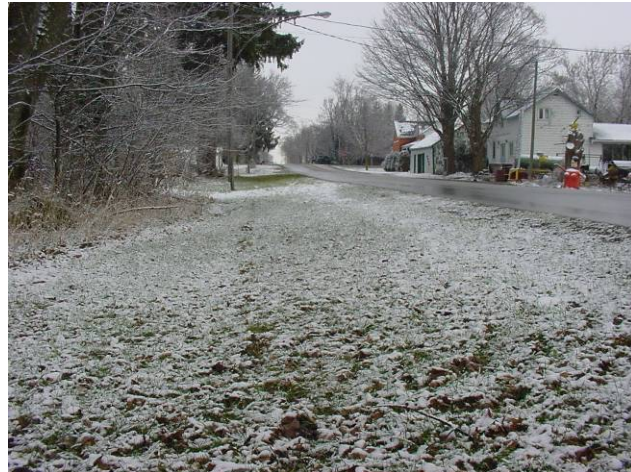
**Plate 51:** view to northeast from south limit of the Cranbrook, judgmental testpitting determined disturbance along southeast side of McNabb.

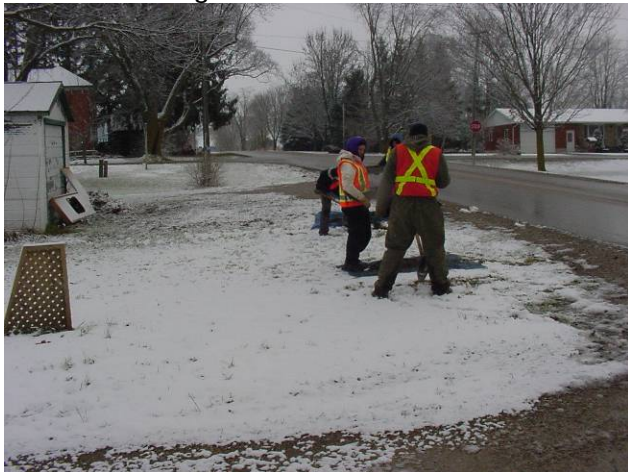
**Plate 52:** view to northeast, from south limit of hamlet of Cranbrook, along northwest side of McNabb. Fill slope disturbance in study corridor.

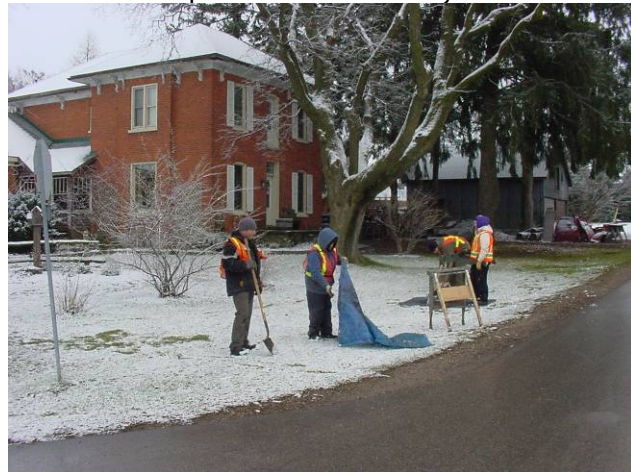
**Plate 53:** view to northeast, judgmental testpits identified disturbance here and on northeast corner

of intersection.

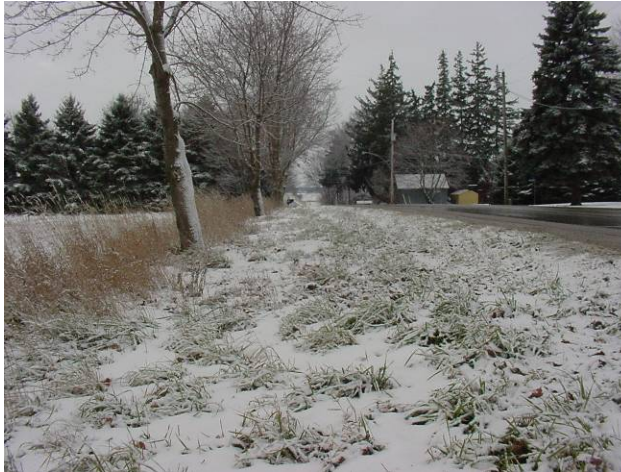
**Plate 54:** view to northwest, test pits excavated at 5m intervals where topsoil was present.

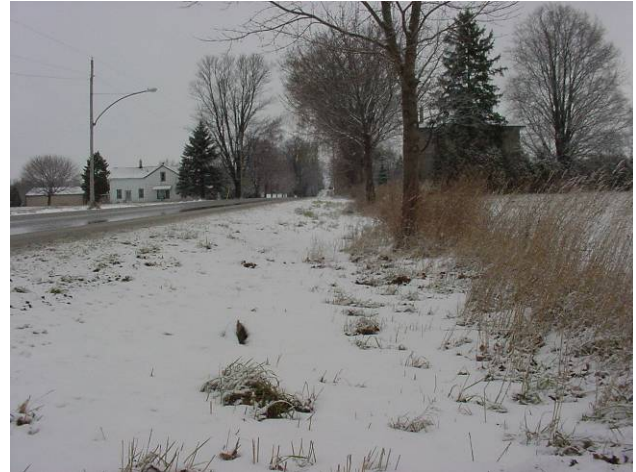
**Plate 55:** view to southwest, fill slope disturbance along southeast side of McNabb.

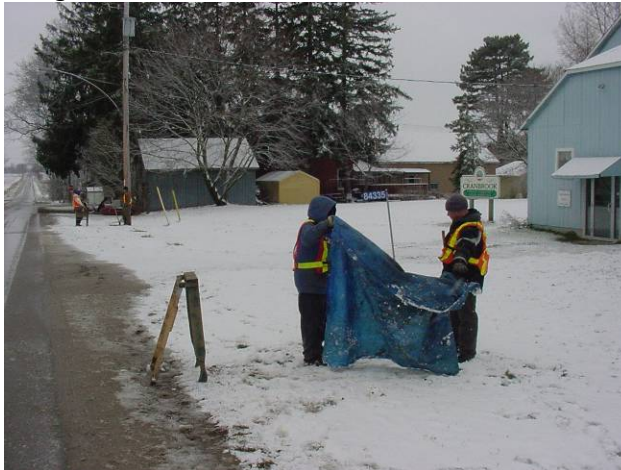
**Plate 56:** view northeast, fill slope disturbance along southeast side of McNabb.

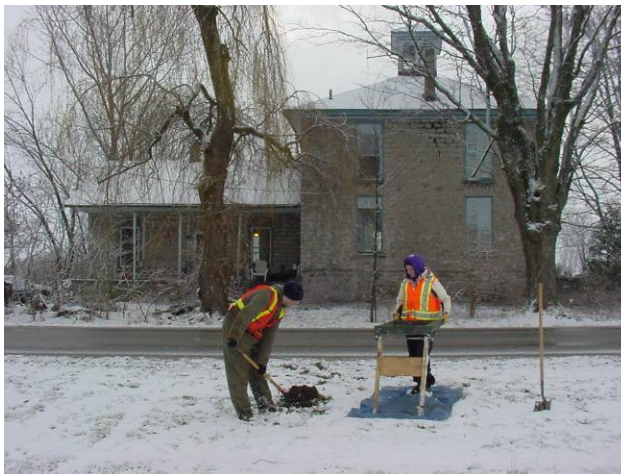
**Plate 58:** view to southwest, judgmental test pitting identified disturbance near 1888 Knox Presbyterian Church. Cemetery at rear.

There are no cemeteries in the immediate vicinity of the project study area. The nearest is the cemetery 50 m to the north behind the Knox Presbyterian Church in Cranbrook (Plate 57).

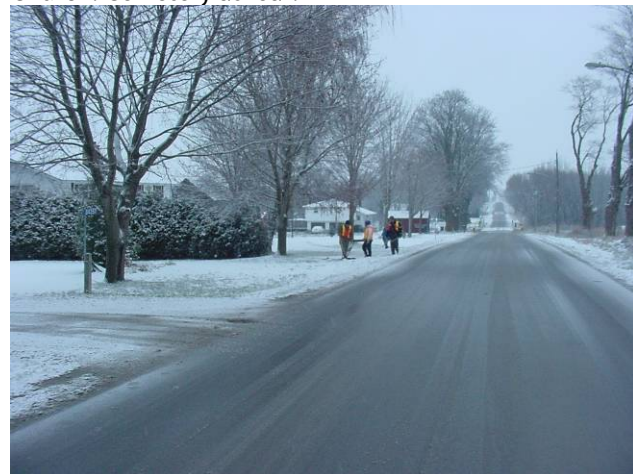
**Plate 59:** view to east, test pit assessment at 5 m intervals on northwest side of McNabb, opposite

Cameron House (local limestone).

The only designated landmark in the study area is Cameron House (Plate 58), situated on the east side of McNabb Line in the hamlet of Cranbrook (84354 McNabb) (Stantec 2011). To avoid possible impact, the directionally bored electrical interconnection line will not be situated on the southeast side of McNabb Line within 30 m on either side of the structure (Shawna Peddle, Senior Project Manager, Stantec, personal communication to D. Pihl, 10 November 2011).

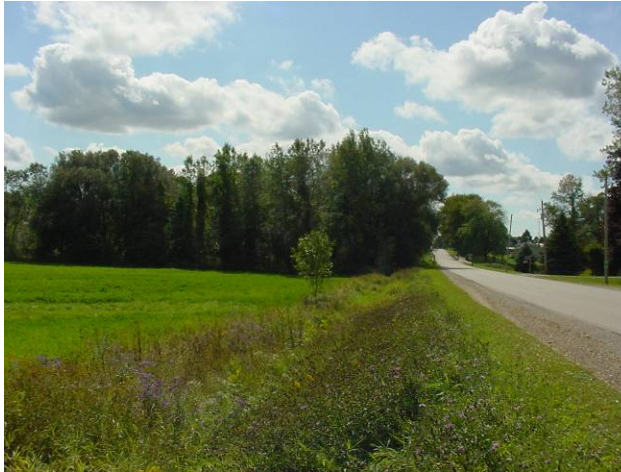
**Plate 60:** view to northeast. Test pitting at 5m interval near river (scanty topsoil present). Judgmental test

pitting elsewhere confirmed disturbance.

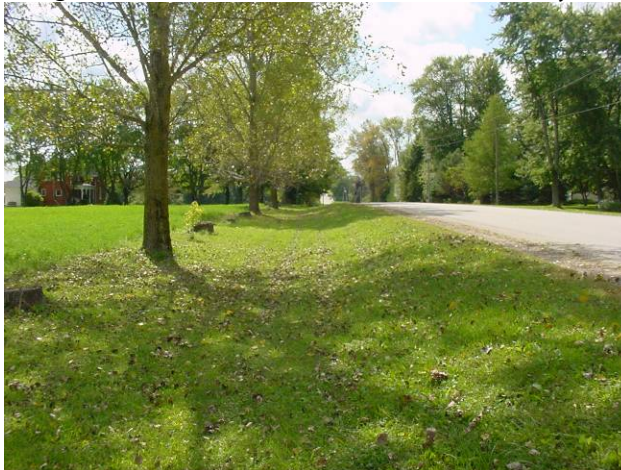
**Plate 61:** view to southwest, fill slope disturbance along McNabb within Middle Maitland River valley.

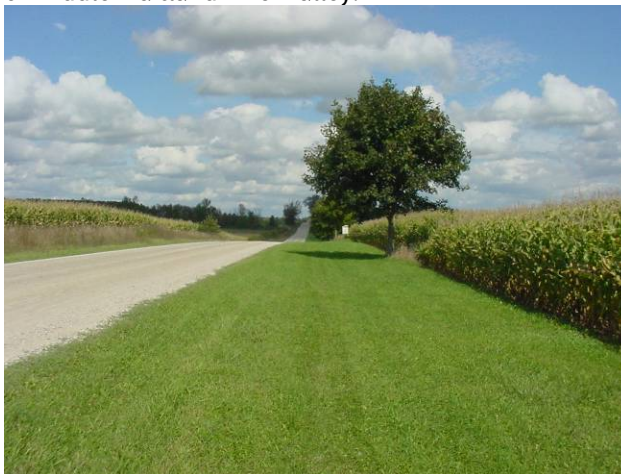
**Plate 63:** view to southwest, fill slope and shallow ditch disturbance along McNabb atop the north wall of Middle Maitland River valley.

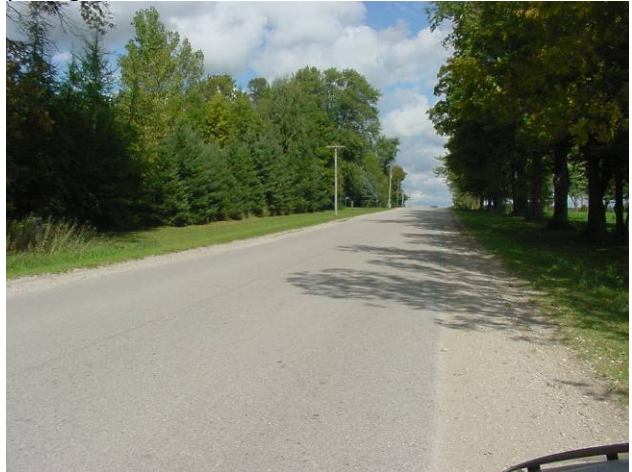
**Plate 62:** view to northeast, fill slope and ditch disturbance on the valley slope.

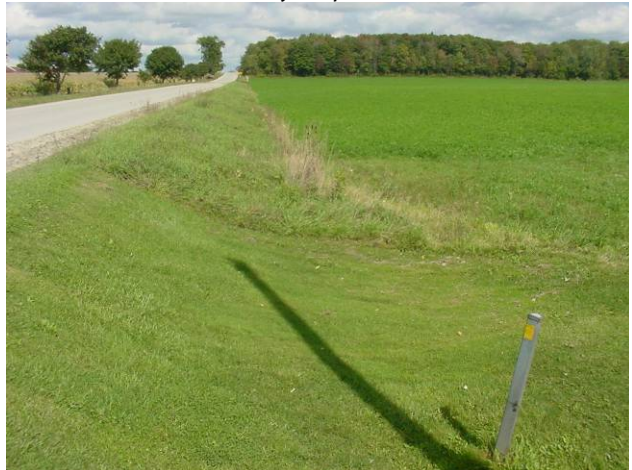
**Plate 64:** view to northeast, fill slope disturbance along the southeast side of McNabb.

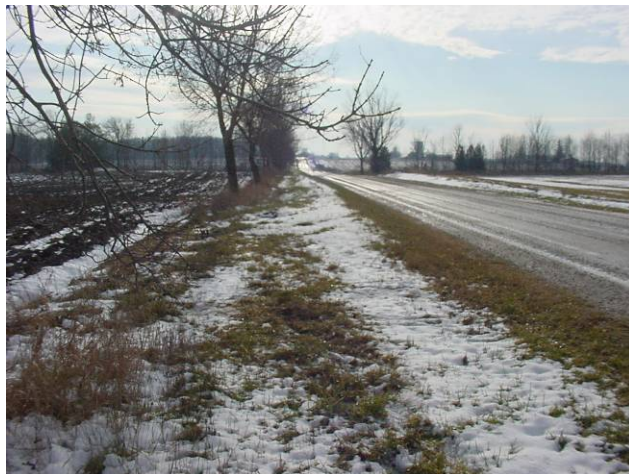
**Plate 66:** view to southwest, fill slope disturbance. Abandoned rail bed at tree line in distance.

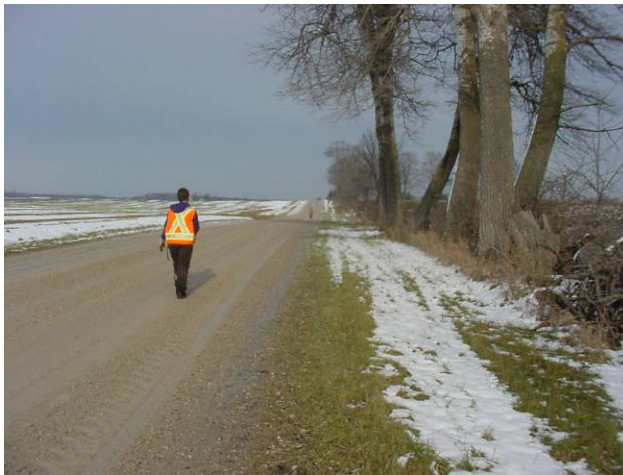
**Plate 67:** view to northeast, fill slope disturbance along McNabb.

| PLATE 66: VIEW TO NORTHEAST, FILL SLOPE DISTURBANCE ALONG McNABB. | 53 |

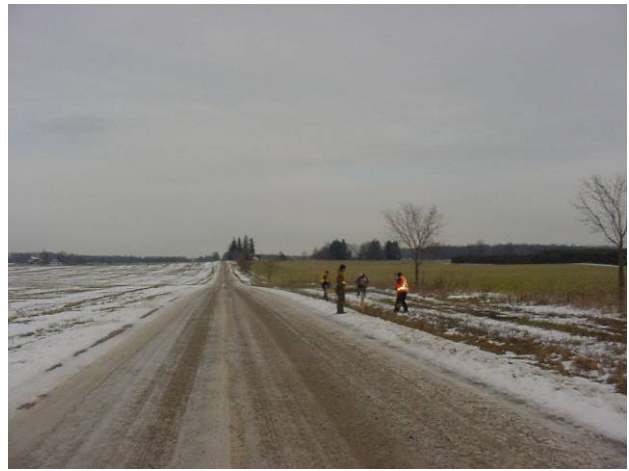
**Plate 68:** view to northeast, judgmental test pitting of isolated patch of well drained soils near historic farmstead identified disturbance.

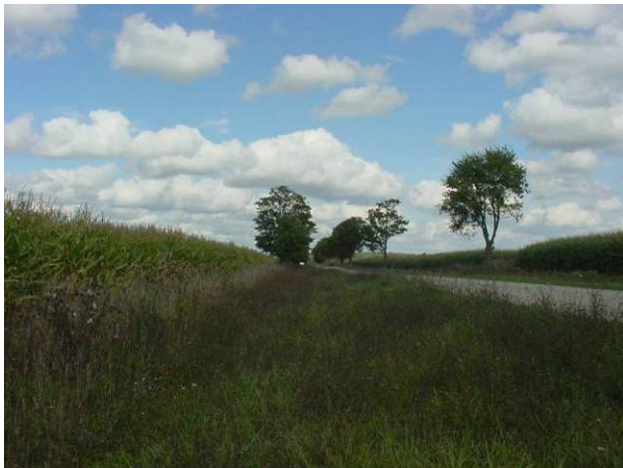
**Plate 69:** view to northeast, ditch disturbance along McNabb Line.

| PLATE 68: VIEW TO NORTHEAST, DITCH DISTURBANCE ALONG McNABB LINE. | 53 |

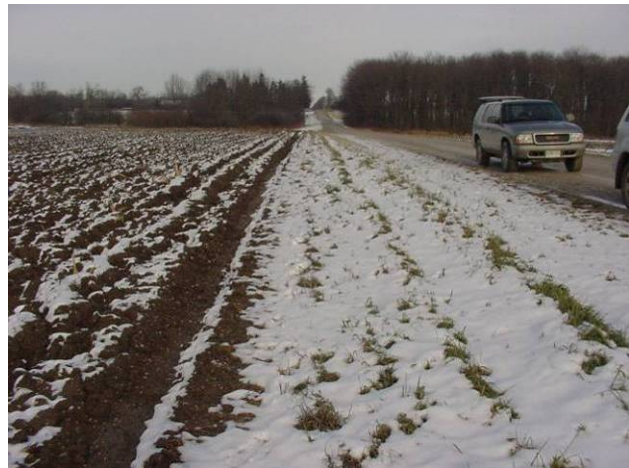
**Plate 70:** view to northeast, fill slope disturbance long northwest side of McNabb. Judgmental test pitting confirmed disturbance on southeast side.

| PLATE 69: VIEW TO NORTHEAST, FILL SLOPE DISTURBANCE LONG NORTHWEST SIDE OF McNABB. JUDGMENTAL TEST PITTING CONFIRMED DISTURBANCE ON SOUTHEAST SIDE. | 53 |

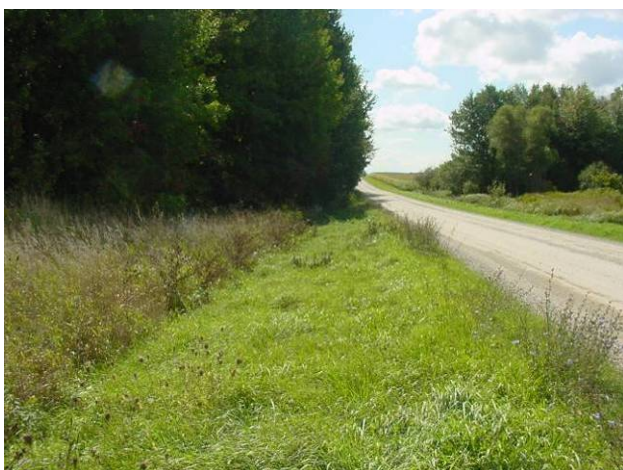
**Plate 71:** view to southwest, along northwest side of McNabb.

| PLATE 70: VIEW TO SOUTHWEST, ALONG NORTHWEST SIDE OF McNABB. | 53 |

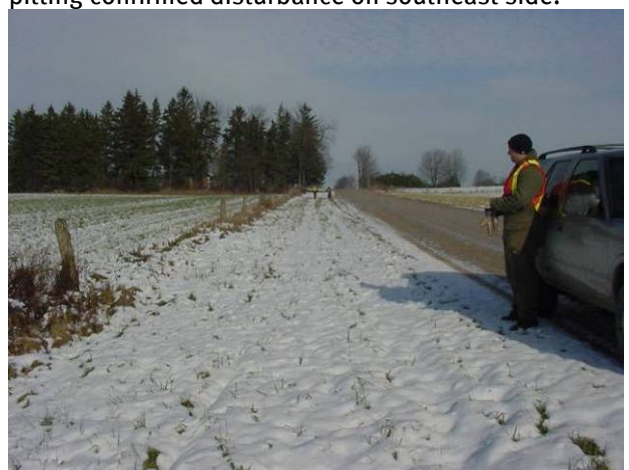
**Plate 72:** view to northeast, 12 test pits at 5 m intervals identified no cultural remains on northwest side of McNabb.

| PLATE 71: VIEW TO NORTHEAST, 12 TEST PITS AT 5 M INTERVALS IDENTIFIED NO CULTURAL REMAINS ON NORTHWEST SIDE OF McNABB. | 53 |

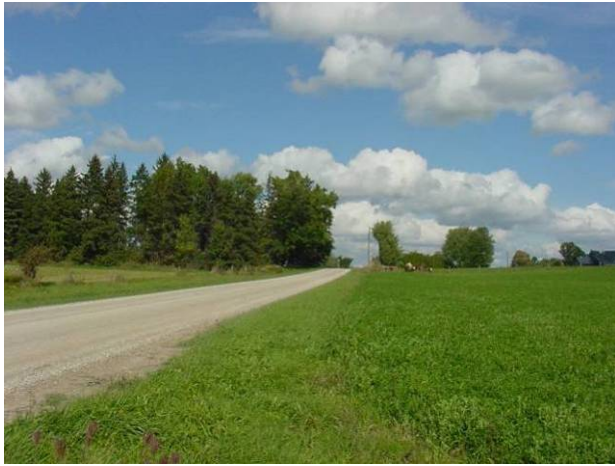
**Plate 73:** view to northeast, fill slope and ditch disturbance along southeast side of McNabb.

| PLATE 72: VIEW TO NORTHEAST, FILL SLOPE AND DITCH DISTURBANCE ALONG SOUTHEAST SIDE OF McNABB. | 54 |

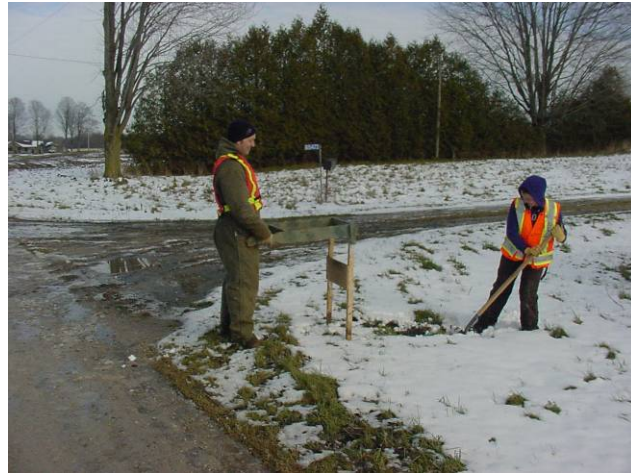
**Plate 74:** view to northeast, judgmental test pitting confirmed disturbance in vicinity of historic farmstead.

| PLATE 73: VIEW TO NORTHEAST, JUDGMENTAL TEST PITTING CONFIRMED DISTURBANCE IN VICINITY OF HISTORIC FARMSTEAD. | 54 |

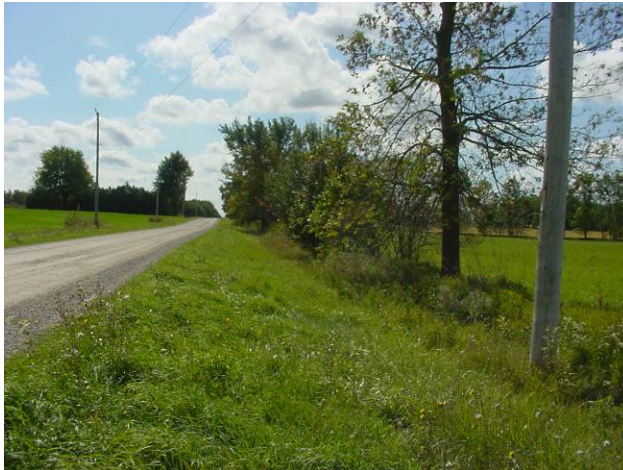
**Plate 75:** view to southwest, fill slope along McNabb, south of Cardiff intersection.

| PLATE 74: VIEW TO SOUTHWEST, FILL SLOPE ALONG McNABB, SOUTH OF CARDIFF INTERSECTION. | 54 |

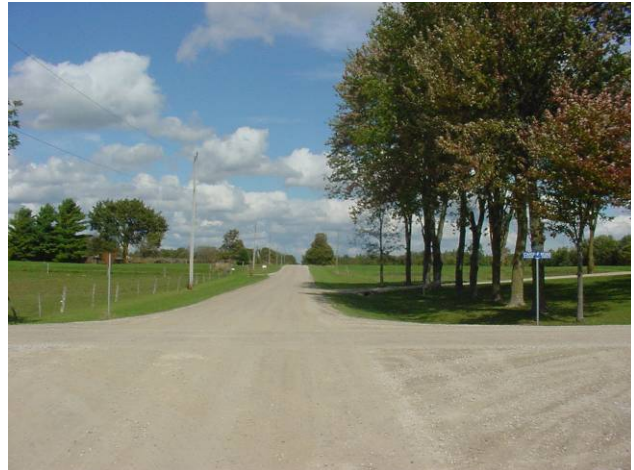
**Plate 76:** view to northeast, ditch and fill slope disturbance along McNabb, north of Cardiff Road intersection.

| PLATE 75: VIEW TO NORTHEAST, DITCH AND FILL SLOPE DISTURBANCE ALONG McNABB, NORTH OF CARDIFF ROAD INTERSECTION. | 54 |

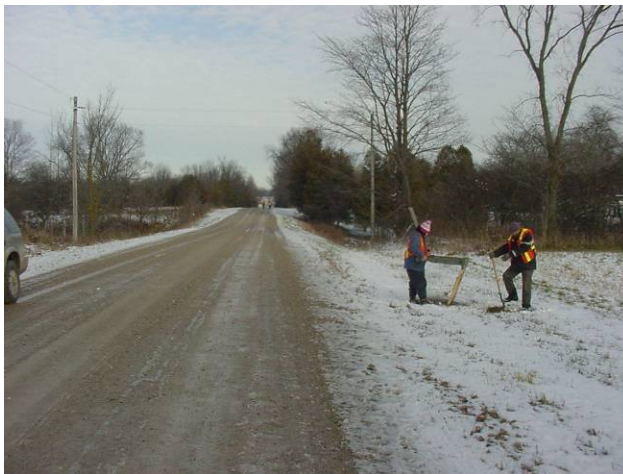
**Plate 77:** view to northeast, judgmental test pitting on both sides of McNabb confirmed disturbance. Rise

in distance also judgmentally tested.

| PLATE 76: VIEW TO NORTHEAST, JUDGMENTAL TEST PITTING ON BOTH SIDES OF McNABB CONFIRMED DISTURBANCE. RISE IN DISTANCE ALSO JUDGMENTALLY TESTED. | 54 |

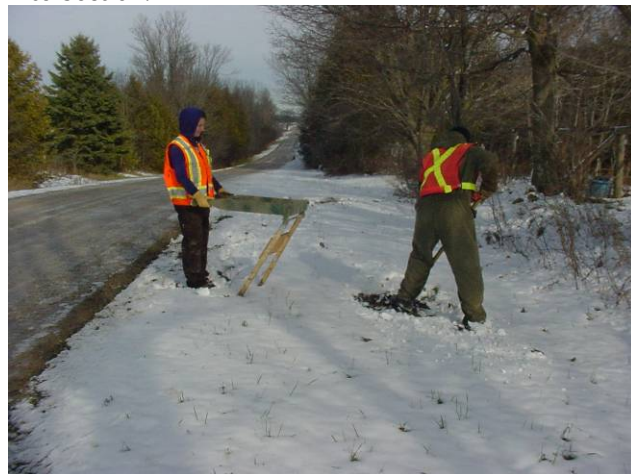
**Plate 78:** view to northeast, judgmental test pitting confirmed disturbance. Creek valley in background.

| PLATE 77: VIEW TO NORTHEAST, JUDGMENTAL TEST PITTING CONFIRMED DISTURBANCE. CREEK VALLEY IN BACKGROUND. | 54 |

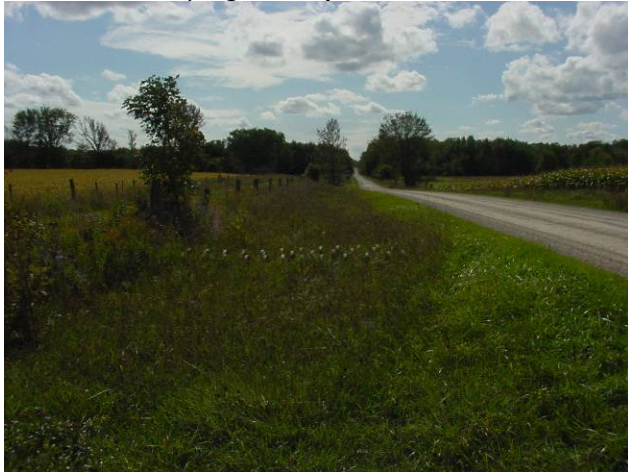
**Plate 79:** view to southwest, ditch and fill slope disturbance along McNabb Line.

| PLATE 78: VIEW TO SOUTHWEST, DITCH AND FILL SLOPE DISTURBANCE ALONG McNABB LINE. | 55 |

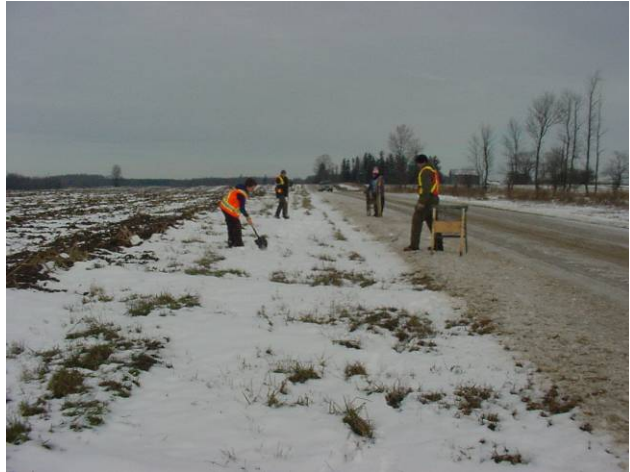
**Plate 80:** view to northeast, 5 m interval test pits on northwest side of McNabb identified scanty topsoil and no cultural remains. Ditch on southeast side.

| PLATE 79: VIEW TO NORTHEAST, 5 M INTERVAL TEST PITS ON NORTHWEST SIDE OF McNABB IDENTIFIED SCANTY TOPSOIL AND NO CULTURAL REMAINS. DITCH ON SOUTHEAST SIDE. | 55 |

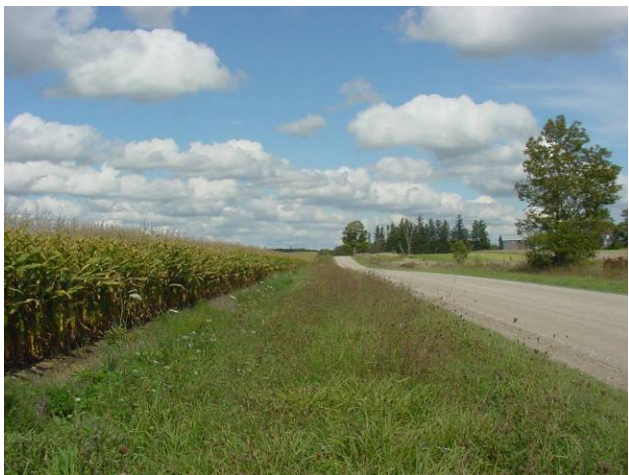
**Plate 81:** view to northeast, ditch and fill slope disturbance along McNabb Line.

| PLATE 80: VIEW TO NORTHEAST, DITCH AND FILL SLOPE DISTURBANCE ALONG McNABB LINE. | 55 |

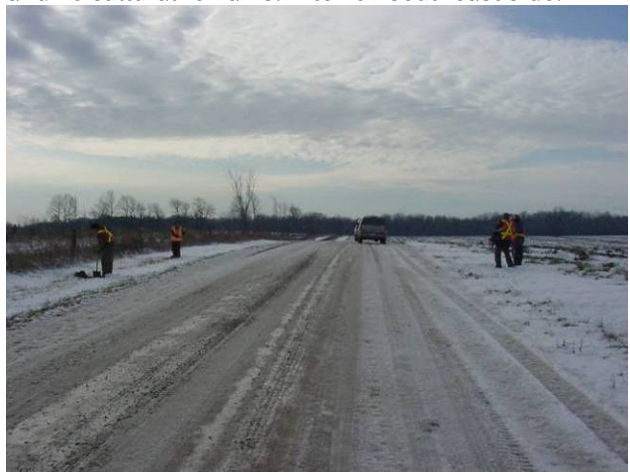
**Plate 82:** view to southwest, 5m interval test pits on southeast side of McNabb (fill was screened). Ditch on west.

| PLATE 81: VIEW TO SOUTHWEST, 5M INTERVAL TEST PITS ON SOUTHEAST SIDE OF McNABB (FILL WAS SCREENED). DITCH ON WEST. | 55 |

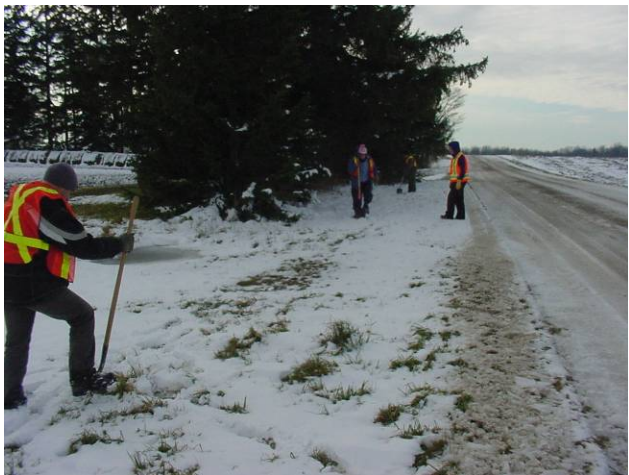
**Plate 83:** view to southeast, judgmental test pitting

confirms disturbance along southeast side of McNabb.

| PLATE 82: VIEW TO SOUTHEAST, JUDGMENTAL TEST PITTING CONFIRMS DISTURBANCE ALONG SOUTHEAST SIDE OF McNABB. | 55 |

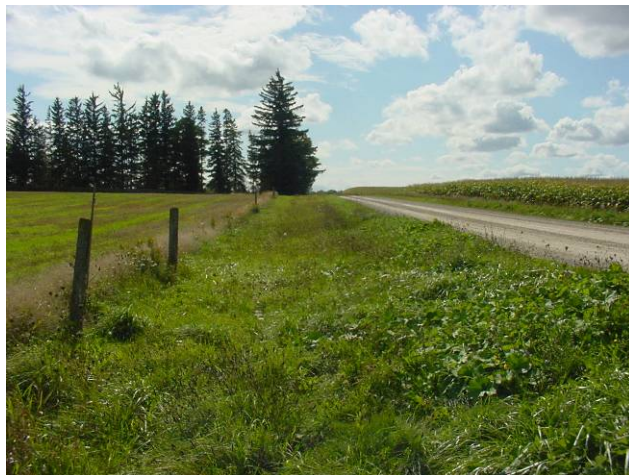
**Plate 84:** view to southeast, ditch and fill slope

disturbance along McNabb.

| PLATE 83: VIEW TO SOUTHEAST, DITCH AND FILL SLOPE DISTURBANCE ALONG McNABB. | 55 |

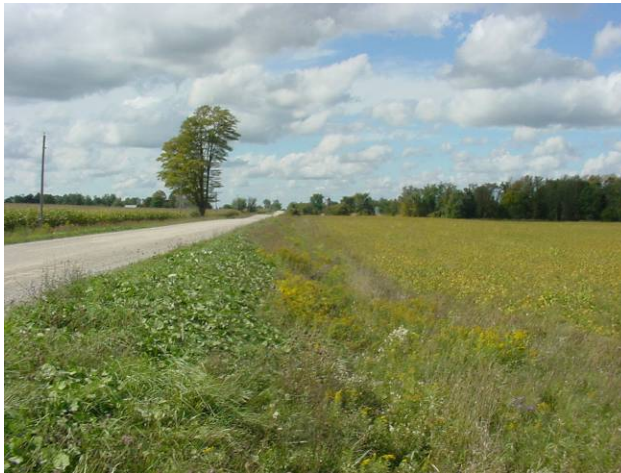
**Plate 85:** view to northwest, fill slope along gravelled and well elevated roadbed of Browntown Line.

| PLATE 84: VIEW TO NORTHWEST, FILL SLOPE ALONG GRAVELLED AND WELL ELEVATED ROADBED OF BROWNTOWN LINE. | 56 |

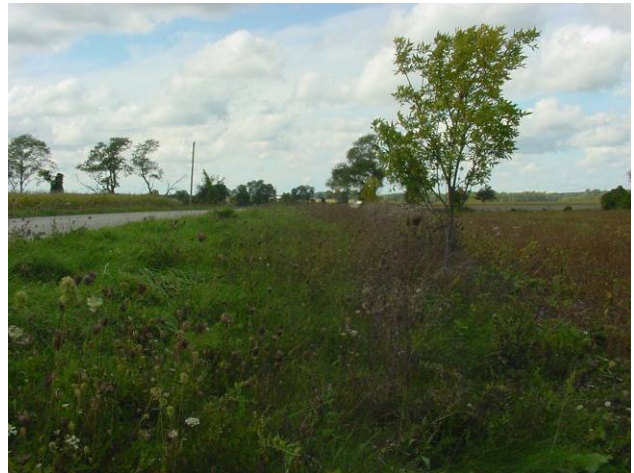
**Plate 86:** view to northeast, fill slope along gravelled and well elevated roadbed of Browntown Line.

| PLATE 85: VIEW TO NORTHEAST, FILL SLOPE ALONG GRAVELLED AND WELL ELEVATED ROADBED OF BROWNTOWN LINE. | 56 |

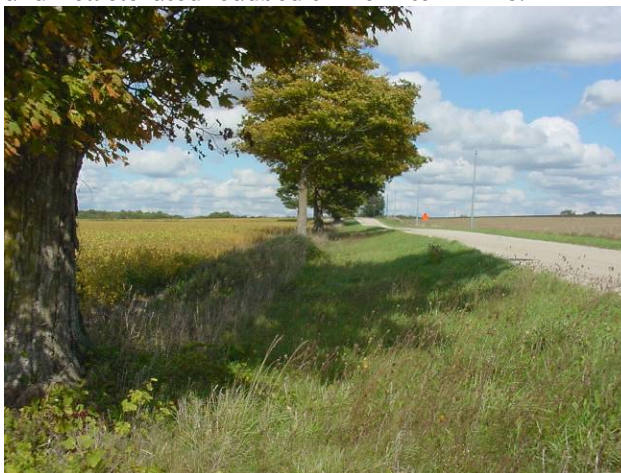
**Plate 87:** view to northeast, fill slope and ditch disturbance along Johnston Line.

| PLATE 86: VIEW TO NORTHEAST, FILL SLOPE AND DITCH DISTURBANCE ALONG JOHNSTON LINE. | 56 |

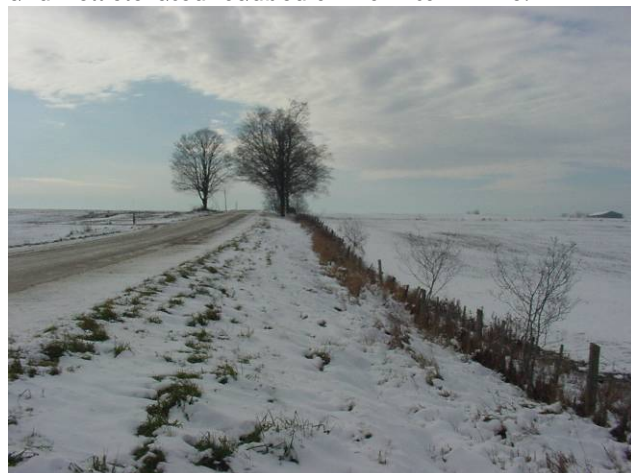
**Plate 88:** view to southwest, fill slope disturbance on Johnston Line.

| PLATE 87: VIEW TO SOUTHWEST, FILL SLOPE DISTURBANCE ON JOHNSTON LINE. | 56 |

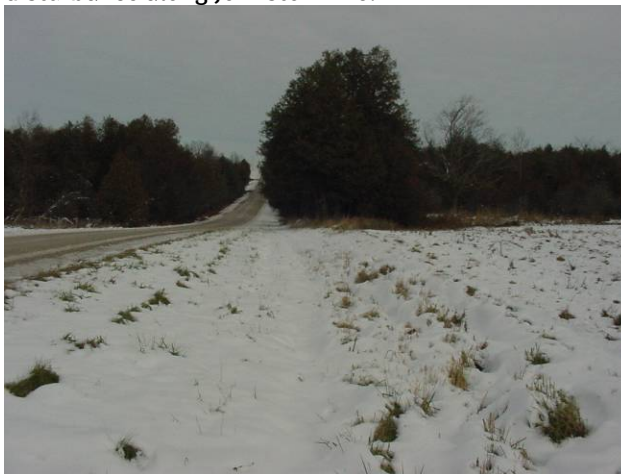
**Plate 89:** view to northeast, ditch and fill slope disturbance along Johnston Line.

| PLATE 88: VIEW TO NORTHEAST, DITCH AND FILL SLOPE DISTURBANCE ALONG JOHNSTON LINE. | 56 |

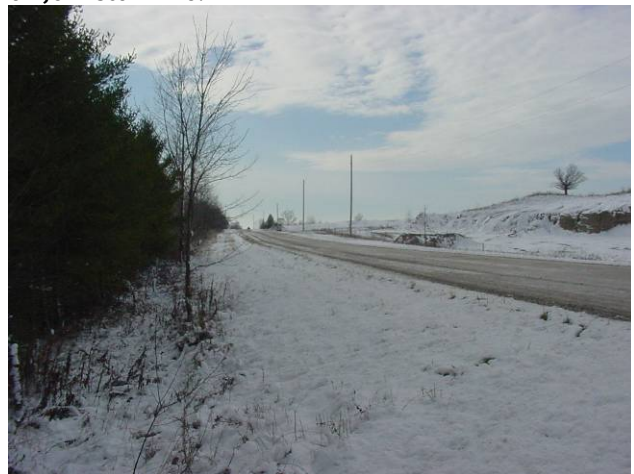
**Plate 90:** view to southwest, fill slope disturbance along Johnston Line.

| PLATE 89: VIEW TO SOUTHWEST, FILL SLOPE DISTURBANCE ALONG JOHNSTON LINE. | 56 |

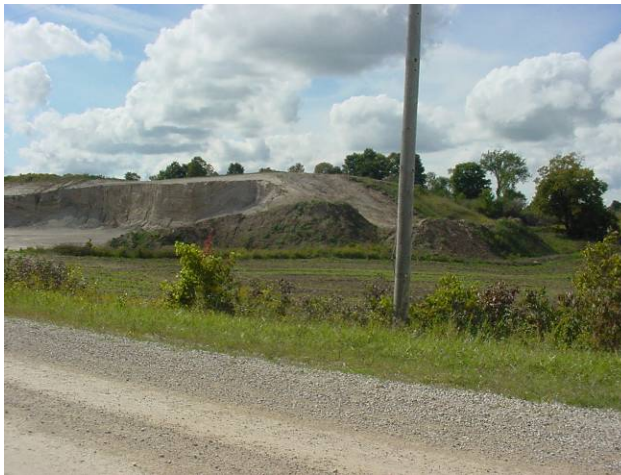
**Plate 91:** view to west-southwest, fill slope adjacent to lower ground along Johnston Line. Gravel extraction operation on esker in background.

| PLATE 90: VIEW TO WEST-SOUTHWEST, FILL SLOPE ADJACENT TO LOWER GROUND ALONG JOHNSTON LINE. GRAVEL EXTRACTION OPERATION ON ESKER IN BACKGROUND. | 57 |

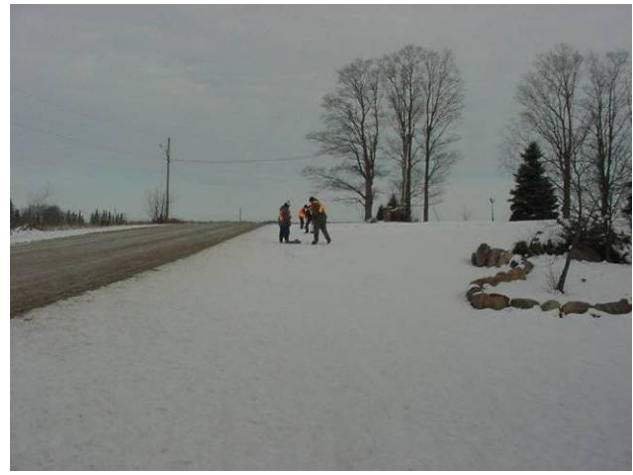
**Plate 92:** view to northeast, judgmental test pitting confirmed disturbance on the southeast side of Johnston Line near farmstead location.

| PLATE 91: VIEW TO NORTHEAST, JUDGMENTAL TEST PITTING CONFIRMED DISTURBANCE ON THE SOUTHEAST SIDE OF JOHNSTON LINE NEAR FARMSTEAD LOCATION. | 57 |

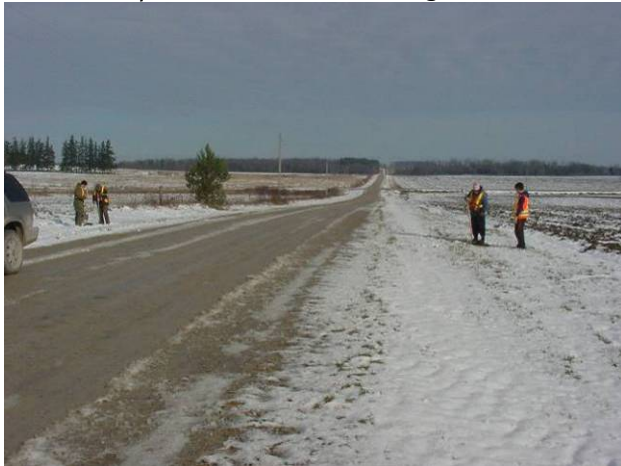
**Plate 93:** view to northeast, judgmental test pits along Johnston Line confirm disturbance.

| PLATE 92: VIEW TO NORTHEAST, JUDGMENTAL TESTPITS ALONG JOHNSTON LINE CONFIRM DISTURBANCE. | 57 |

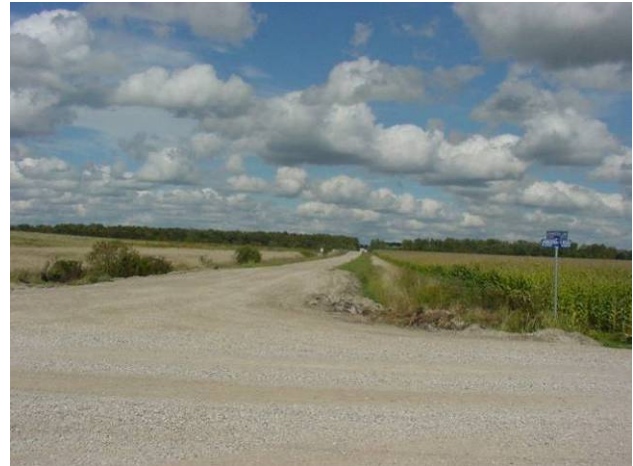
**Plate 94:** view to northeast, ditch & fill slope disturbance along Johnston Line through low and level terrain.

| PLATE 93: VIEW TO NORTHEAST, DITCH & FILL SLOPE DISTURBANCE ALONG JOHNSTON LINE THROUGH LOW AND LEVEL TERRAIN. | 57 |

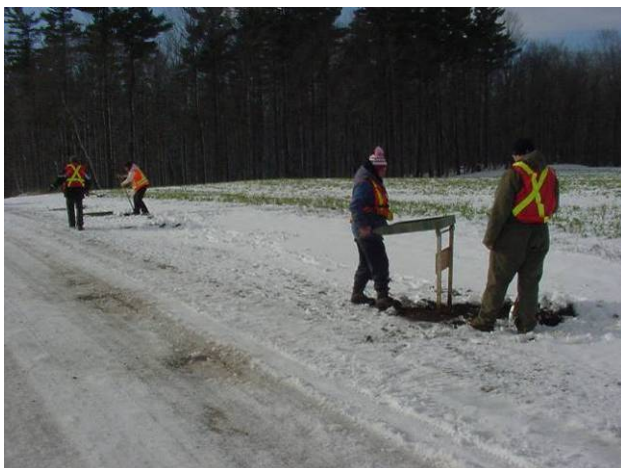
**Plate 95:** view to west, test pit assessment at 5m intervals along northeast side of Johnston Line. High ground. No cultural remains recovered.

| PLATE 94: VIEW TO WEST, TEST PIT ASSESSMENT AT 5M INTERVALS ALONG NORTHEAST SIDE OF JOHNSTON LINE. HIGH GROUND. NO CULTURAL REMAINS RECOVERED. .... | 57 |

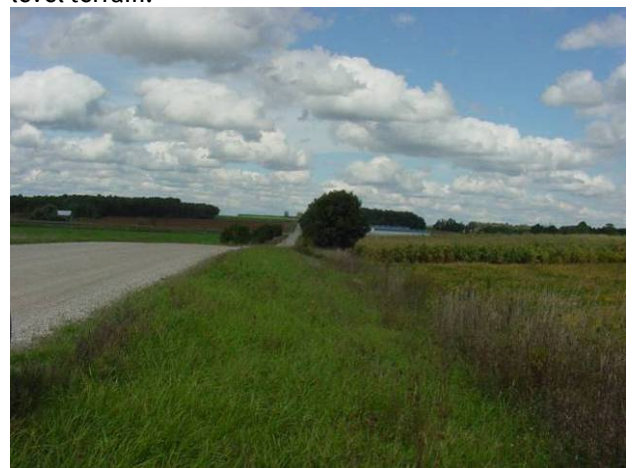
**Plate 96:** view to northeast, fill slope & steep slope on southeast side of Johnston Line high ground.

| PLATE 95: VIEW TO NORTHEAST, FILL SLOPE & STEEP SLOPE ON SOUTHEAST SIDE OF JOHNSTON LINE HIGH GROUND. .... | 57 |

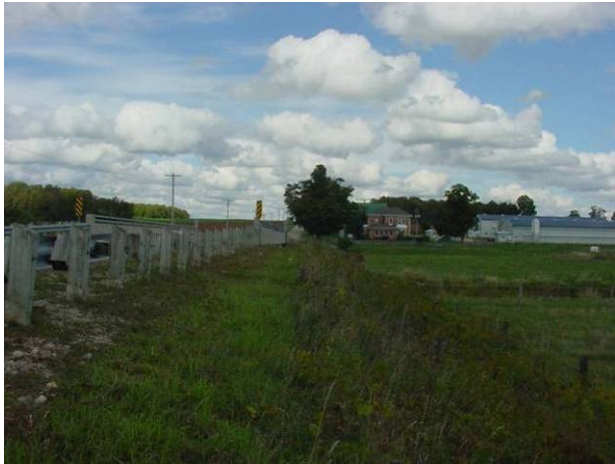
**Plate 97:** view to northeast, fill slope adjacent to Johnston Line at Amberley Rd & Little Maitland River crossings. Historic farmstead in background.

| PLATE 96: VIEW TO NORTHEAST, FILL SLOPE ADJACENT TO JOHNSTON LINE AT AMBERLEY RD & LITTLE MAITLAND RIVER CROSSINGS. HISTORIC FARMSTEAD IN BACKGROUND. .... | 58 |

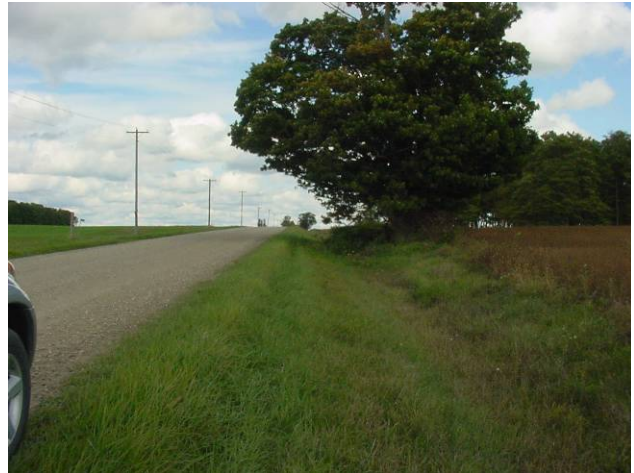
**Plate 98:** view to northeast, deep ditch and fill slope disturbance adjacent to gravelled and improved Johnston Line.

| PLATE 97: VIEW TO NORTHEAST, DEEP DITCH AND FILL SLOPE DISTURBANCE ADJACENT TO GRAVELLED AND IMPROVED JOHNSTON LINE. .... | 58 |

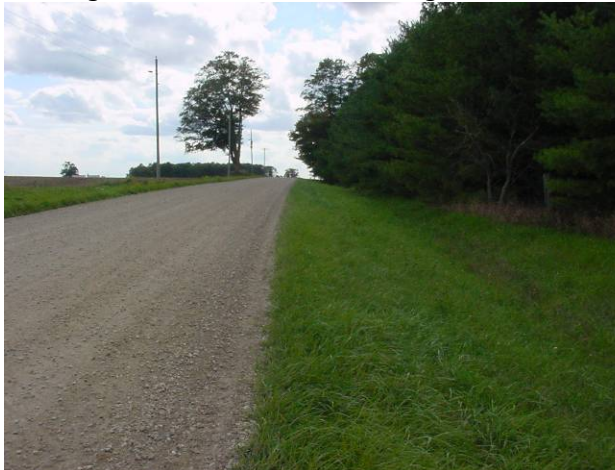
**Plate 99:** view to southeast, ditch and fill slope disturbance along Johnston Line. Historic farmstead at right.

| PLATE 98: VIEW TO SOUTHEAST, DITCH AND FILL SLOPE DISTURBANCE ALONG JOHNSTON LINE. HISTORIC FARMSTEAD AT RIGHT. .... | 58 |

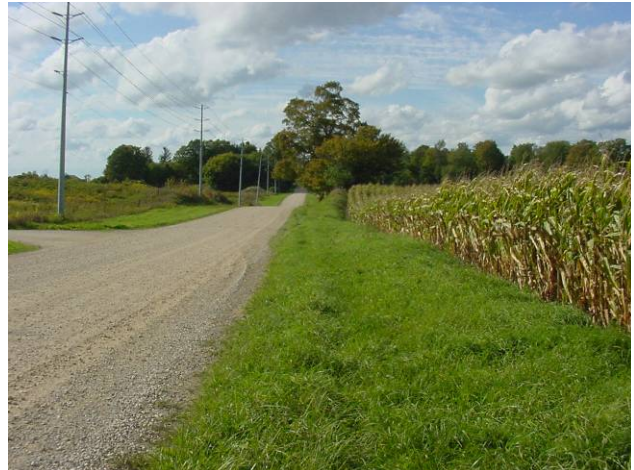
**Plate 100:** view to northwest, ditching and cut slope disturbance along Centre Line Rd.

| PLATE 99: VIEW TO NORTHWEST, DITCHING AND CUT SLOPE DISTURBANCE ALONG CENTRE LINE Rd. .... | 58 |

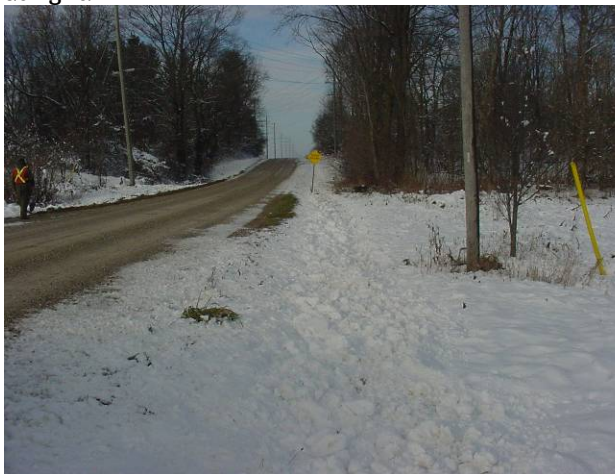
**Plate 101:** view to northwest, ditch, fill slope and cut slope disturbance along Centre line Rd.

| PLATE 100: VIEW TO NORTHWEST, DITCH, FILL SLOPE AND CUT SLOPE DISTURBANCE ALONG CENTRE LINE Rd. .... | 58 |

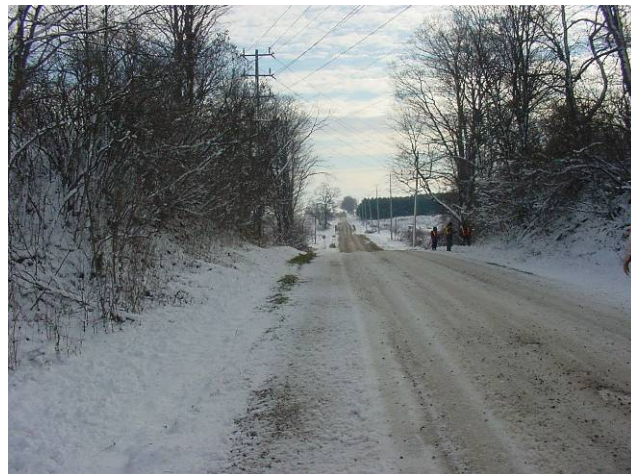
**Plate 102:** view to southwest, road cut disturbance on both sides of Centre Line Road.

| PLATE 101: VIEW TO SOUTHWEST, ROAD CUT DISTURBANCE ON BOTH SIDES OF CENTRE LINE ROAD. .... | 58 |

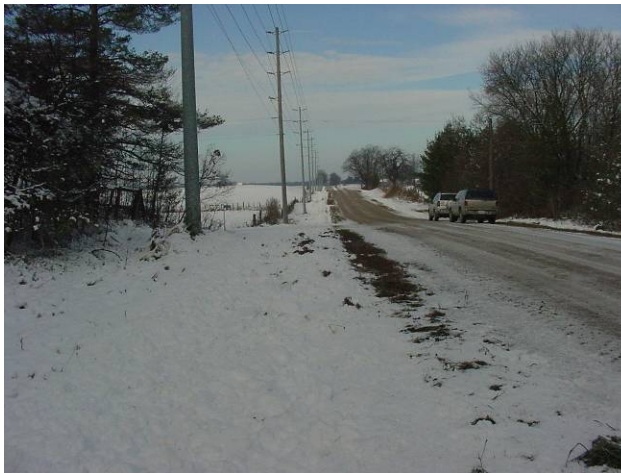
**Plate 103:** view to northeast, judgmental testpits confirm disturbance on southwest side of Centre Line Rd. Northeast side ditch.

| PLATE 102: VIEW TO NORTHEAST, JUDGMENTAL TESTPITS CONFIRM DISTURBANCE ON SOUTHWEST SIDE OF CENTRE LINE Rd. NORTHEAST SIDE DITCH. .... | 59 |

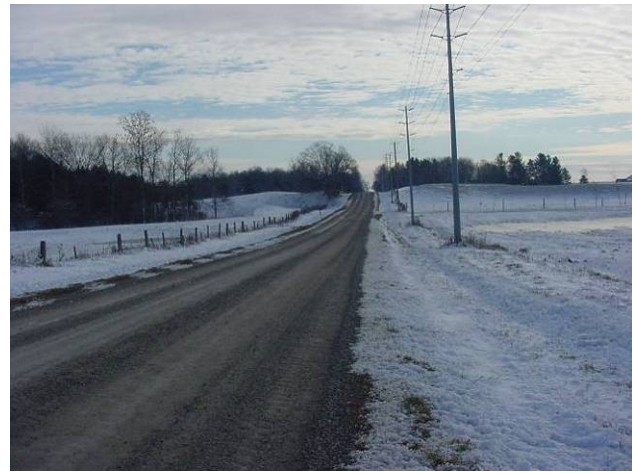
**Plate 104:** view to southwest, ditch disturbance along both sides of Centre Line Road near wetland & farm.

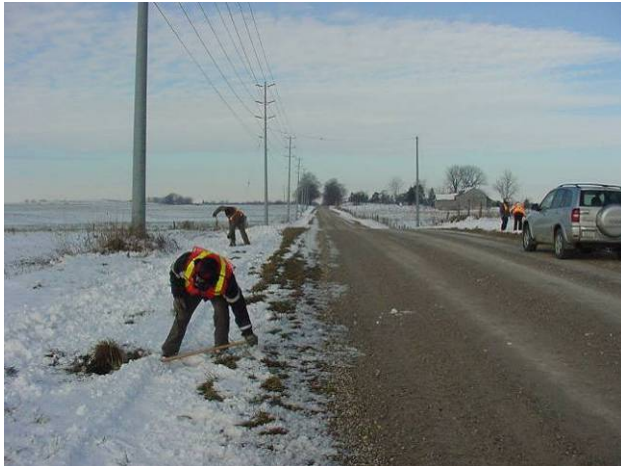
**Plate 105:** view to northeast, 5 m interval test pits along southwest side of road. Judgmental test pits on opposite side confirmed disturbance.

Test pit survey involves the excavation of test pits at 30 cm in diameter to sterile subsoil and the screening of all test pit fills through 6 mm mesh to facilitate artifact recovery. Afterwards, test pits are backfilled and their locations recorded on field maps. If archaeological resources are uncovered, test pit intervals are intensified to a maximum of 2.5 m around the positive test pits to define site boundaries. Any factors that precluded the excavation of test pits (e.g. excessive slope, drainage, exposed bedrock, previous disturbance) are noted, and the areas are mapped and photographed. Where necessary, areas of disturbance are confirmed by the excavation of test pits at a judgmental (10 m) interval.

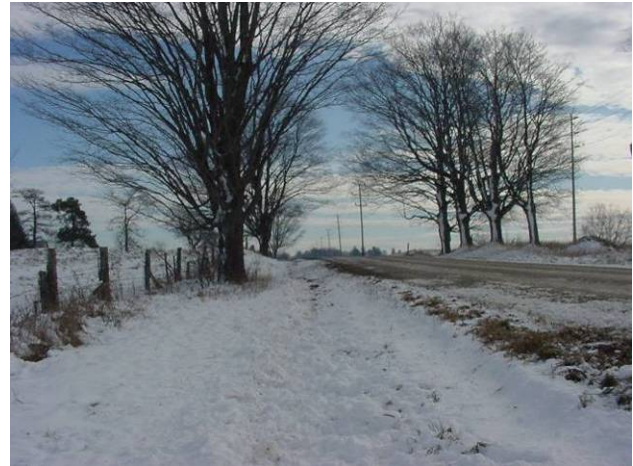
**Plate 106:** view to southwest, ditch & road cut disturbance along Centre Line Road.

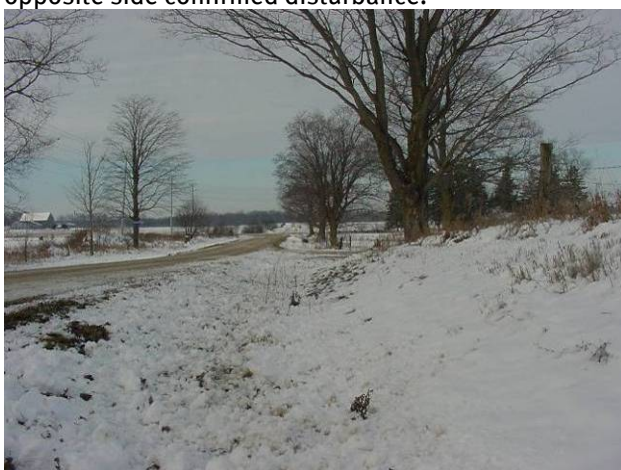
**Plate 107:** view to northeast, road cut, slope & ditch disturbance along Centre Line Road south of intersection with McDonald Line, near farmsteads.

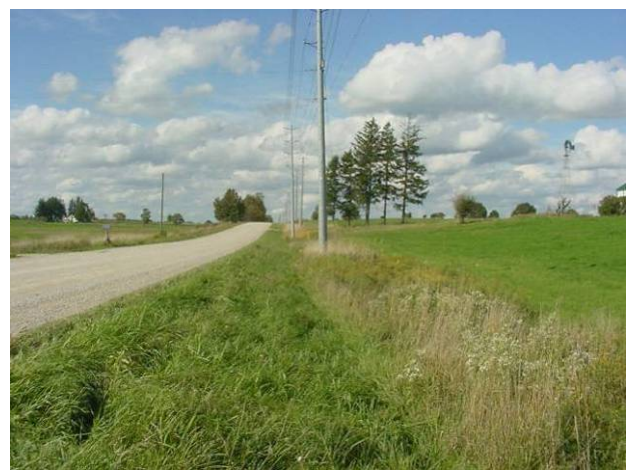
**Plate 108:** view to north, fill slope and ditch disturbance along improved gravel roadbed of McDonald Line near farmsteads.

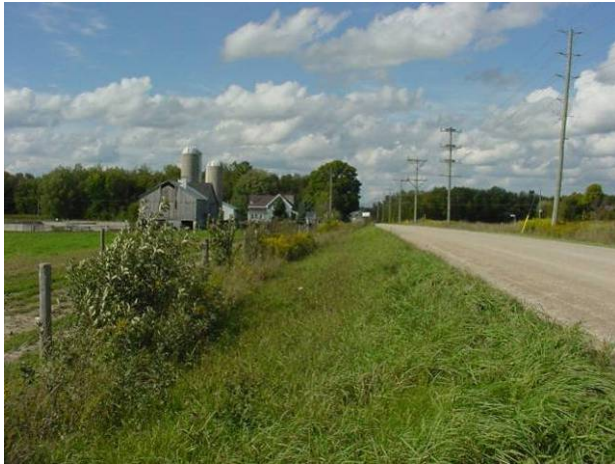
**Plate 109:** view to north, fill slope disturbance along improved roadbed of McDonald line in vicinity of proposed connection facility and historic farmsteads.
