4.0 **Records Review Purpose**

Loyalist Solar LP *Water Assessment Report February 2017 – 16-3674* Photograph 1, facing east. Water body 1, located on a residential property southeast of the intersection of Hinch Road and Rattie Road.

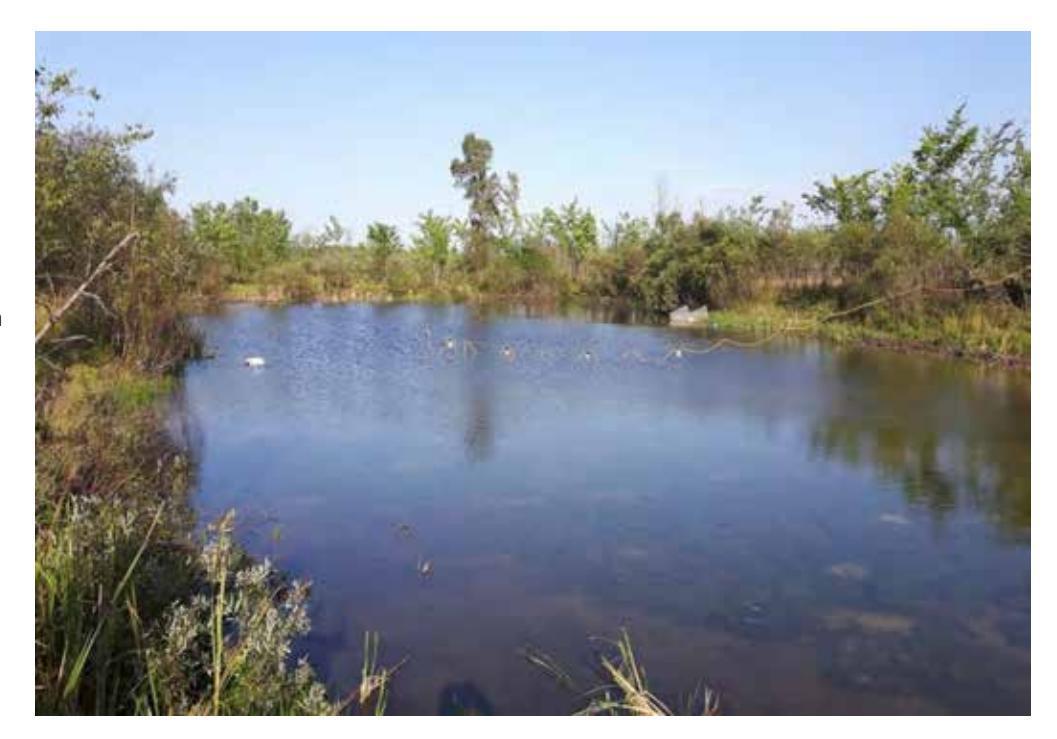
The site investigation found Potential Water Body 1 occurred as mapped by the MNRF and presented in the records review (**Figure 3**). The water body was determined to be a small pond on a residential property at 894 Hinch Road, approximately 105 m south of the Project Location on Hinch Road (see **Photograph 1** in *Appendix D*; Figure 4a).

Roughly 65 m x 25 m in area, the pond is located on the edge of a cow pasture/meadow habitat and mown lawn area. The shoreline was well-vegetated with grass and shrub species and sloped gradually (10% grade) towards the pond. Minor erosion around the banks was observed, presumed to be a direct result of cattle grazing and/or cattle accessing the pond. Overall, the shoreline of the pond was well-vegetated. Shoreline substrates were found to be predominantly silt with smaller amounts of muck and detritus, while bottom substrates was found to be predominantly muck and detritus. Along the banks of the pond there were small areas with accumulated woody and organic debris. Underwater cover consisted of pre-dominantly organic debris with sparse cover from vegetation. Vegetation noted comprised of mostly species from the Characeae family and Broad-leaved Cattail (*Typha latifolia*). Contributory water flow appears to originate from a grassed swale adjacent to the pond, flowing southeast across the pasture area from the roadside ditch adjacent to Hinch Road.

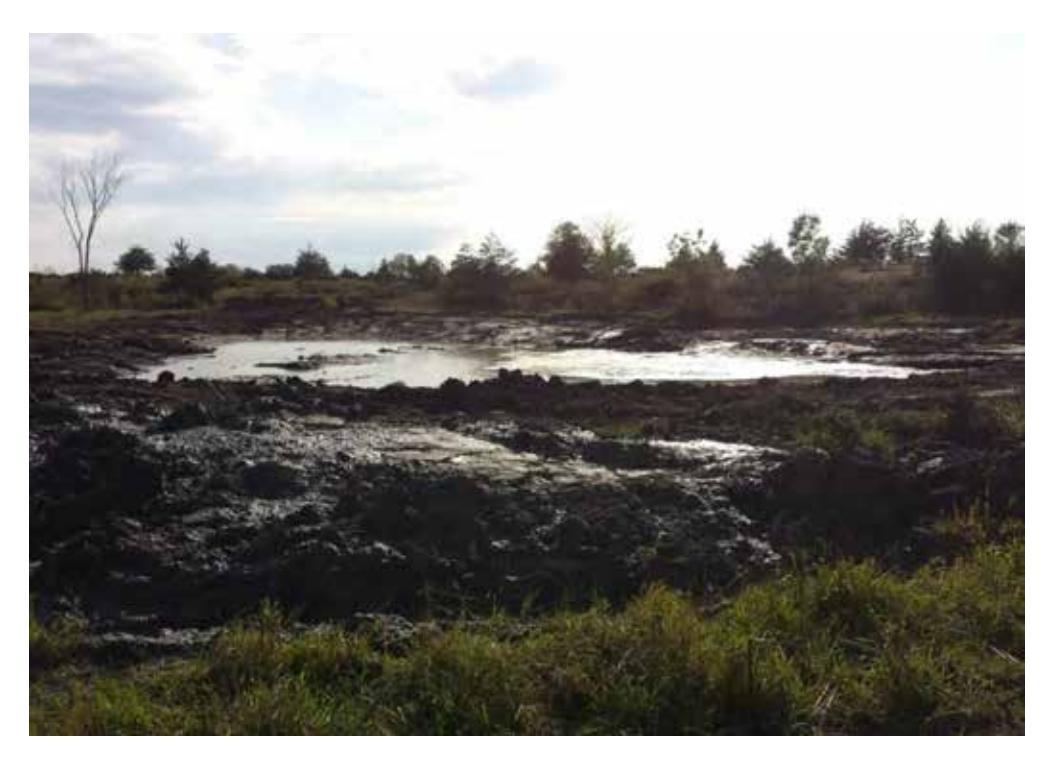
Photograph 2, facing west. Location of potential water body 2, determined to be a dugout pond.

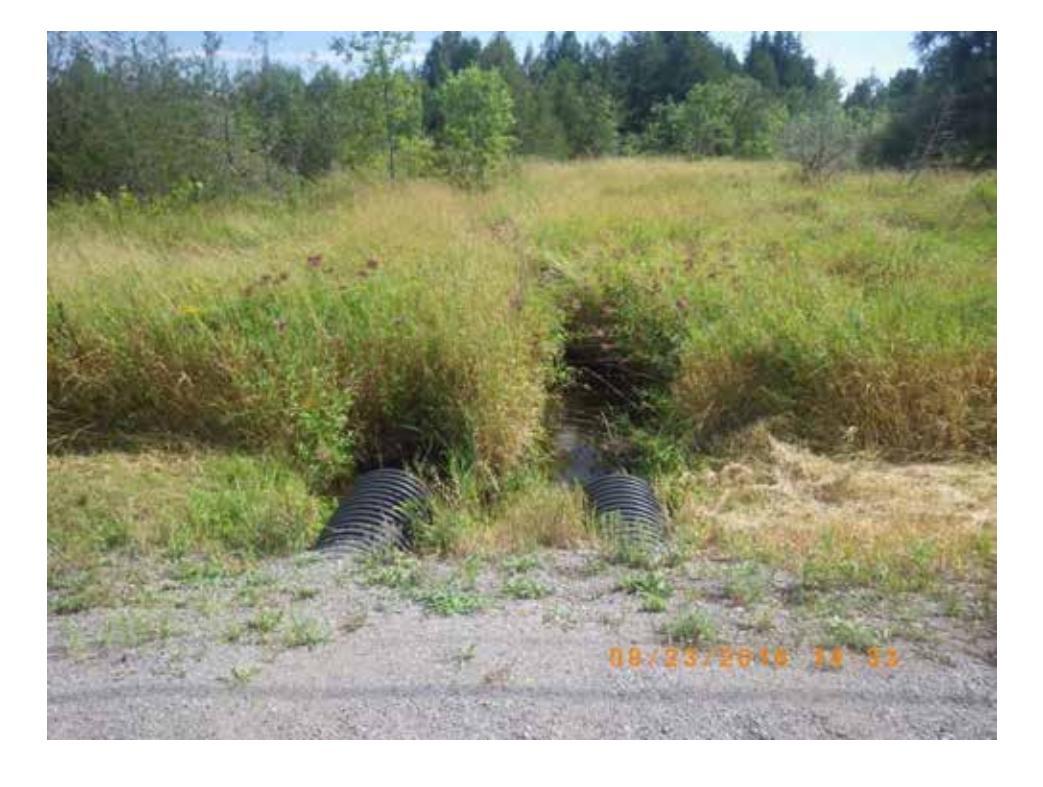
Photograph 6, facing south. Downstream end of Mud Creek where it crosses Centreville Road, flowing southward into an adjacent Reed Canary Grass Mineral Meadow Marsh.

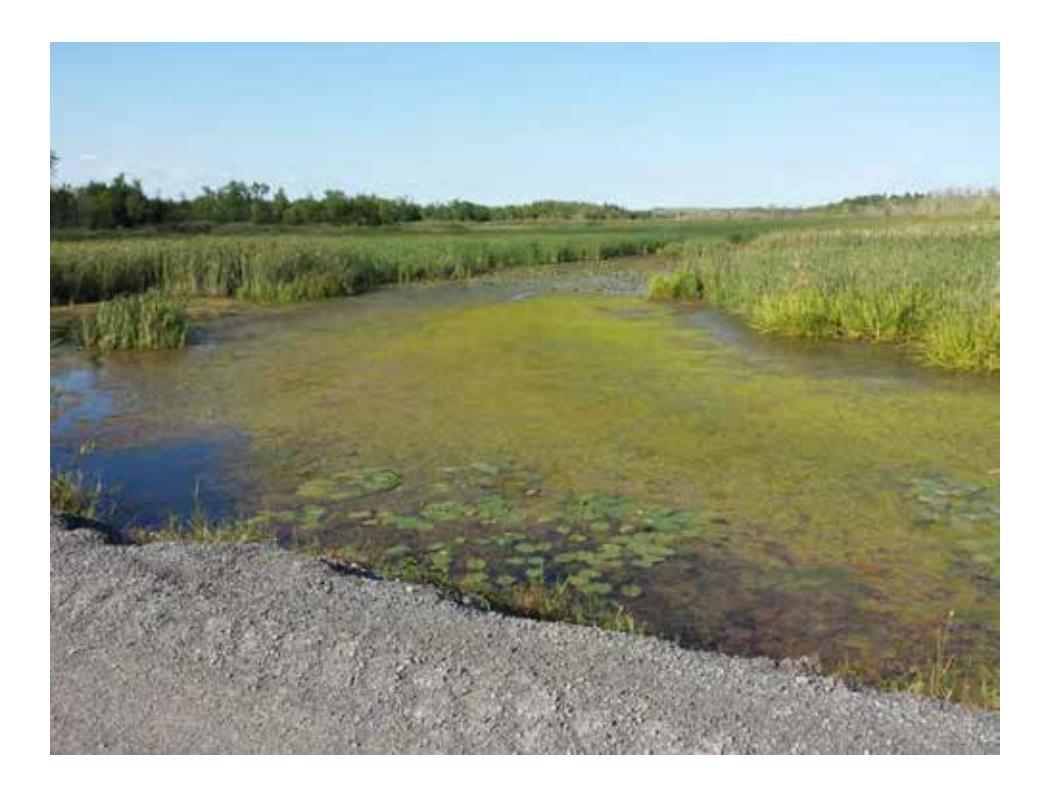
Photograph 7, facing southwest. Mud Creek, flowing under Rattie Road within the Project Location via a series of CSP culverts.

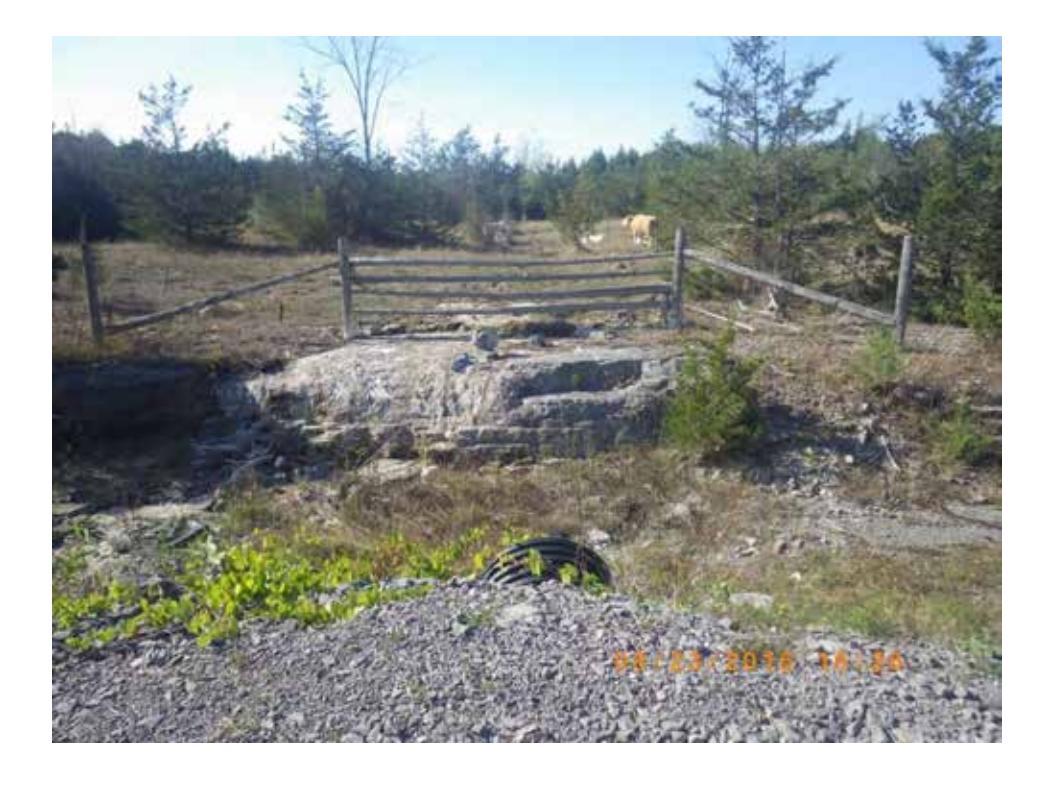
The location where Tributary 1 to Mud Creek was mapped as part of the records review (see **Figure 3**) was assessed during the site investigation. The site investigation found that Tributary 1 to Mud Creek did not meet the definition of a water body as per *Ontario Regulation 359/09* in the area where it intersected the Project Location along Centreville Road (see **Figure 3**). Observations made during the site investigation revealed a shallow grassed spillway without a defined channel. This area was determined to likely drain surface water from the surrounding pasture area (see **Photograph 8** in *Appendix D*). At this time of the site investigation, no pooling or flowing water was observed within the assessment area.

Photograph 8, facing north. Location of Tributary 1 to Mud Creek, determined to be a shallow grassed spillway used for drainage of the surrounding pasture area.

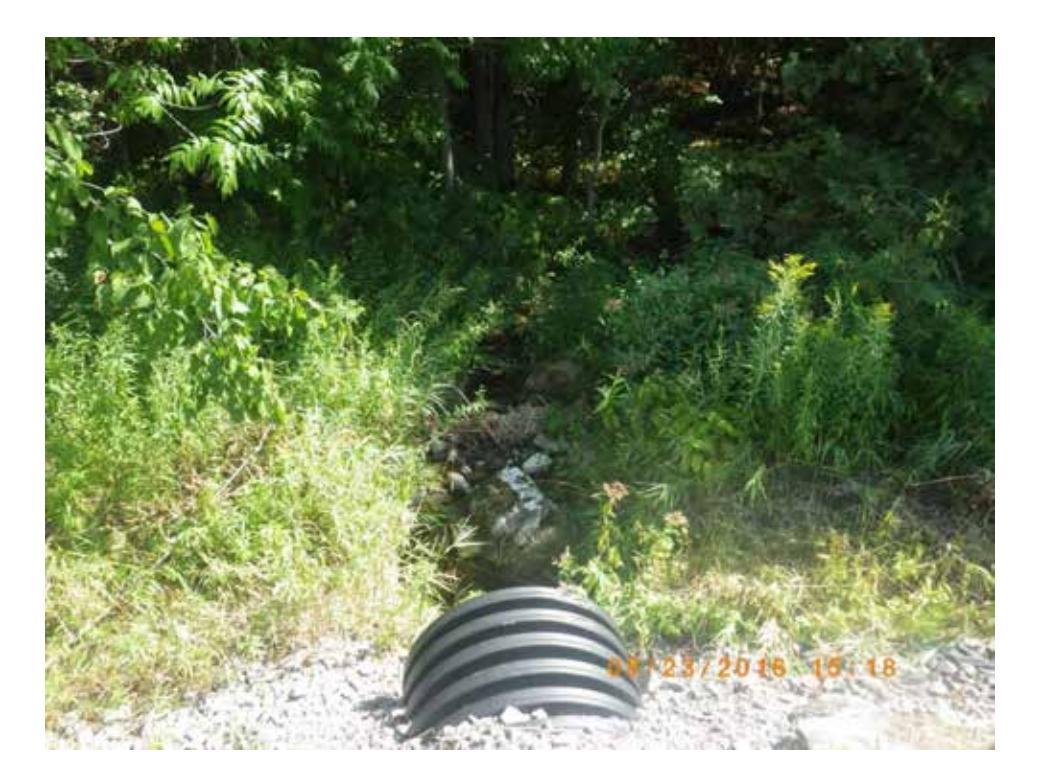
The site investigation found that Tributary 2 to Mud Creek occurred as mapped by the MNRF and as presented in the records review. The watercourse was found to be a natural intermittent stream and as such meets the definition of a water body under *Ontario Regulation 359/09*. The tributary intersects the Project Location where there is an existing culvert under Centreville Road approximately 440 m west of Lockridge Road (see **Photograph 9** in *Appendix D*; see **Figure 4d**).

Photograph 9, facing south. Location of Tributary 2 to Mud Creek, flowing southward under Centreville road via an culvert.

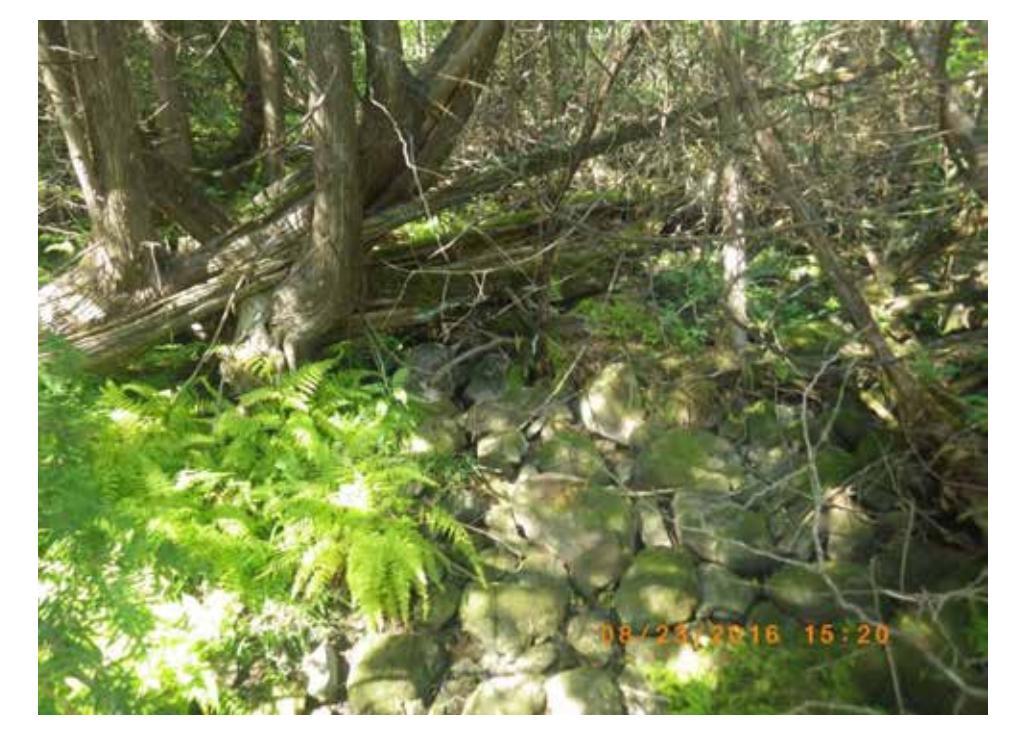
Photograph 10, facing northeast. Substrates found within Tributary 2 to Mud Creek were predominantly cobble, gravel and boulders.

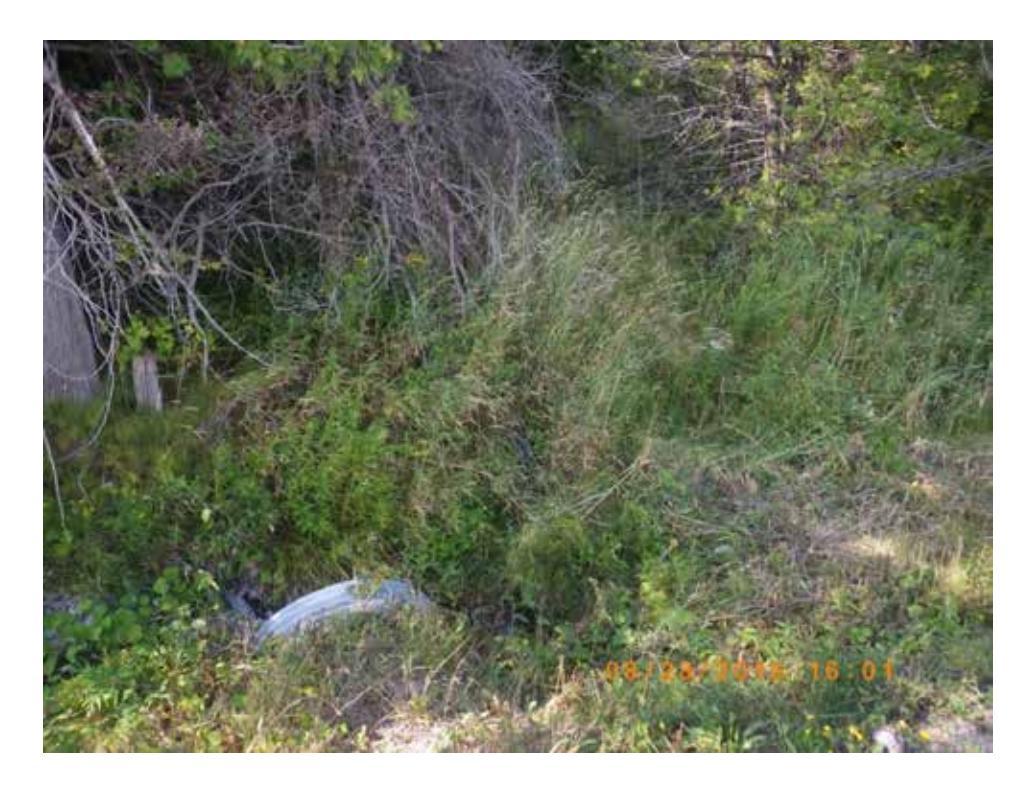
Photograph 11, facing northeast. Upstream end of Tributary 2.1 to Mud Creek at the intersection with the Project Location on Centreville Road, facing upstream.

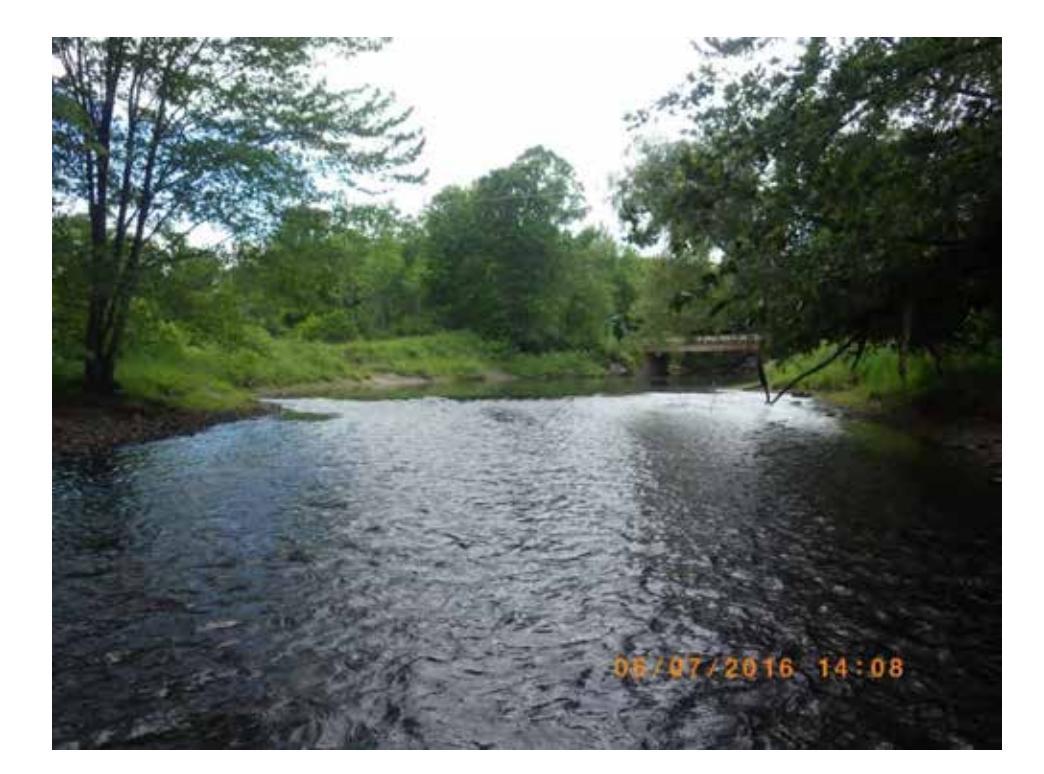
Photograph 13, facing northeast. Location of Salmon River, facing upstream towards the intersection with Sheffield Bridge Road.

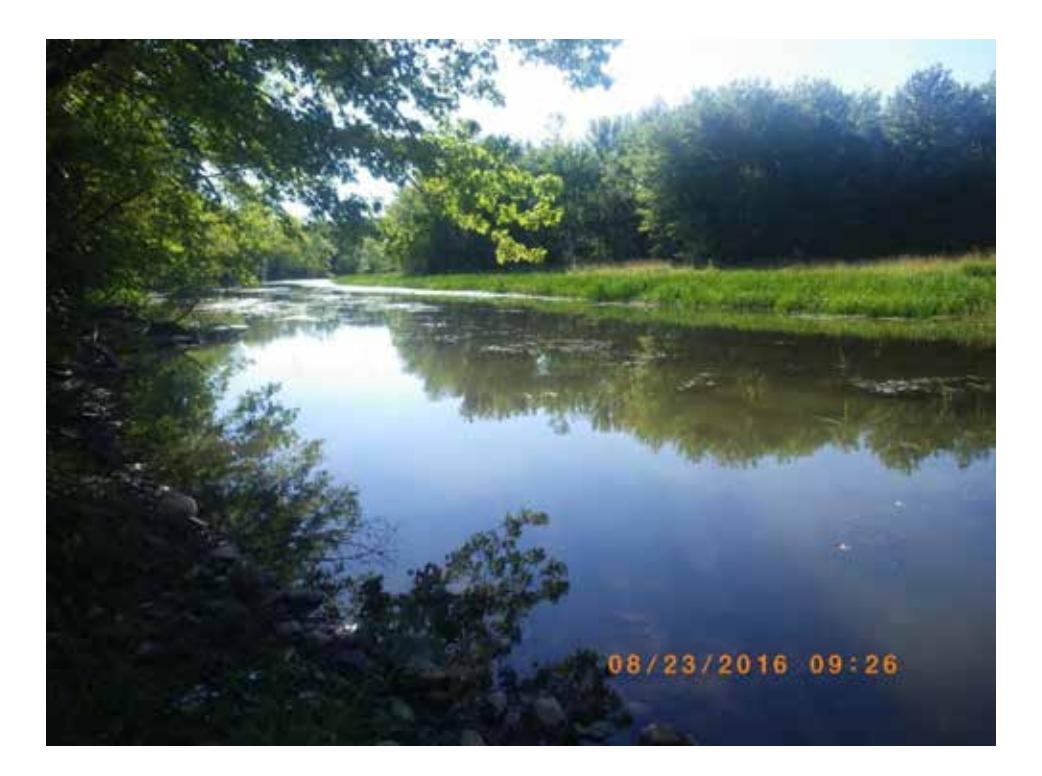
Photograph 14, facing southeast. Habitat within the Salmon River was observed as primarily flat morphology. Photo taken near Sheffield Bridge Road when Salmon River flows within 120 m setback of the Project Location.

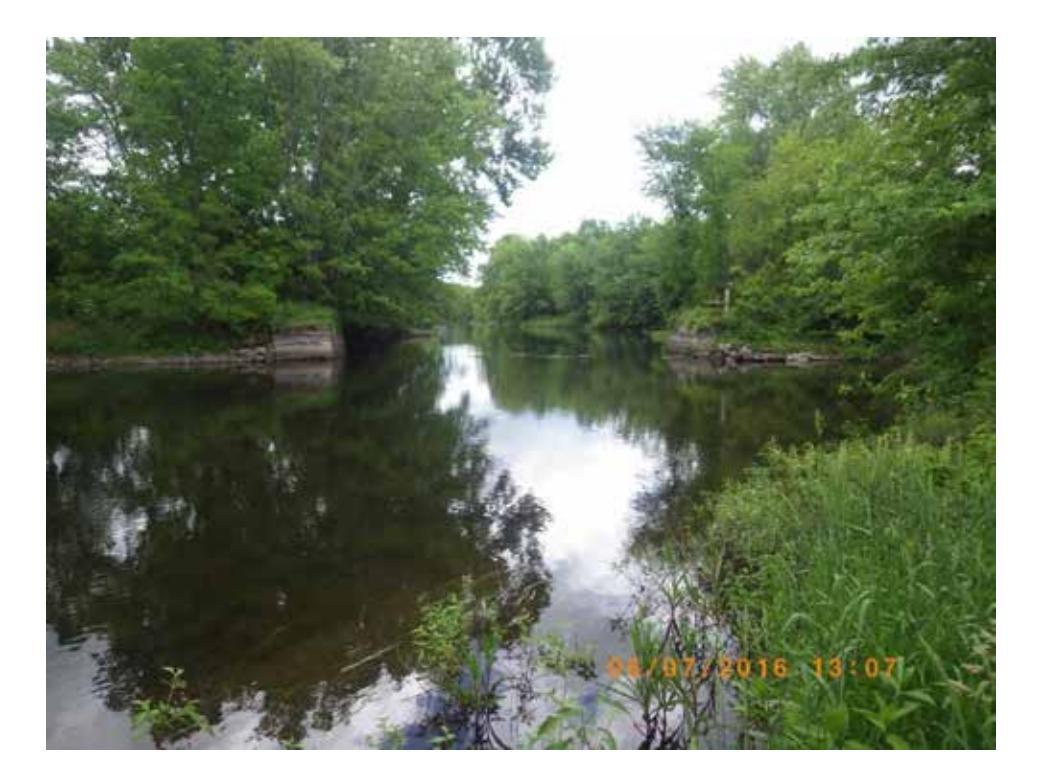
Photograph 15, facing south. Salmon River, facing downstream toward the intersection of the River with the Project near Haggerty Road.

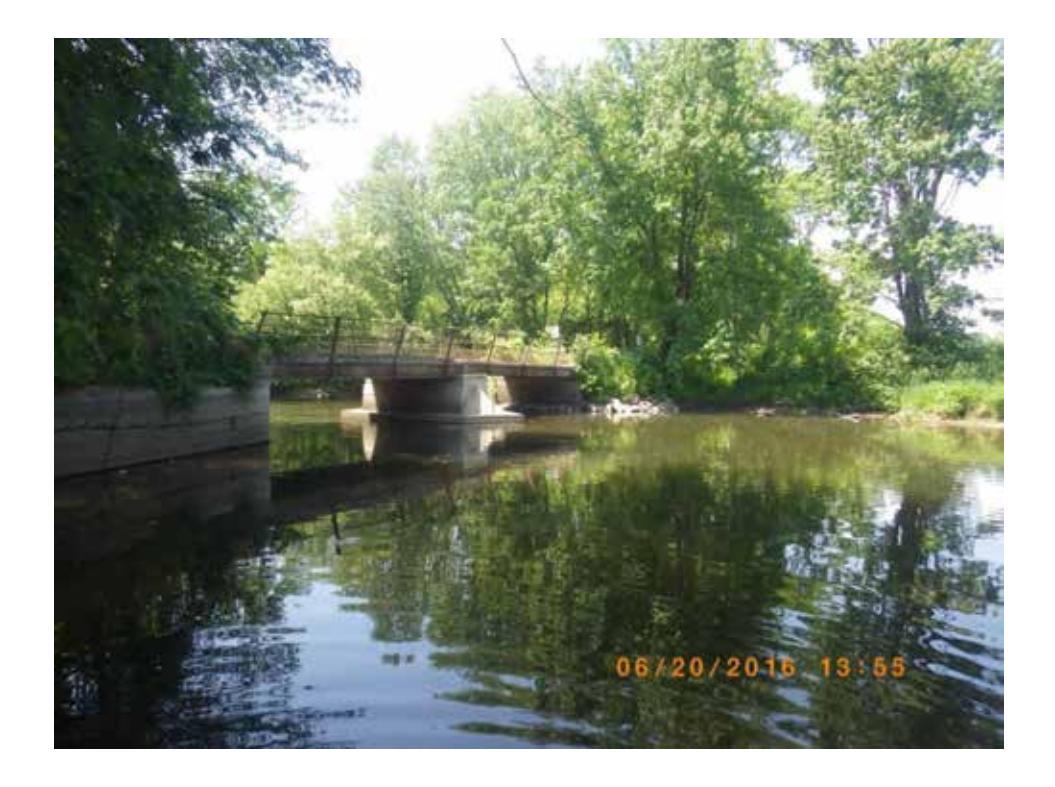
Photograph 16 Salmon River at intersection with Teskey Road.

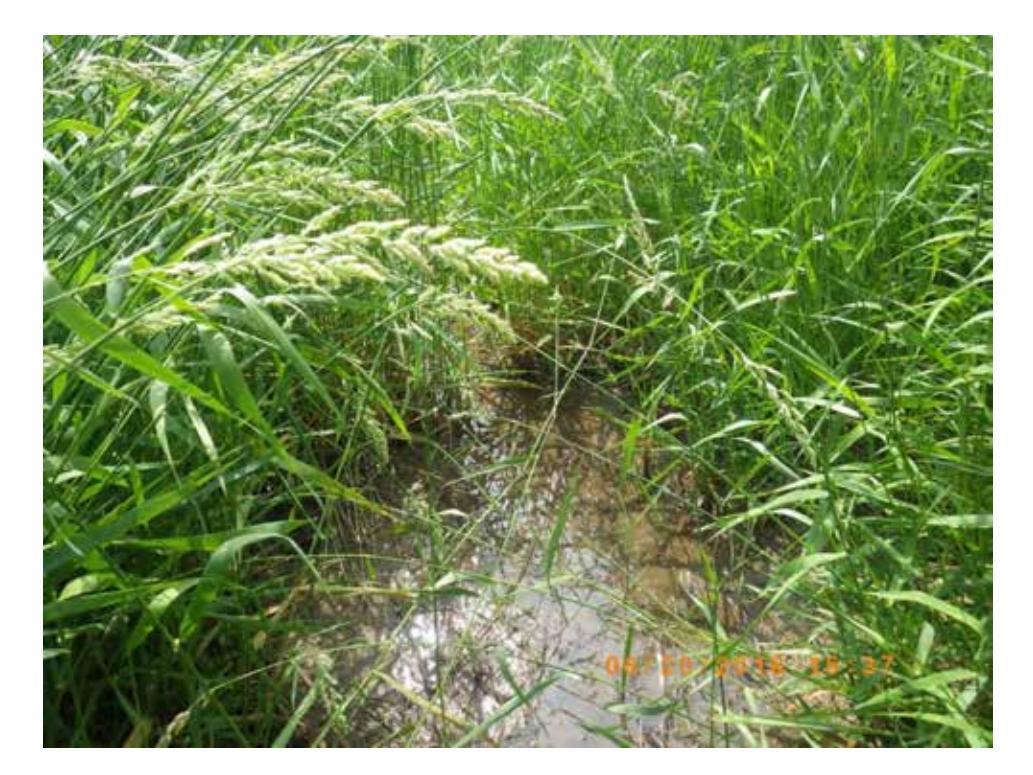
Photograph 17, facing west.

Tributary 1 to the Salmon River was surrounded by meadow habitat, with overhanging vegetation providing in-stream cover. Muck was observed as the dominant substrate. Photo taken upstream of the intersection with Teskey Road.

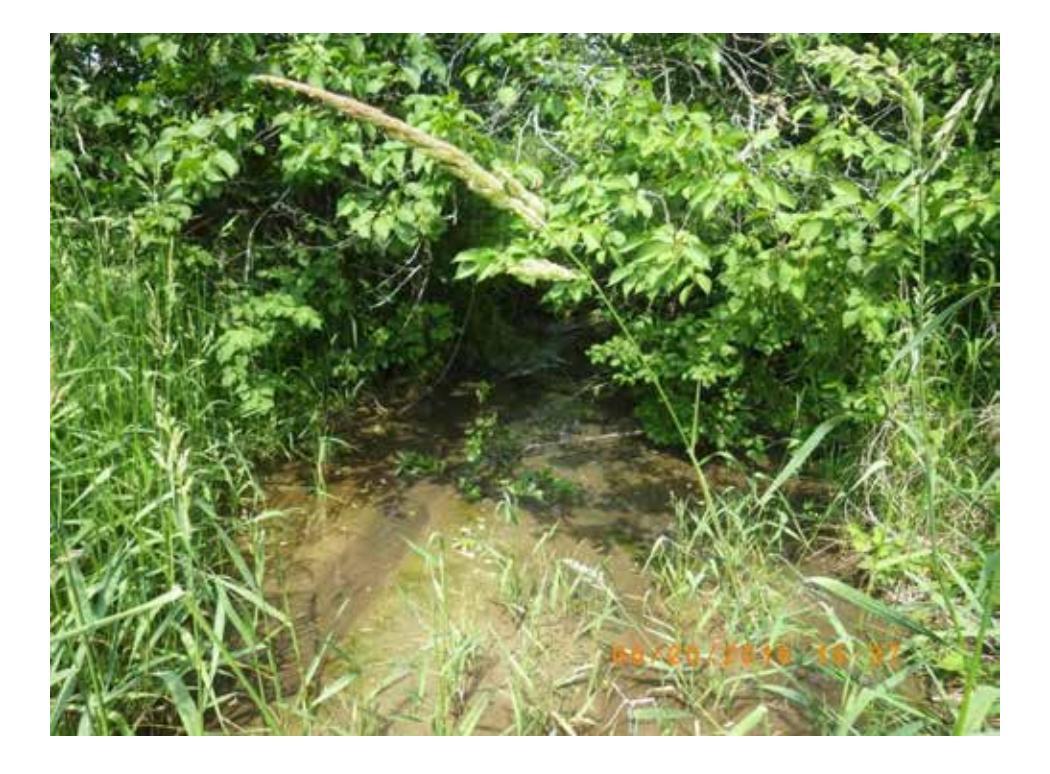
Photograph 18, facing east. Tributary 1 to the Salmon River. Photo taken downstream of intersection with Teskey Road.

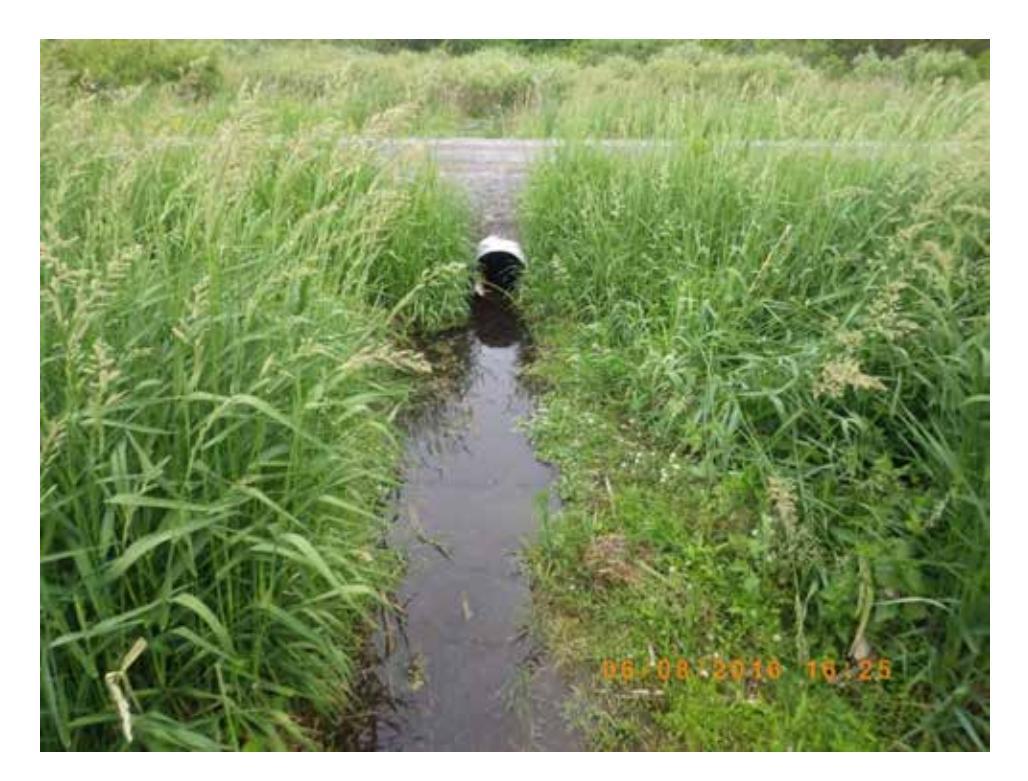
Photograph 19, facing west.

Tributary 2 to the Salmon River, flowing westward within the Project Location under Edges Road via a CSP culvert.

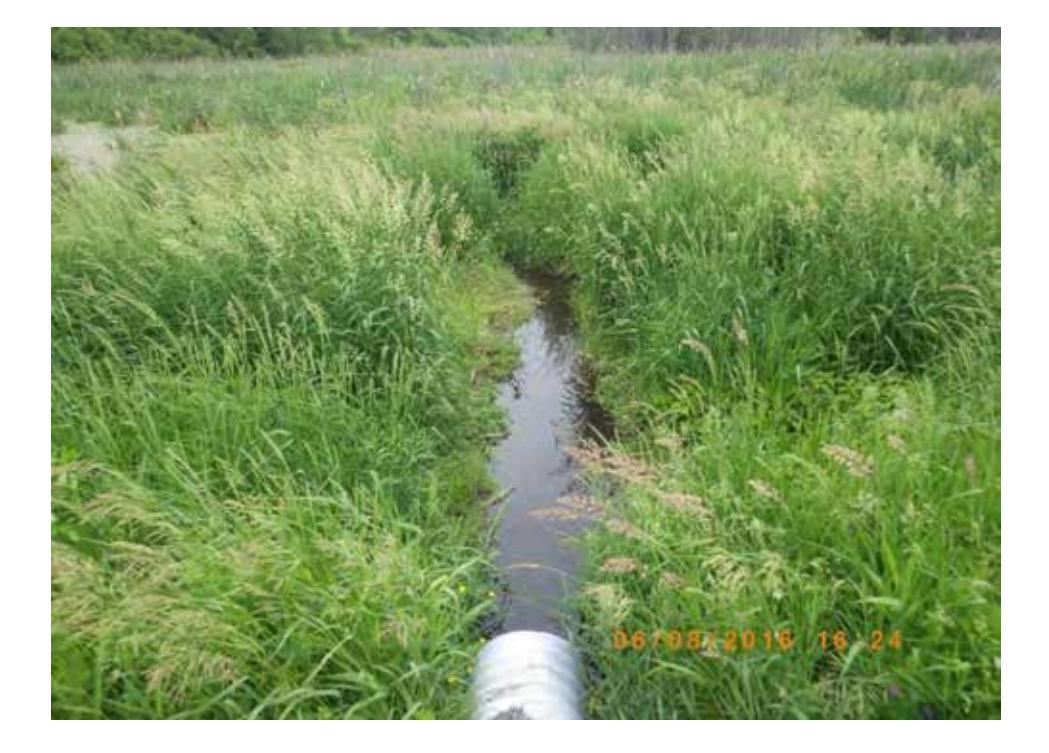
Photograph 20, facing west. Downstream end of Tributary 2 to the Salmon River.

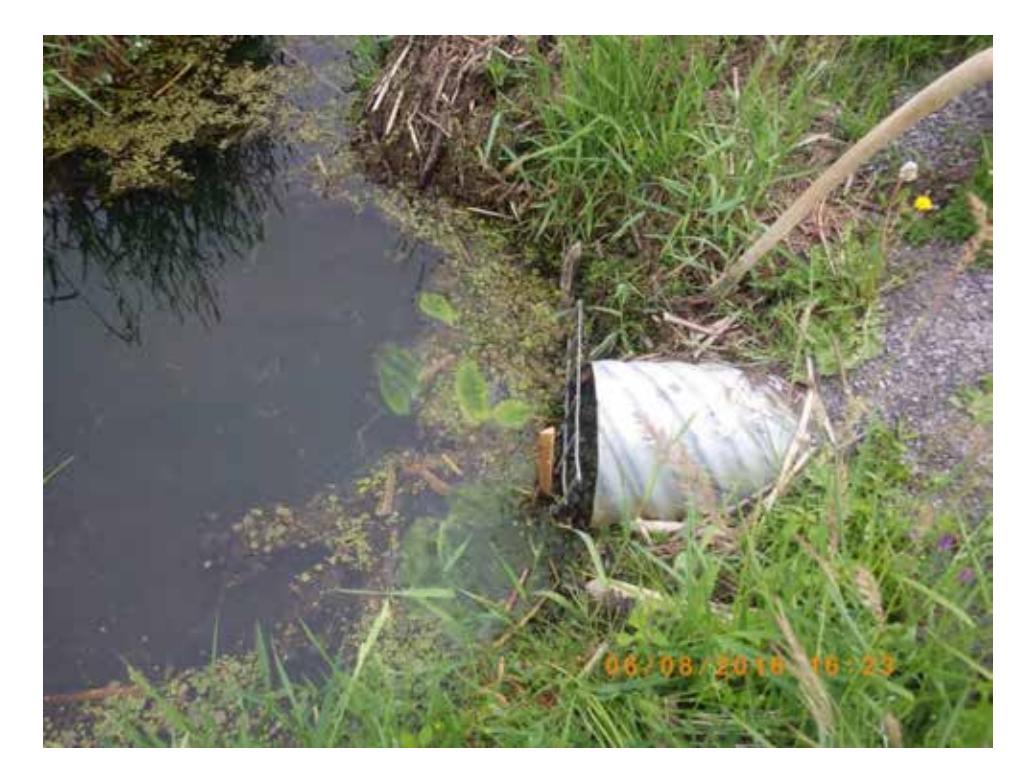
Photograph 21, facing northeast.

A small grate attached to the upstream end of the culvert at the intersection of Tributary 2 to the Salmon River and Edges Road could provide migratory obstruction for various fish species.

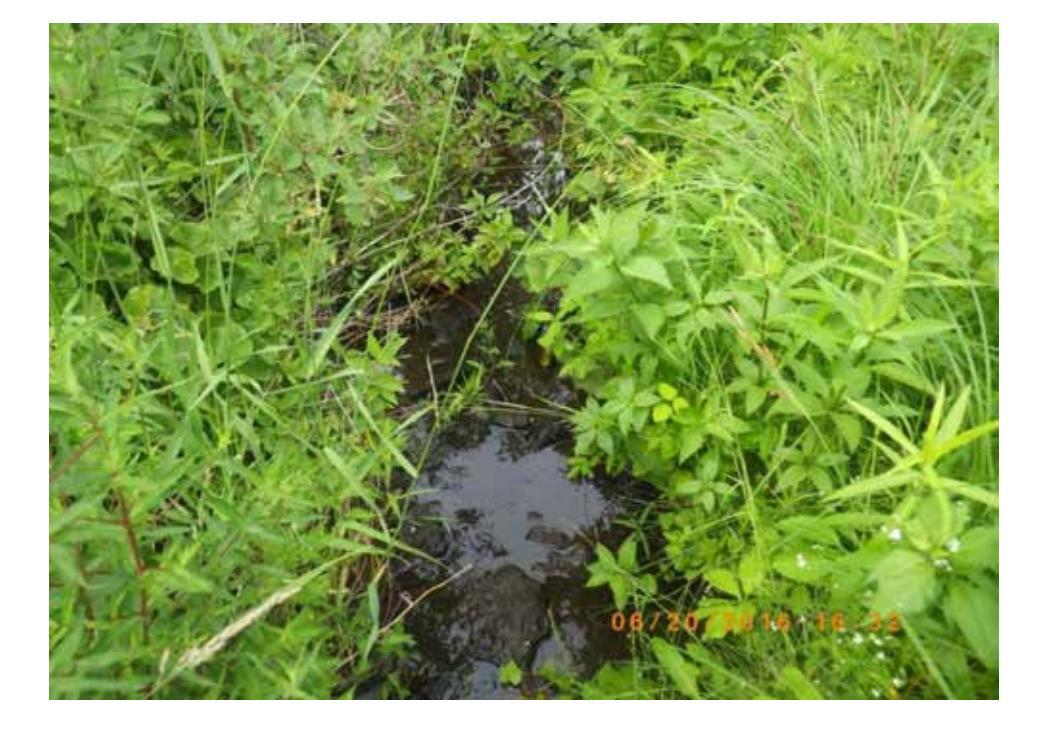
The watercourse was then assessed where it intersects the Project Location at County Road 27, approximately 210 m east of Teskey Road (see **Photograph 22** in *Appendix D*; Figure 4g). The habitat type was observed as run morphology, with minimal but steady water flow observed in a northward direction. Substrates were comprised of a mix of gravel, sand, muck, detritus and cobble. Mean wetted width was 0.8 m, mean wetted depth was 0.4 m, mean bankfull width was 1.3 m and mean bankfull depth was 0.9 m (widths and depths are approximate). The surrounding riparian community consisted of Green Ash-hardwood Lowland Deciduous Forest. The watercourse surface was approximately 60% shaded by shore cover. Upstream and downstream water temperature readings were taken as 13°C and 11°C (respectively) and upwelling water with a slight sheen was observed on the upstream end of the assessment area, indicating the potential presence of groundwater input (Seep 2, see Section 9.4.2).

Photograph 22, facing south. Tributary 2.1 to the Salmon River. Photo taken facing upstream near the intersection with County Road 27, east of Teskey Road.

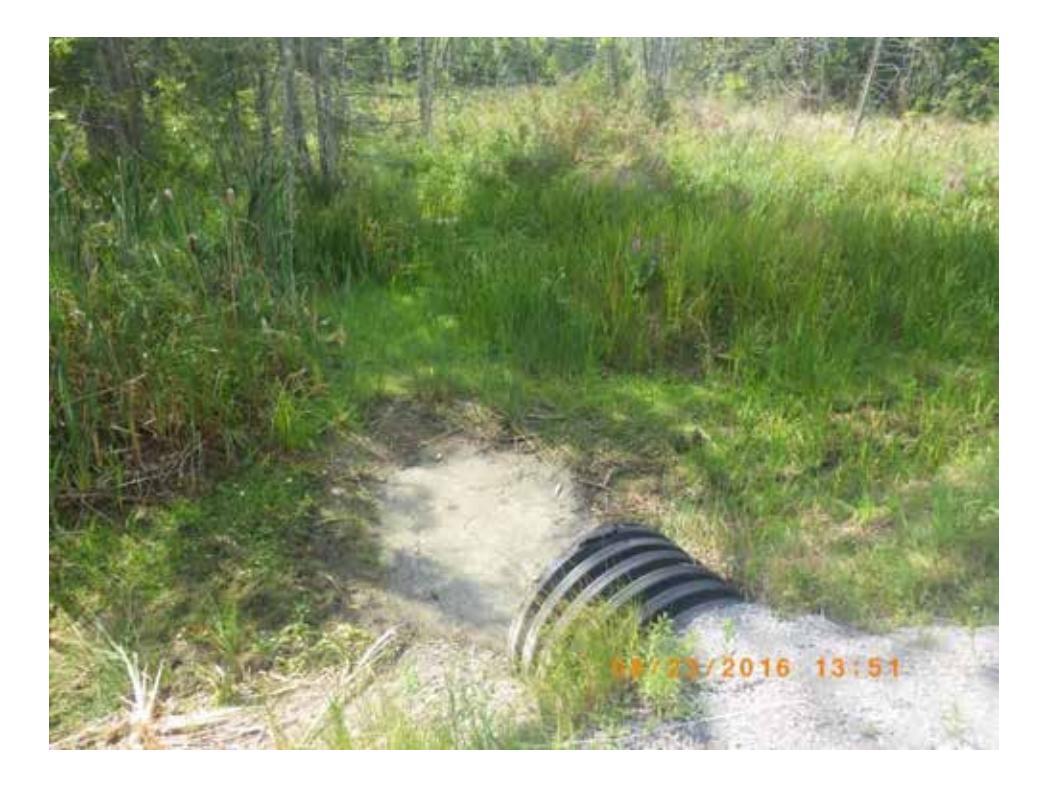
The watercourse was assessed where it crosses County Road 27 through a culvert and intersects with the Project Location; approximately 670 m south of Marlin Road (see **Photographs 23 and 24** in **Appendix D**). Based on aerial photography, the watercourse appears to originate from a mineral deciduous swamp area east of County Road 27, flowing west to a small pool area adjacent to the road (see **Photograph 25** in **Appendix D**; **Figure 4e**) before continuing north for approximately 50 m to the culvert location. The watercourse was observed as dry upstream and downstream of the pool area at the culvert, indicating the watercourse is intermittent. Substrates were muck and detritus. Mean wetted width of the pool was 2.7 m and mean wetted depth was 0.30 m. For the overall channel, the mean bankfull width was 4.1 m and mean bankfull depth was 0.8 m (widths and depths are approximate). Both banks showed signs of erosion. In-stream cover was predominantly from overhanging shoreline vegetation with sparse cover from undercut banks, organic and woody debris (in-stream and overhanging), and in-stream vegetation consisted of a small amount of emergent Burreed species (*Sparganium sp*). The watercourse surface was approximately 1-30% shaded by shore cover. No obstructions to fish movement or evidence of groundwater were observed, however, the intermittent nature of the watercourse in this location could lead to seasonal migratory impediments for fish.

Photograph 23, facing west. Tributary 2.1 to the Salmon River at intersection with County Road 27, south of Marlin Road. Photo taken facing downstream.

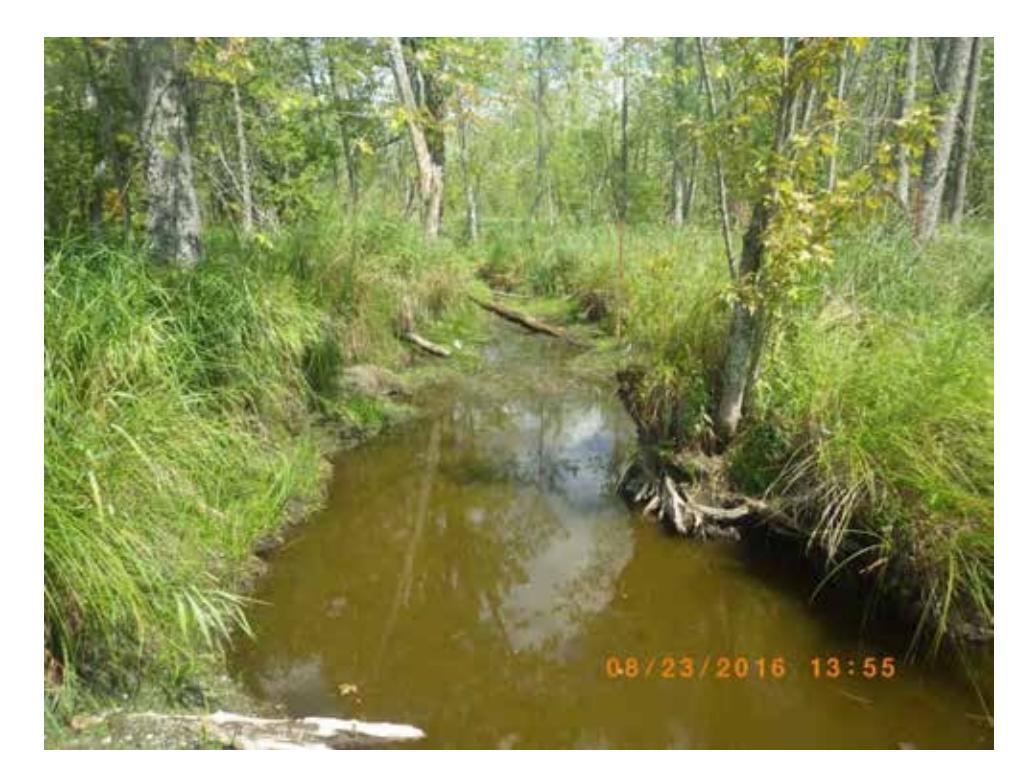
Loyalist Solar LP *Water Assessment Report - Loyalist Solar Project* February 2017 – 16-3674 Photograph 25, facing northeast. Tributary 2.1 to the Salmon River at pool area approximately 50 m south of the intersection with County Road 27, south of Marlin Road.

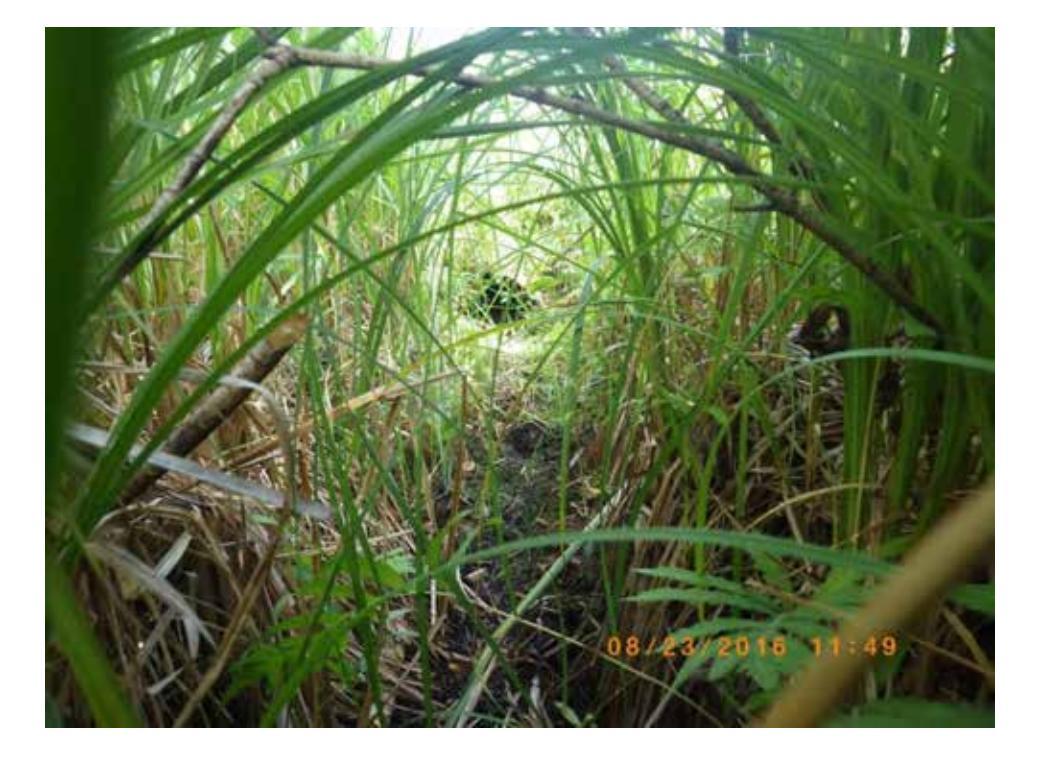
Photograph 26, facing west. Tributary 2.2 to the Salmon River. Photo taken facing downstream towards the CSP culvert at the intersection with Edges Road.

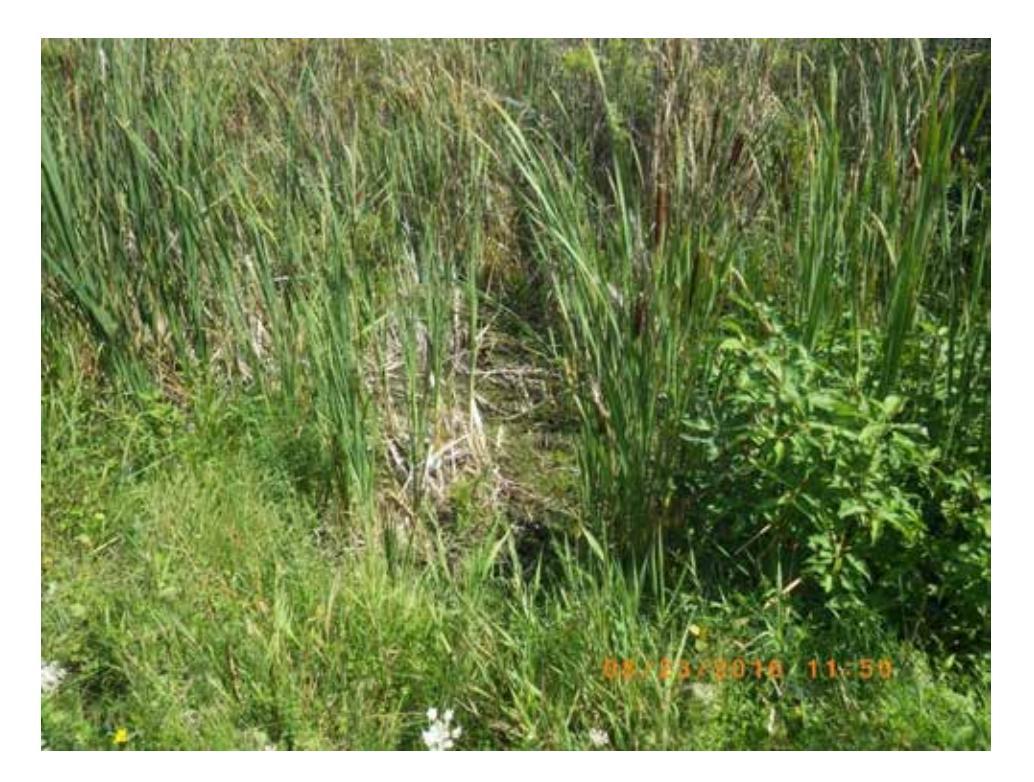
Photograph 27, facing west. Intersection of Tributary 2.2 to the Salmon River with Edges Road. Photo taken from the road.

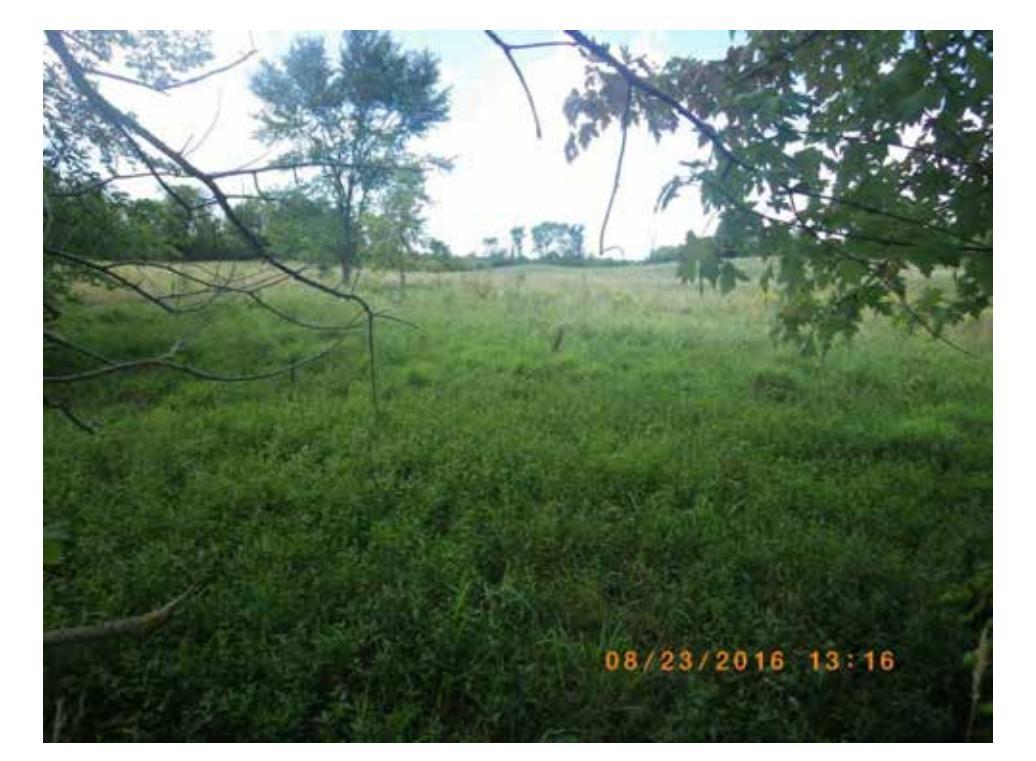
Photograph 29, facing northwest.

Pooling surface water was observed within a cattail graminoid mineral meadow marsh southeast of the assessment location on Marlin Road (see **Photograph 28** in *Appendix D*) and is suspected of entering the adjacent culvert installed under the road during periods of extended high precipitation, however, no evidence of a defined watercourse channel was observed at the downstream end of the culvert northwest of the road (see **Photograph 29** in *Appendix D*).

Area where Tributary 2.3 to the Salmon River was mapped during records review. No evidence of a watercourse was observed downstream of the culvert location adjacent to the wetland on Marlin Road.

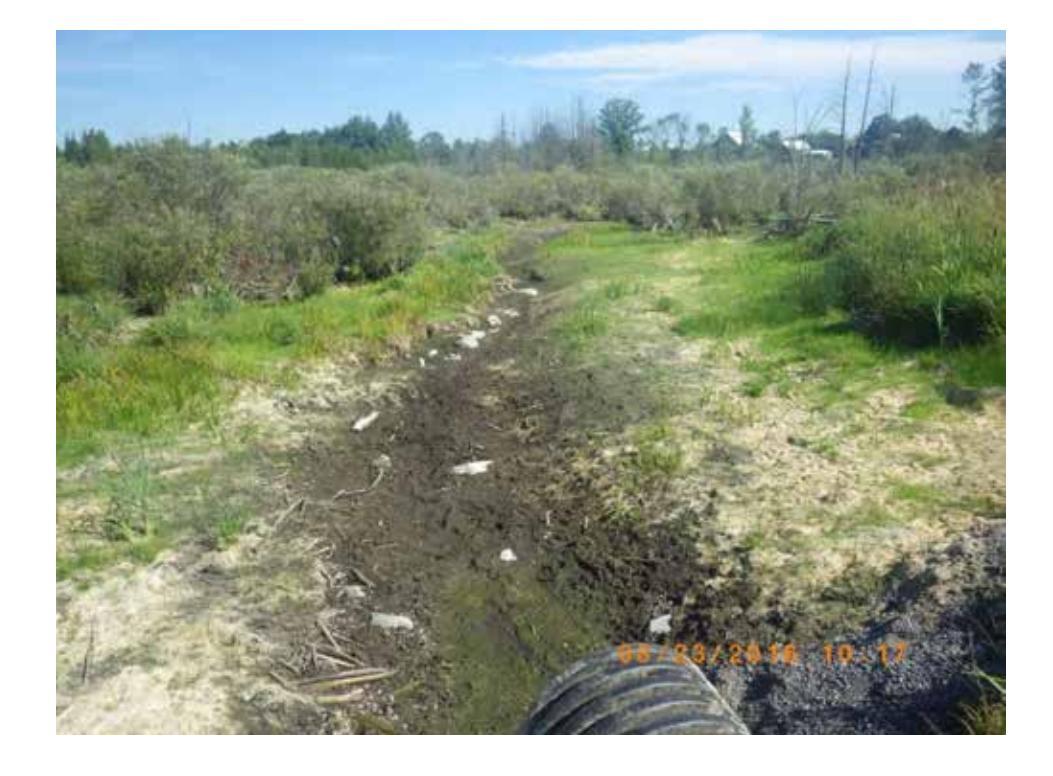
Photograph 30, facing northeast. Tributary 3 to the Salmon River at intersection with Haggerty Road.

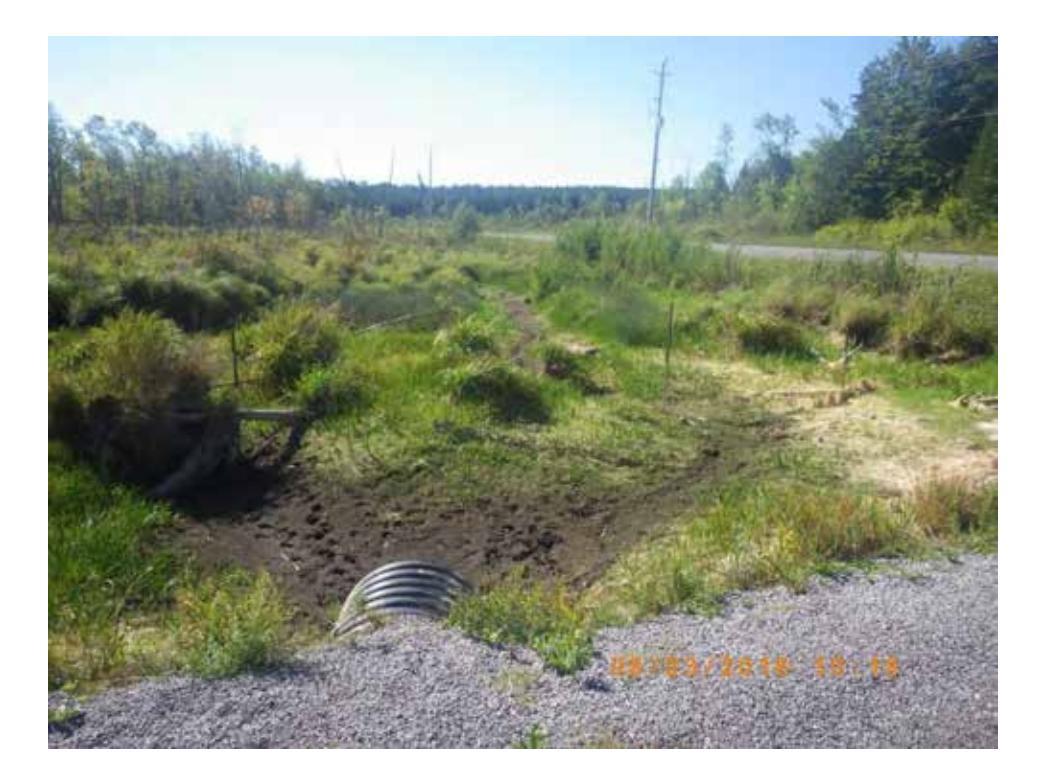
Photograph 31, facing southwest. Tributary 3 to the Salmon River at intersection with Haggerty Road.
