4.0 **Records Review Purpose**

Loyalist Solar LP *Water Assessment Report February 2017 – 16-3674* Photograph 1, facing east. Water body 1, located on a residential property southeast of the intersection of Hinch Road and Rattie Road.

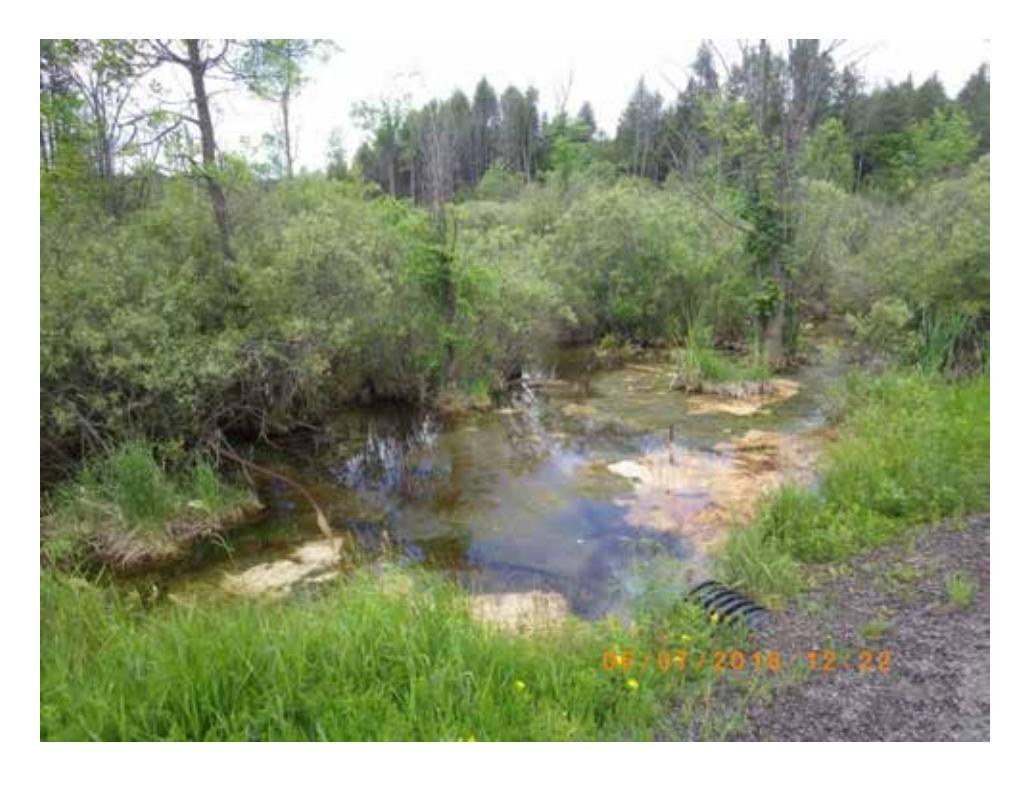
Photograph 32, facing northwest. Upstream end of Tributary 3.1 of the Salmon River at the intersection with the Project Location on Miller Road, facing upstream.

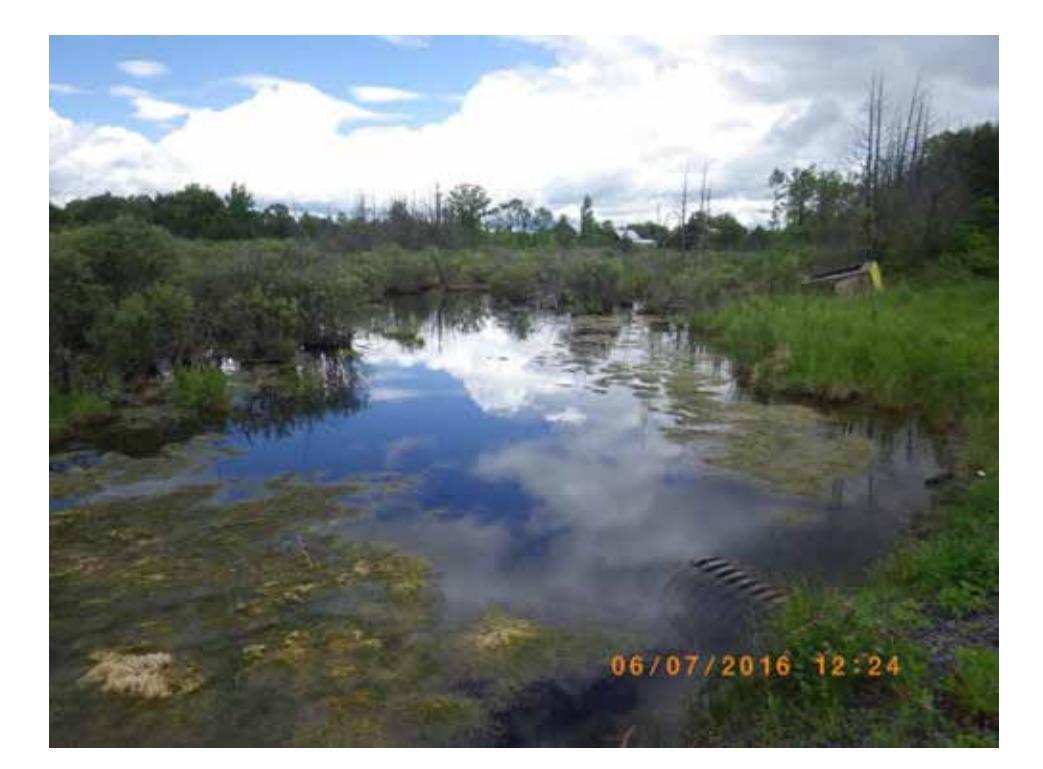
Photograph 33, facing southeast. Downstream end of Tributary 3.1 of the Salmon River at the intersection with the Project Location on Miller Road, facing downstream.

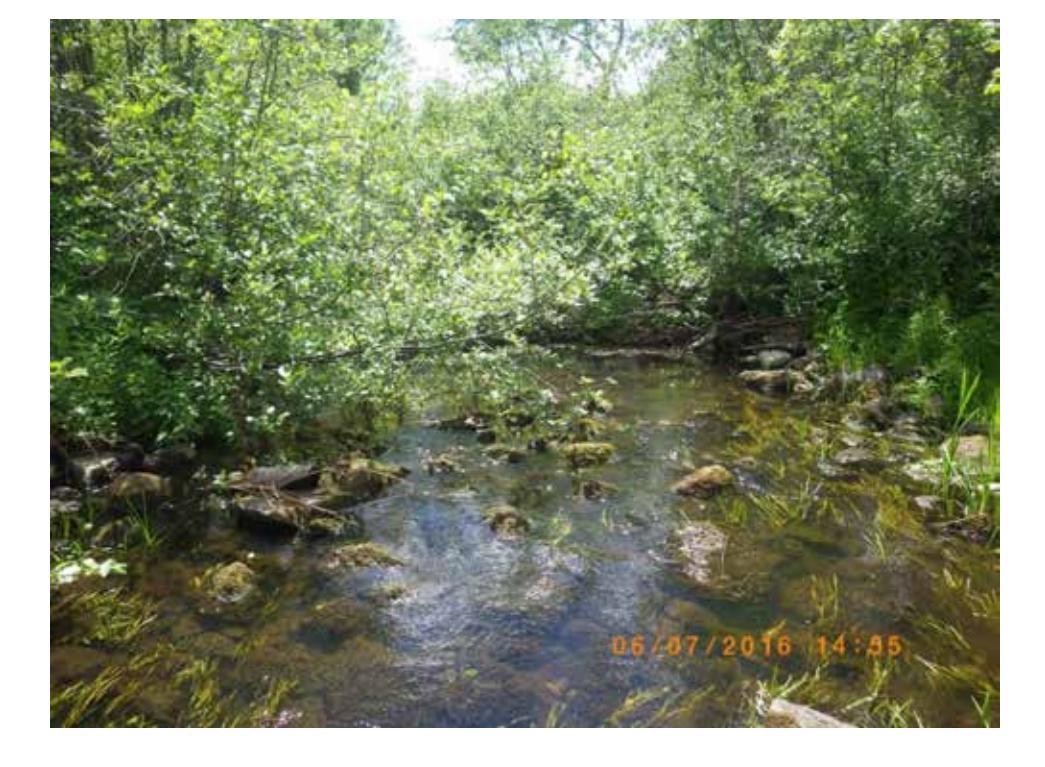
Photograph 34, facing west. Downstream end of intersection between Black Creek and the Project Location on

Murphy Road.

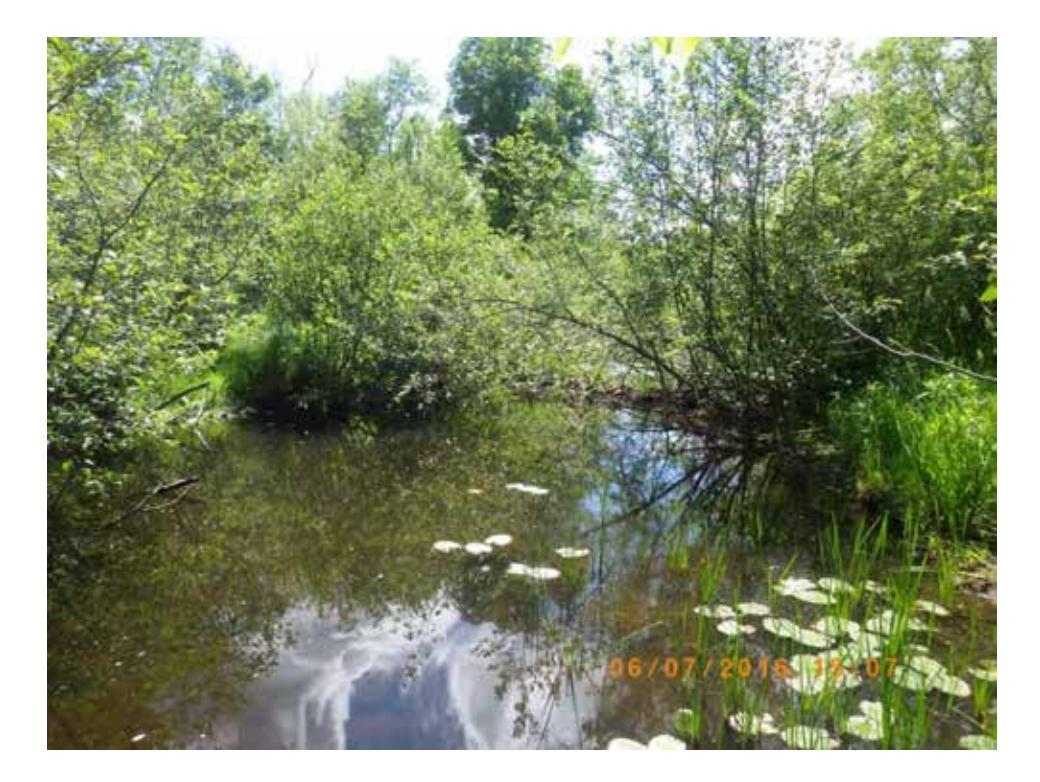
Photograph 35, facing east.

Upstream end of intersection between Black Creek and the Project Location on Murphy Road, facing upstream.

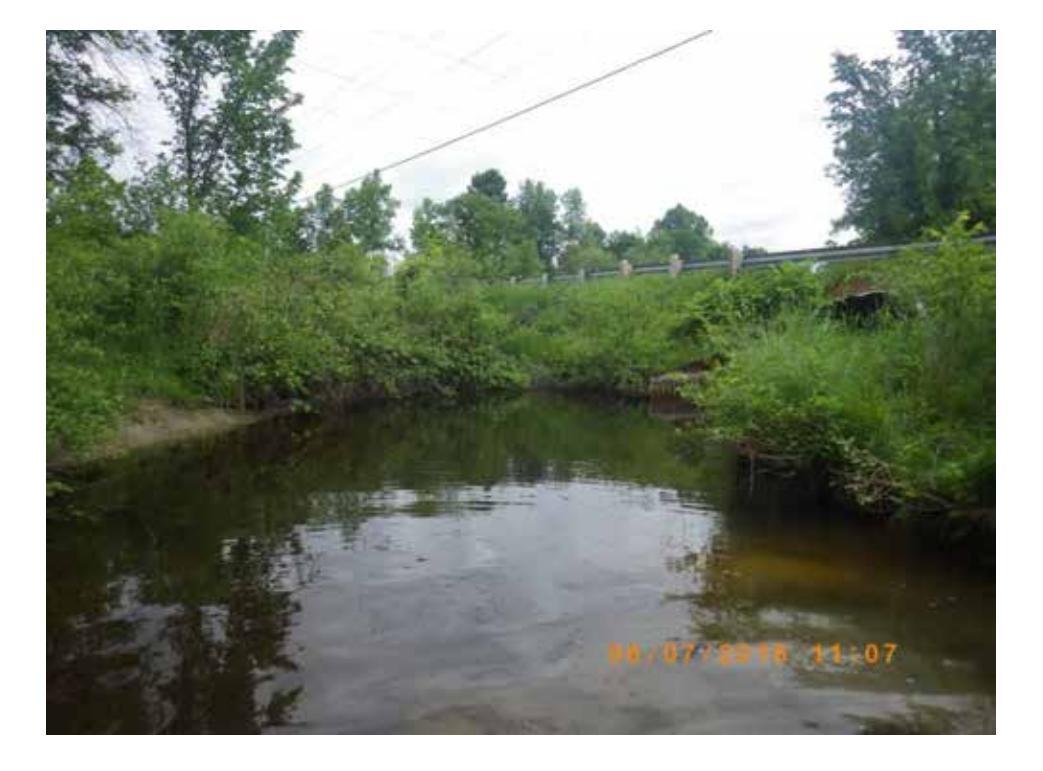
Photograph 36, facing east. Upstream end of Pennell's Creek near intersection with the Project Location on Miller Road, facing downstream.

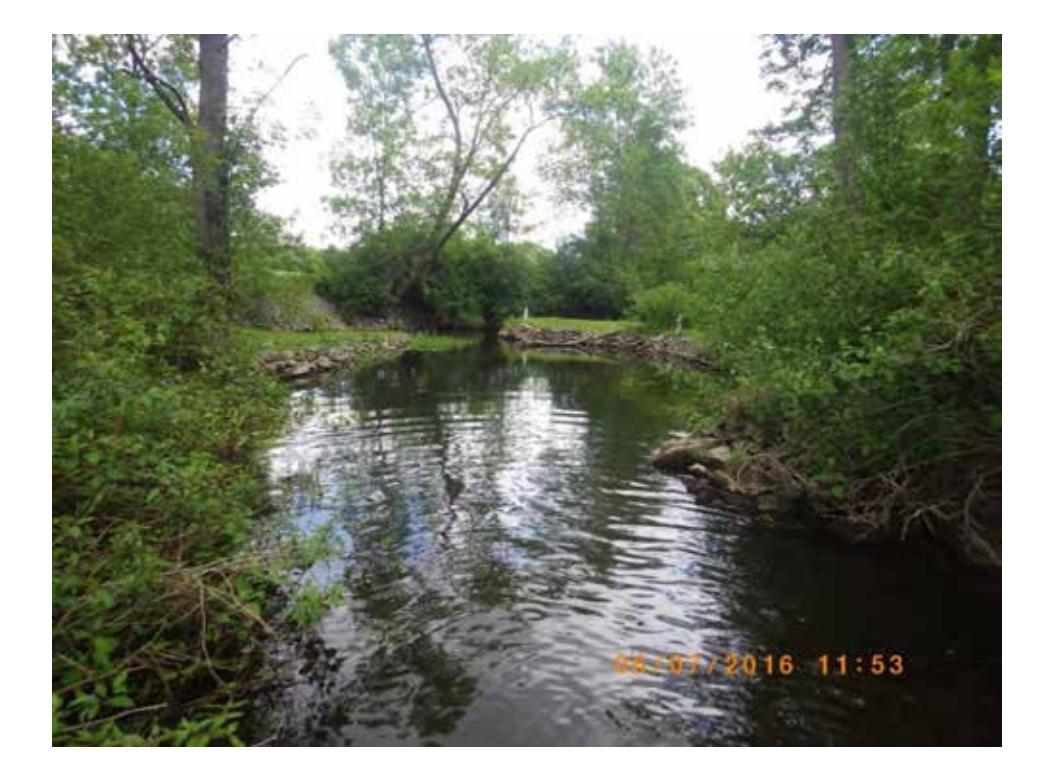
Photograph 37, facing east.

Downstream end of Pennell's Creek near intersection with the Project Location on Miller Road, facing downstream.

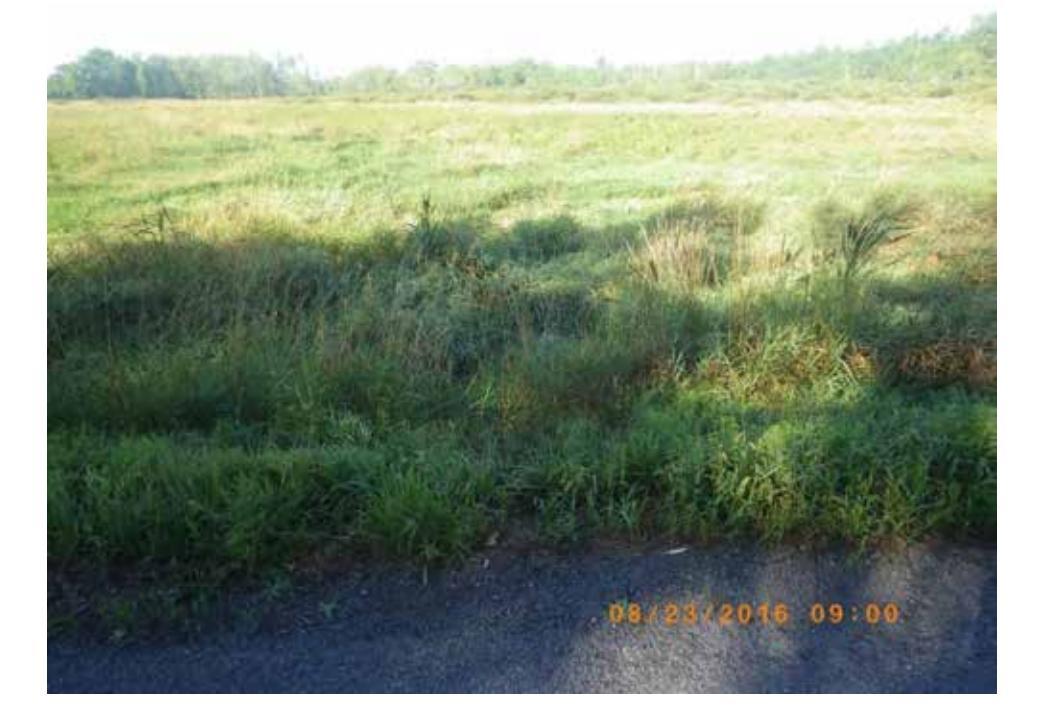
Photograph 38, facing west. Evidence of the mapped Tributary to Pennell's Creek was not observed in assessment location. Mapped watercourse is estimated to be a combination of drainage swales through the agricultural field to the east and surface water in the grassed roadside ditches.
